STEPS FOR REMOVING REAR ASHTRAY & CUP HOLDER, CENTER ARMREST, E-BRAKE CONSOLE, FRONT ASHTRAY, LOWER CENTER CONSOLE AND GLOVE BOX

STEPS FOR REMOVING DRIVER'S SIDE DASH TRIM, BRAKE-LIGHT SWITCH, RADIO/CUBBY HOLE, FRONT CUPHOLDER AND RADIO/HVAC TRIM CAGE

The following outlines the procedure for removing the above items on a MKIV Jetta and Golf/GTI. The procedure was based on a 99.5 Jetta GLS VR6 with a manual transmission - it may be slightly different on later-models cars (those with no rear cup holder) and all models with automatic transmission. Please do these procedures at your own risk and be ready to make small adjustments while doing them. Also, please be observant while removing parts so that they go back together correctly.

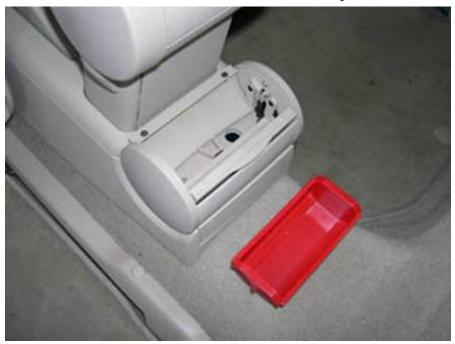
- 1. Slide the driver's and front passenger's seats completely forward.
- 2. Open rear ashtray and remove red insert as shown in picture below.

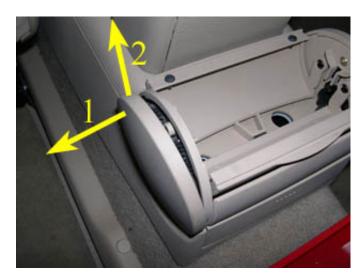
3. Remove the two sides to the rear ashtray as shown in the picture below. Pry the top of the ashtray side off of the ashtray housing (1). Once this is done, pull upwards on the ashtray side (may have to pull hard) to remove it (2).

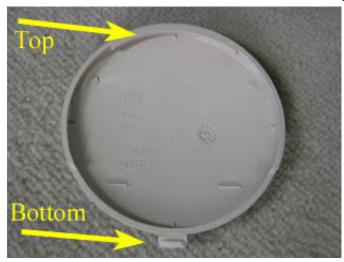
4. The picture below illustrates how the top and bottom of the ashtray sides are connected to the ashtray.

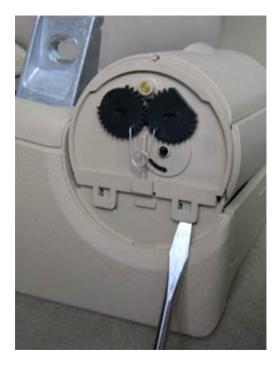
5. Remove the rear ashtray housing by carefully prying up the two tabs on each side with a screwdriver, as shown in the picture below. Be careful not to break the tabs while doing this - they are somewhat difficult to get off.

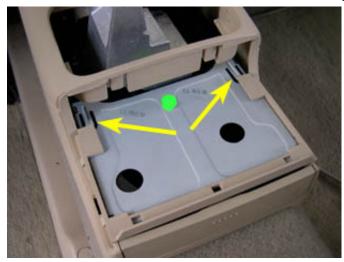
6. To remove the rear cup holder (if applicable), push down the two retaining tabs indicated by the arrows in the picture below.

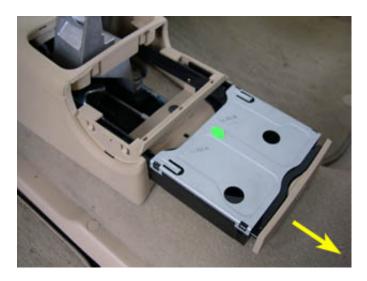
7. Slide the rear cupholder out of the e-brake console as shown in the picture below.

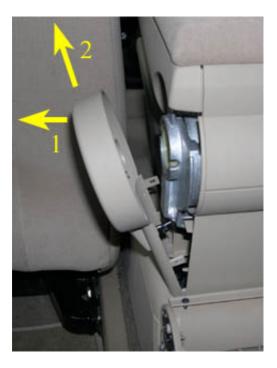
8. Remove the driver's side of the armrest trim as shown in the picture below. First pull the top of the trim towards the driver's side (1) and then pull upwards at an angle to remove (2).

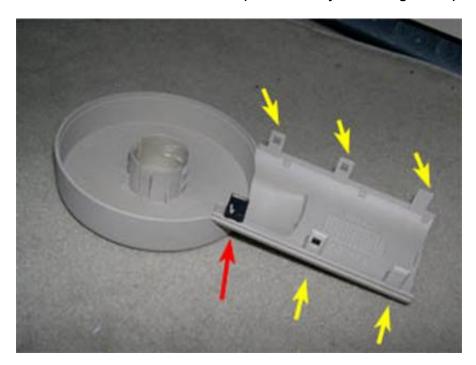
9. Be careful doing the above. The trim piece is held in by 6 tabs as shown in the picture below (arrows). I've removed this piece enough times that I've partially broken one of the tabs (red arrow). You can use a thin screwdriver protected by a thin rag to help ease the tabs out.

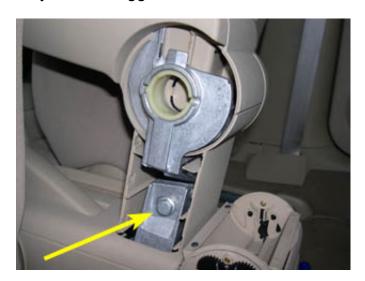
10. Remove the 13mm bolt in the picture below to remove the armrest. Once the bolt is out, you may need to wiggle the armrest back and forth to get it free - then move it up to remove.

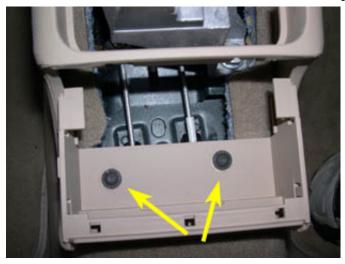
11. Remove the two T20 Torx screws indicated by the arrows in the picture below.

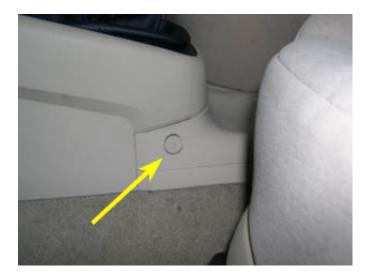
12. Slide the driver's and front passenger's seats completely backward. Pry out the trim tab on both sides of the e-brake console indicated by the arrow in the picture below.

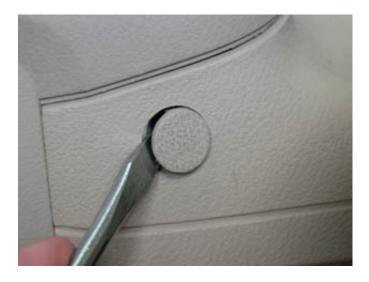
13. This is easily done with a screwdriver, as shown below.

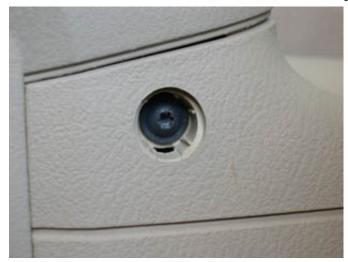
14. Remove the T20 Torx screws behind the tabs, as shown below.

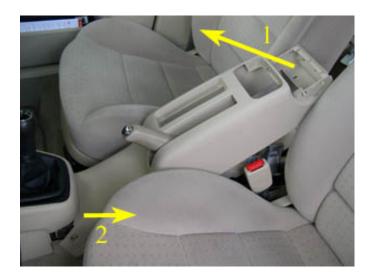
15. Pull up the emergency brake handle as high as it will go - the higher it is, the easier the next step will be. Remove the e-brake console by (1) raising the rear of the console relatively high (see picture below for approximate position) and then (2) sliding the front of the console out from under the lower center console (where the shifter is). When the front of the e-brake console is free, slide the console up and over the e-brake handle. This may take a few attempts - it's somewhat difficult to free the front of the e-brake console from under the lower center console.

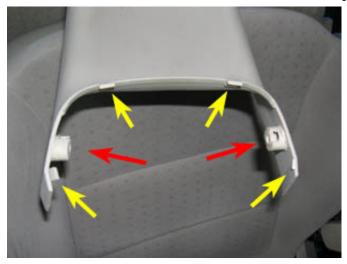
16. The image below shows the 4 tabs (yellow arrows) and two posts (red arrows) that make it difficult to release the front of the e-brake console from under the lower center console.

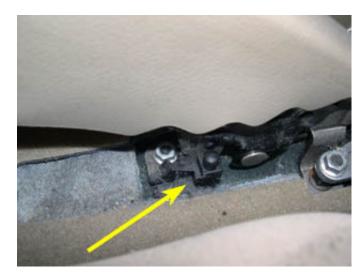
17. The picture below shows the position of the e-brake microswitch. It just clips onto the e-brake support and can be easily removed.

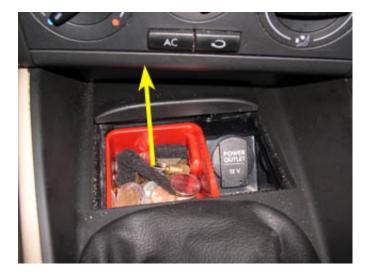
18. Slide open the front ashtray lid and remove the red insert seen in the picture below. (I apologize for the detritus - I should have done some detailing before I took the pics.)

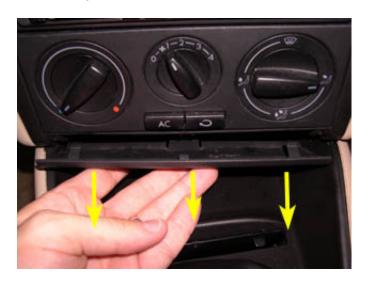
19. Remove the small trim piece just below the A/C controls (or Climatronic if that's what you have) by pulling it towards the rear of the car, as shown below. While this step is not absolutely

necessary, it makes the removal of the front ashtray significantly easier.

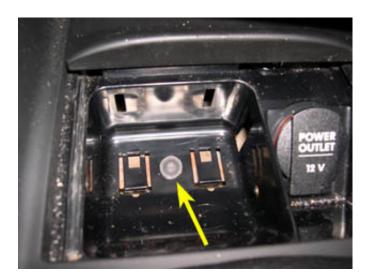
20. Remove the T20 Torx screw at the bottom of the front ashtray indicated by the arrow in the picture below.

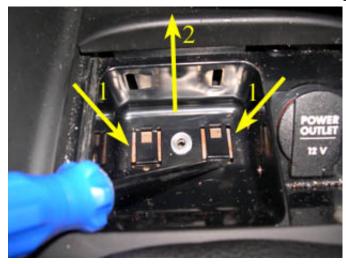
21. Using two screwdrivers (only one is shown), pull the two tabs indicated by the arrows in the picture below up simultaneously (1) and slide the ashtray toward the front of the car (into the center console) approximately 1/2" (2). Be careful to only pry the tabs up slightly as they break very easily - I managed to break the left one in the picture. They only need to come up enough to clear the metal bracket underneath that the ashtray attaches to.

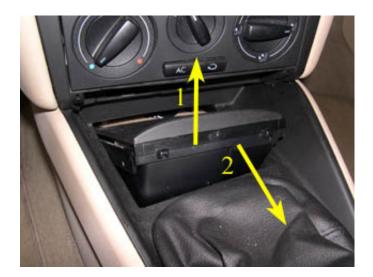
22. Raise the rear edge of the ashtray upwards, as shown below, making sure the two tabs on the edge of the ashtray clear the center console (1). Once they're clear, slide the ashtray towards the rear of the car and out of the center console (2).

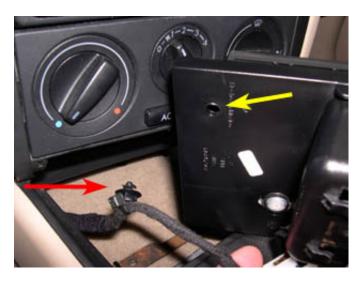
23. Disconnect the power wire for the 12v outlet from the ashtray by removing the wire retaining clip (red arrow) from the hole in the bottom of the ashtray (yellow arrow), as shown below.

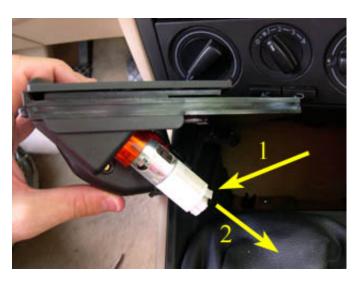
24. Disconnect the power wire from the 12v outlet by pressing in the white tab (1) and pulling the

harness connector out (2), as shown below.

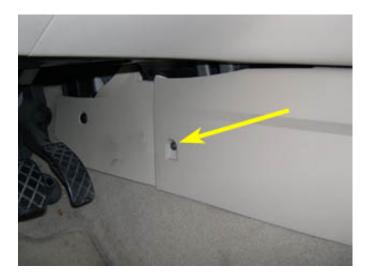
25. Remove the T20 Torx screw from each side of the front of the lower center console in the footwell, as shown below.

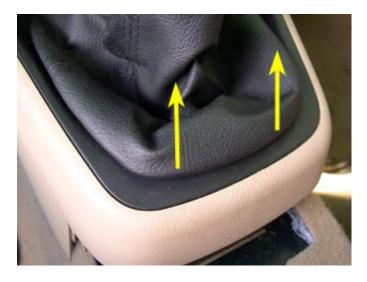
26. Disconnect shifter boot from lower center console by pulling up on the rear edge of the boot support, as shown below.

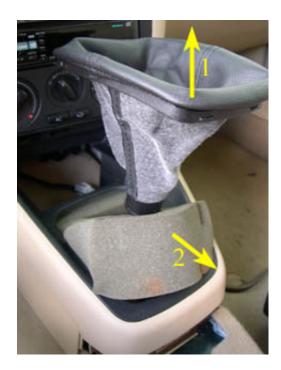
27. Slide the boot all the way up and out of the way and remove the foam piece that surrounds the

shifter mechanism inside the lower center console, as shown below.

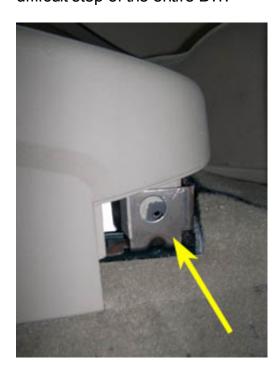
29. If you can't slide the lower center console backward easily, there is a good chance that there is a small metal bracket in the way, indicated by the yellow arrow in the image below. From what I can gather, this bracket only interferes with the lower center console removal on early-model MKIV cars. To remove the lower center console, the bracket must be removed - this is by far the most difficult step of the entire DIY.

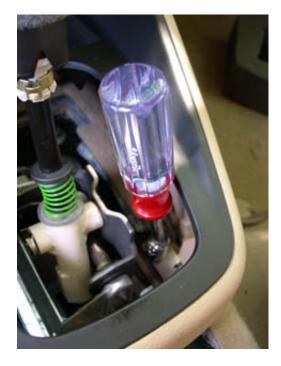
31. The lower center console sits directly above the nut, so a flex-joint socket or something similar is needed to remove the nut. I put a 10mm socket onto the nut and then used a socket driver which was not fully inserted into the socket and at an angle to remove the nut (see picture below).

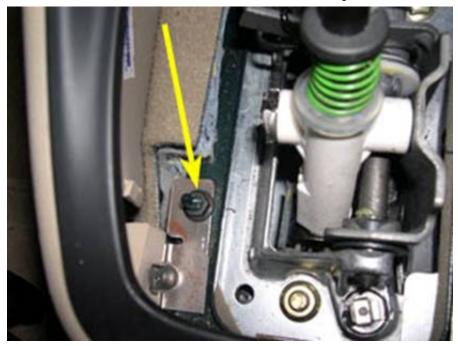
32. Do the same for the left bracket nut, which is shown below.

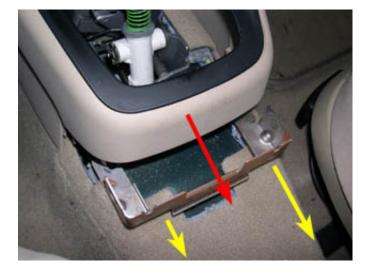
33. When both 10mm nuts are off, raise the front of the bracket over the posts that the nuts were on and then slide the bracket backward and out from underneath the lower center console (yellow arrows in picture below). This is difficult to do due to the limited amount of space under the console. Once the bracket is out, you should be able to slide the lower center console backward (red arrow in picture below) and few inches and then up and over the shifter.

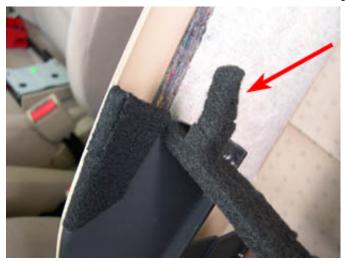
34. The lower center console has two plastic fingers approx. 1.5" long which protrude from the front edge (red arrows in picture below points to driver's side finger).

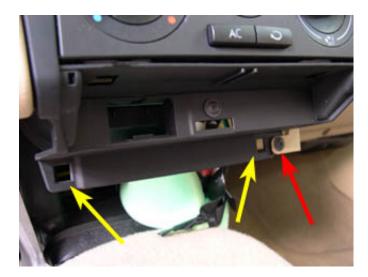
35. These fingers insert into corresponding holes in the bottom of the main center console (yellow arrows), as shown below. The fingers (above) are normally bare plastic, but I covered them with felt to prevent the fingers from rubbing in the holes - this caused a loud creaking when side pressure from my knee was applied to the lower center console while driving. This cured the problem. I recommend that you do this if you have the lower center console removed.

- 36. The hidden/mystery 8th screw that holds the glove box in can also be seen in the above picture (indicated by the red arrow). Remove this screw if you plan on removing the glove box.
- 37. Open the front passenger door, open the glove box and pull the rear edge of the side dashboard panel out and then towards the rear of the car, as shown below. It's easier if you use two hands, but I needed one to hold the camera.

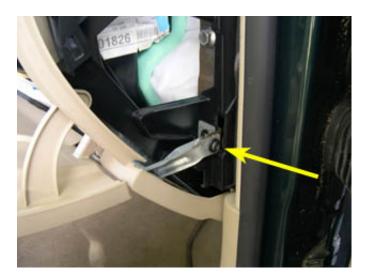
38. Remove the T25 Torx screw indicated by the yellow arrow in the picture below.

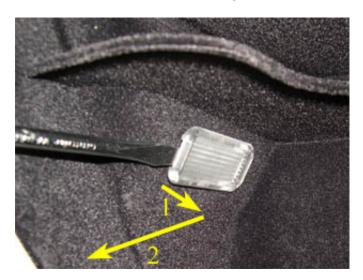
39. Use a screwdriver to carefully pry out the rear of the light in the glove box(1) and then slide it towards the rear of the car to get it out (2), as shown below.

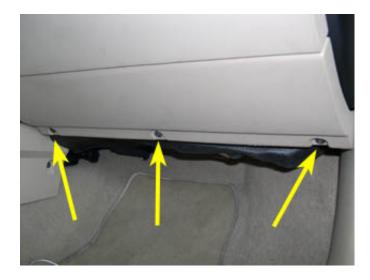
41. Remove the three T20 Torx screws on the bottom of the glove box, as shown below.

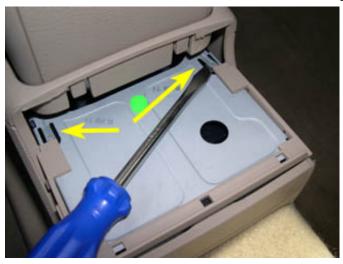
B. When reinstalling the rear cupholder, make sure to pry up the retaining tabs with a screwdriver, as shown below, or the cupholder may slide back out.

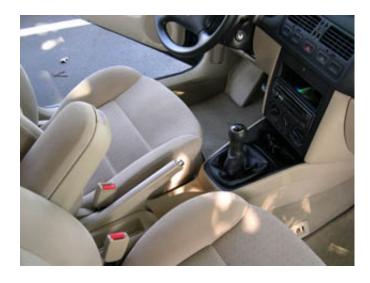
Here's a pic of everything put back together, i.e., the above directions do work!

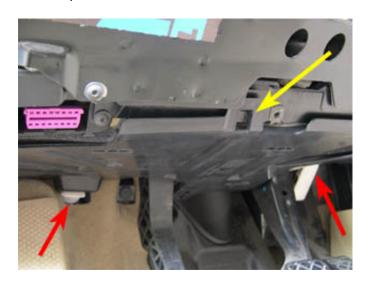
48. If you want to access the brake light switch or anything else up under the dash, remove the panel above the driver's side footwell by uncliping the front of the panel (pull the area indicated by the yellow arrow in the picture below toward the rear of the car) and then sliding the panel out from under the dash. Note that the edge of the panel closest to the front of the car is secured by two horizontal slots (white plastic), indicated the red arrows in the picture below. This step is not

necessary for the further disassembly of the center console/radio/HVAC area. If you are not accessing the brake light switch or anything else up under the dash, goto step 51 (ignore steps 49 and 50).

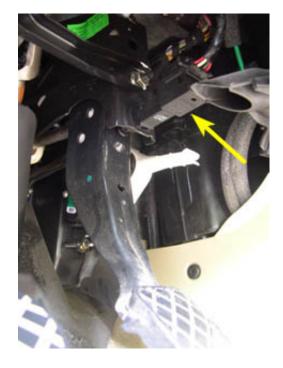
49. The picture below shows the location of the brake light switch, which is indicated by the arrow. This switch often malfunctions and need to be adjusted or replaced. To remove the switch from it's bracket, rotate the switch CCW (35-45° or 90°, depending on which version you have) and slide it towards the rear of the car. DO NOT PRESS DOWN THE BRAKE PEDAL WHILE DOING THIS OR THE INTERNAL MECHANISM OF THE SWITCH (on the most recent versions) WILL BREAK!!! To install a new brake light switch (without destroying it as many people have), follow the directions I posted in the following DIY - Installing a new brake light switch (without destroying it!).

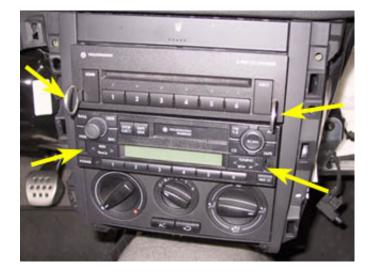
51. The next step is the removal of the radio - the directions for this depend on what type of radio you have. If you have a stock VW radio, insert the radio removal keys into the vertical slots at the edge of the radio face (indicated by the arrows in the picture below), press the keys in all the way while at the same time pulling back on the radio to slide it out of it's DIN slot. Once it's out, disconnect the power, speaker and antenna connections behind the radio.

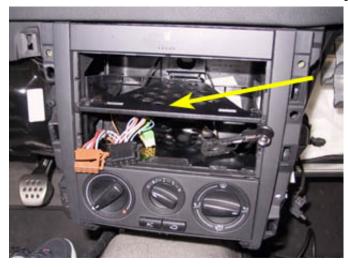
53. Remove the support tray between the two single-DIN slots, shown in the picture below.

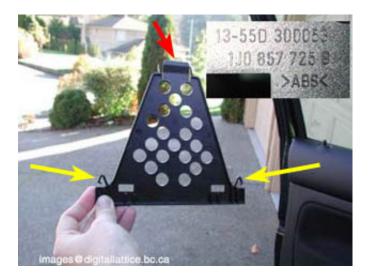
54. The DIN support tray is secured with a clip on either side (yellow arrows in picture below) and a tab at the rear (red arrow in picture below). Undo the clip on both sides of the tray (may need to use a screwdriver or other tool - I can't remember) and then pull the tray out to disconnect the tab at the rear.

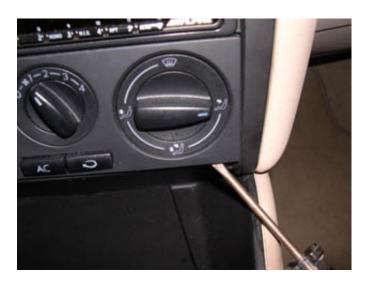
55. Remove the trim from around the HVAC controls using a screwdriver or other suitable tool, as shown below.

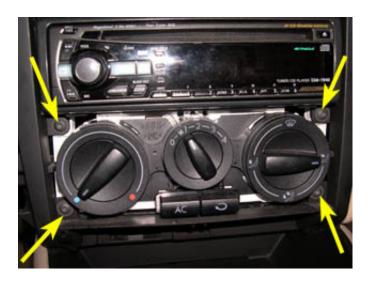
56. Remove the four T20 Torx screws at the corners of the HVAC controls, as indicated by the arrows in the picture below.

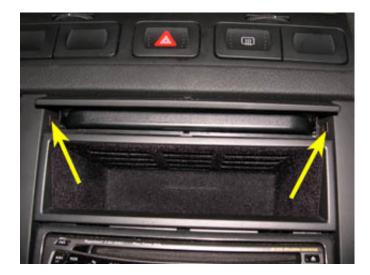
57. Open the front cupholder flap while keeping the actual cupholder tucked away in it's slot. To do this, push on the flap to release the cupholder, push the cuphloder back in but don't fold the flap down, as shown below. The cupholder unit is secured to the cage surrounding the cupholder/radio/HVAC controls by two tabs, indicated by the arrows in the picture below. Move the tabs toward each other simultaneously using a screw driver and then slide the cupholder unit out. This is actually much easier then it sounds - move one clip to the side and then pull that side of the cupholder unit out a little to keep the clip from springing back. Carefully move the clip on the other side and then pull the unit out.

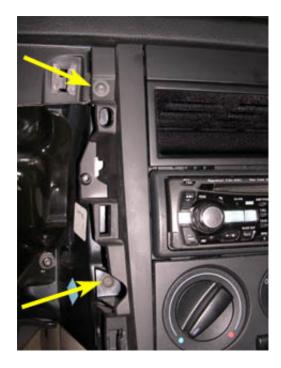
59. Finally, remove the four T20 Torx screws that attach the radio/HVAC trim cage to the dashboard. There are two screws on each side of the cage. The screws on the driver's side are shown in the picture below - the screws on the passenger's side are in the identical spots. You should now be able to remove the trim cage from the dashboard.

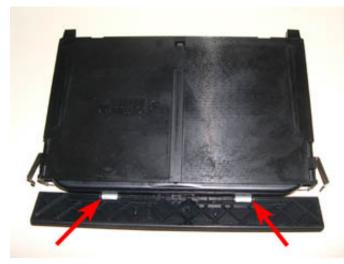
60. If you need to swap the cupholder flap, follow the procedure corresponding to the type of cupholder that you have. If you have the older-style cupholder (the one with out the spring-loaded arms), remove the flap by pushing out the hinge pins on the flap, indicated by the arrows in the picture below.

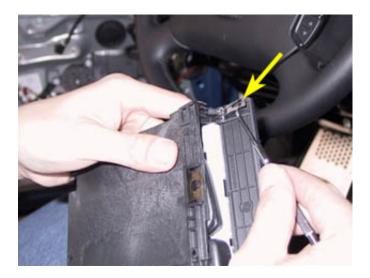
61. If you have the newer-style cupholder (the one with the spring-loaded arms, remove the flap by using a screwdriver to pop off the metal tabs that secure it to the main cupholder unit, as shown below.
