REMOVING AND CLEANING A MKIV THROTTLE BODY (THROTTLE VALVE CONTROL MODULE)

The following outlines the procedure for removing and cleaning the drive-by-wire (DBW) throttle body (officially known as the throttle valve control module) on a MKIV VW. The procedures were based on a 99.5 Jetta GLS VR6 and may be different on MKIV cars with different engines (1.8T, 2.0), body styles (Golf, GTI, New Beetle) and from different model years. Specifically, the

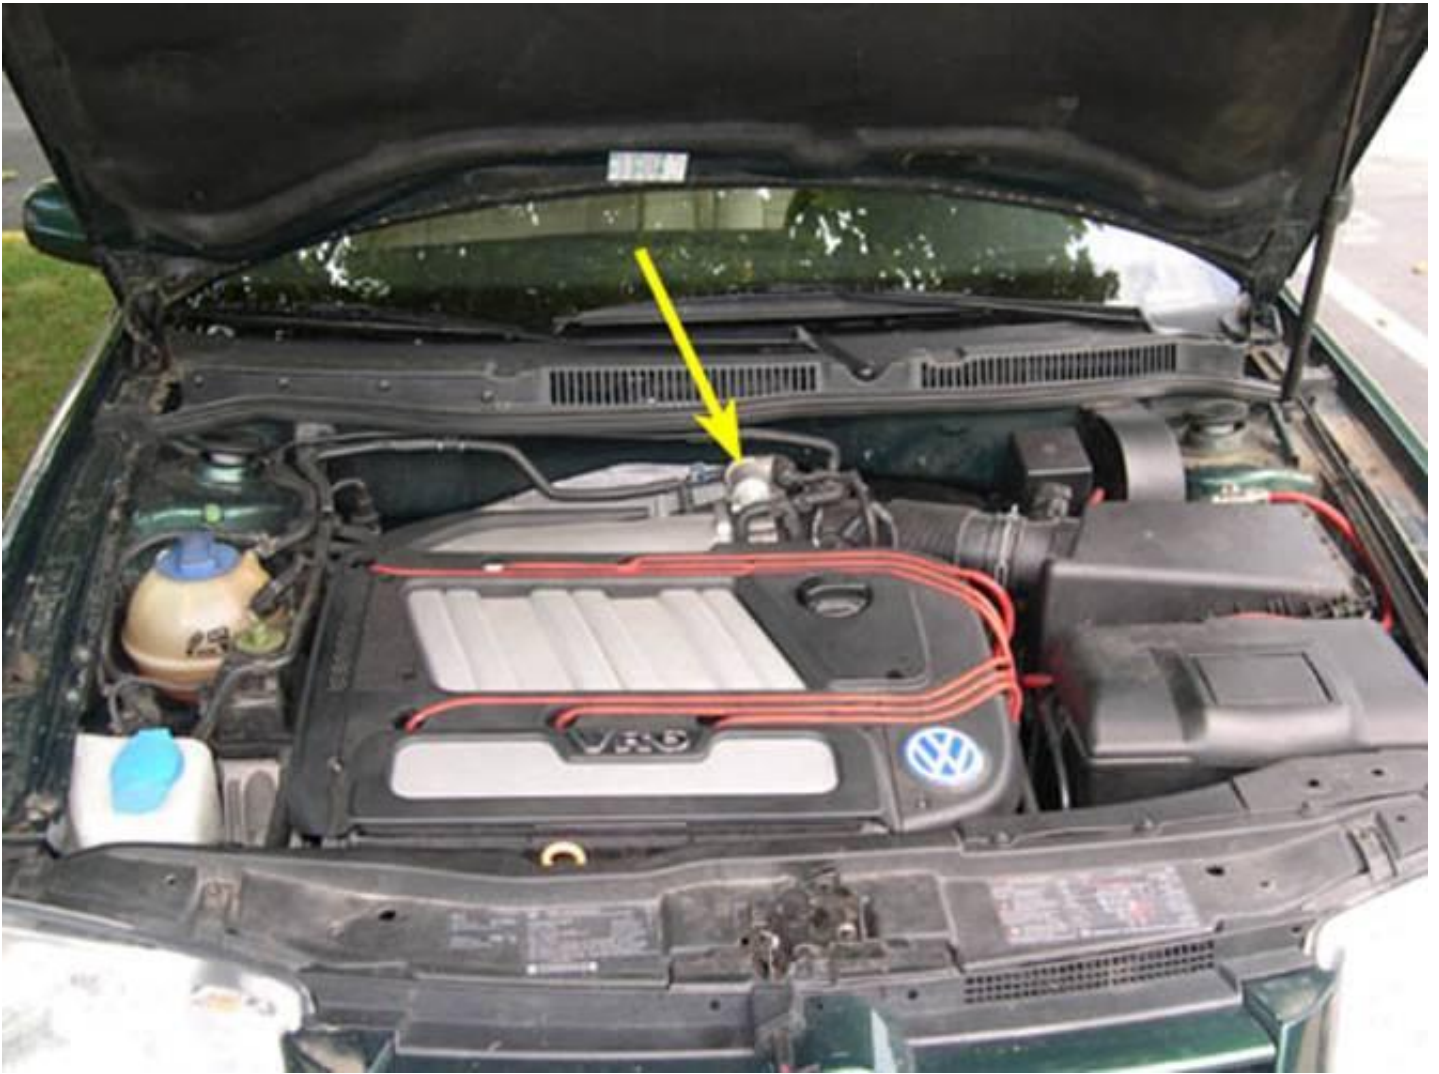
1. The TB is located at the back of the engine bay between the air intake hose and the intake manifold and is indicated by the yellow arrow in picture below.

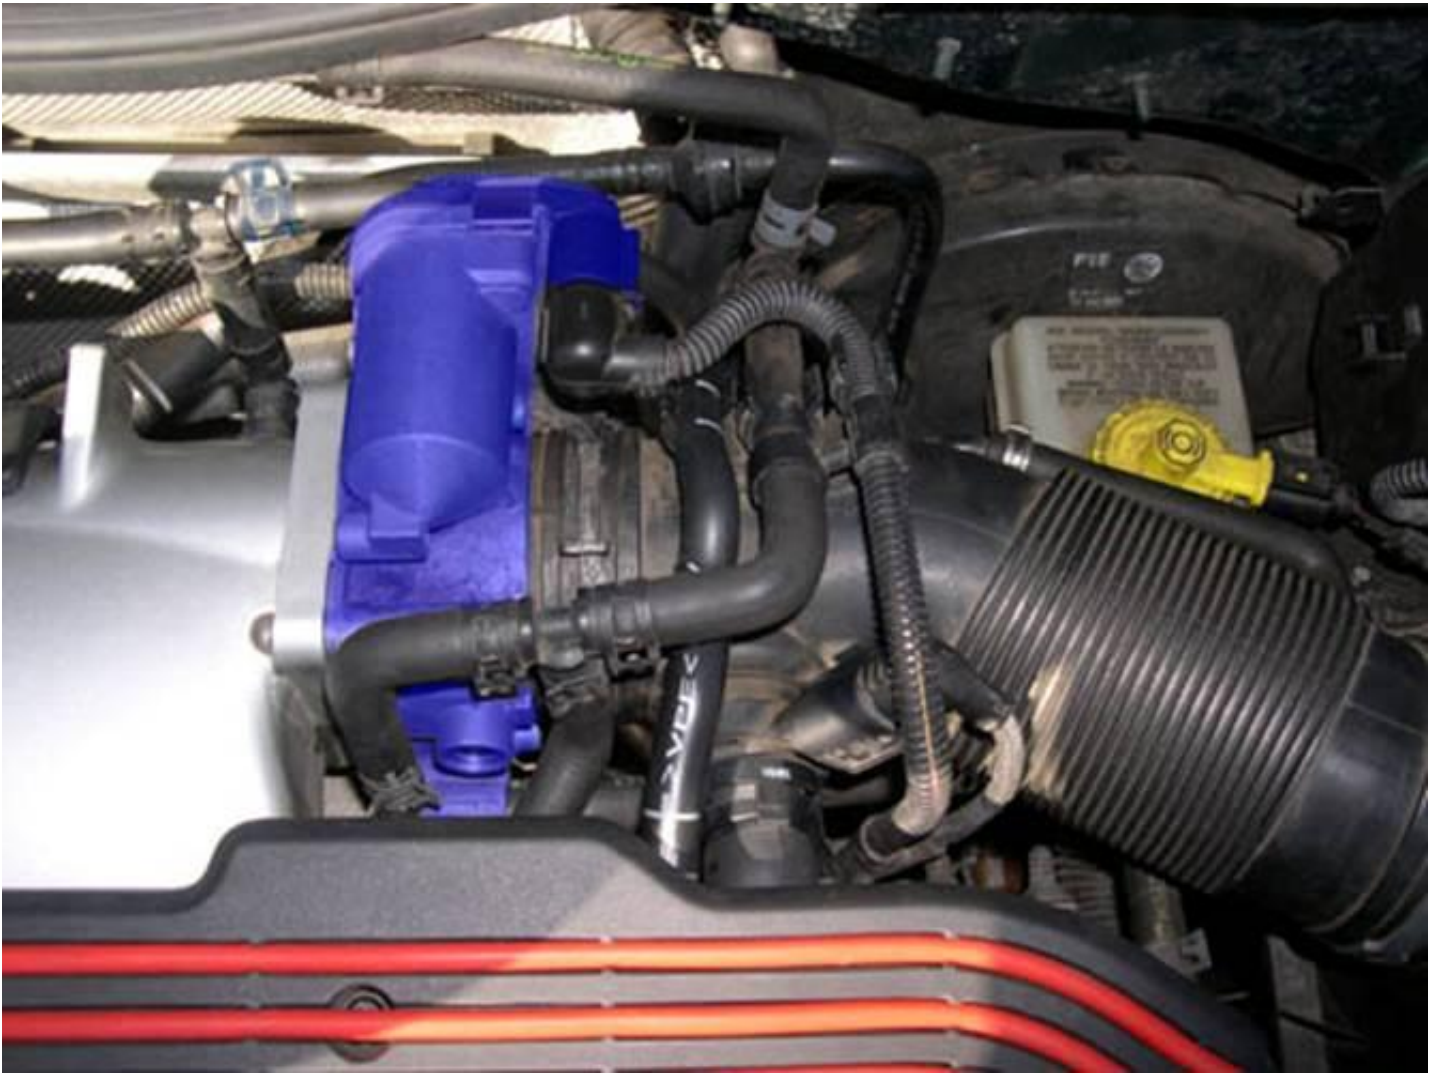
2. The TB is shaded blue in the picture below.

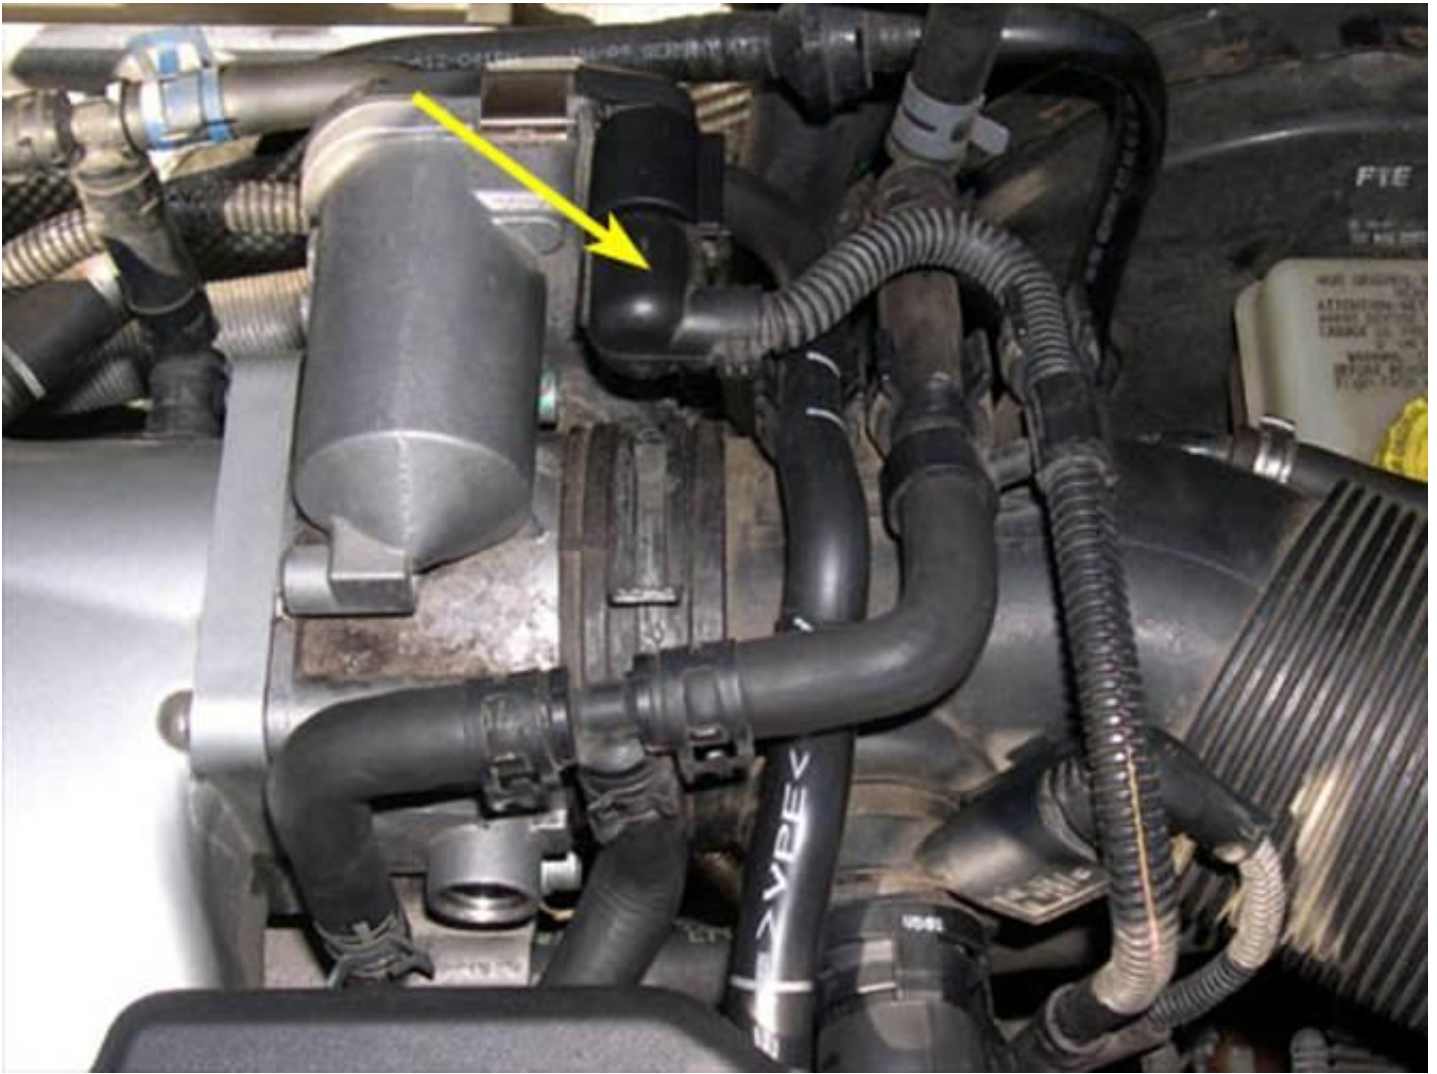
4. Disconnect the harness connector from the TB. The connector is indicated by the yellow arrow in the picture below.

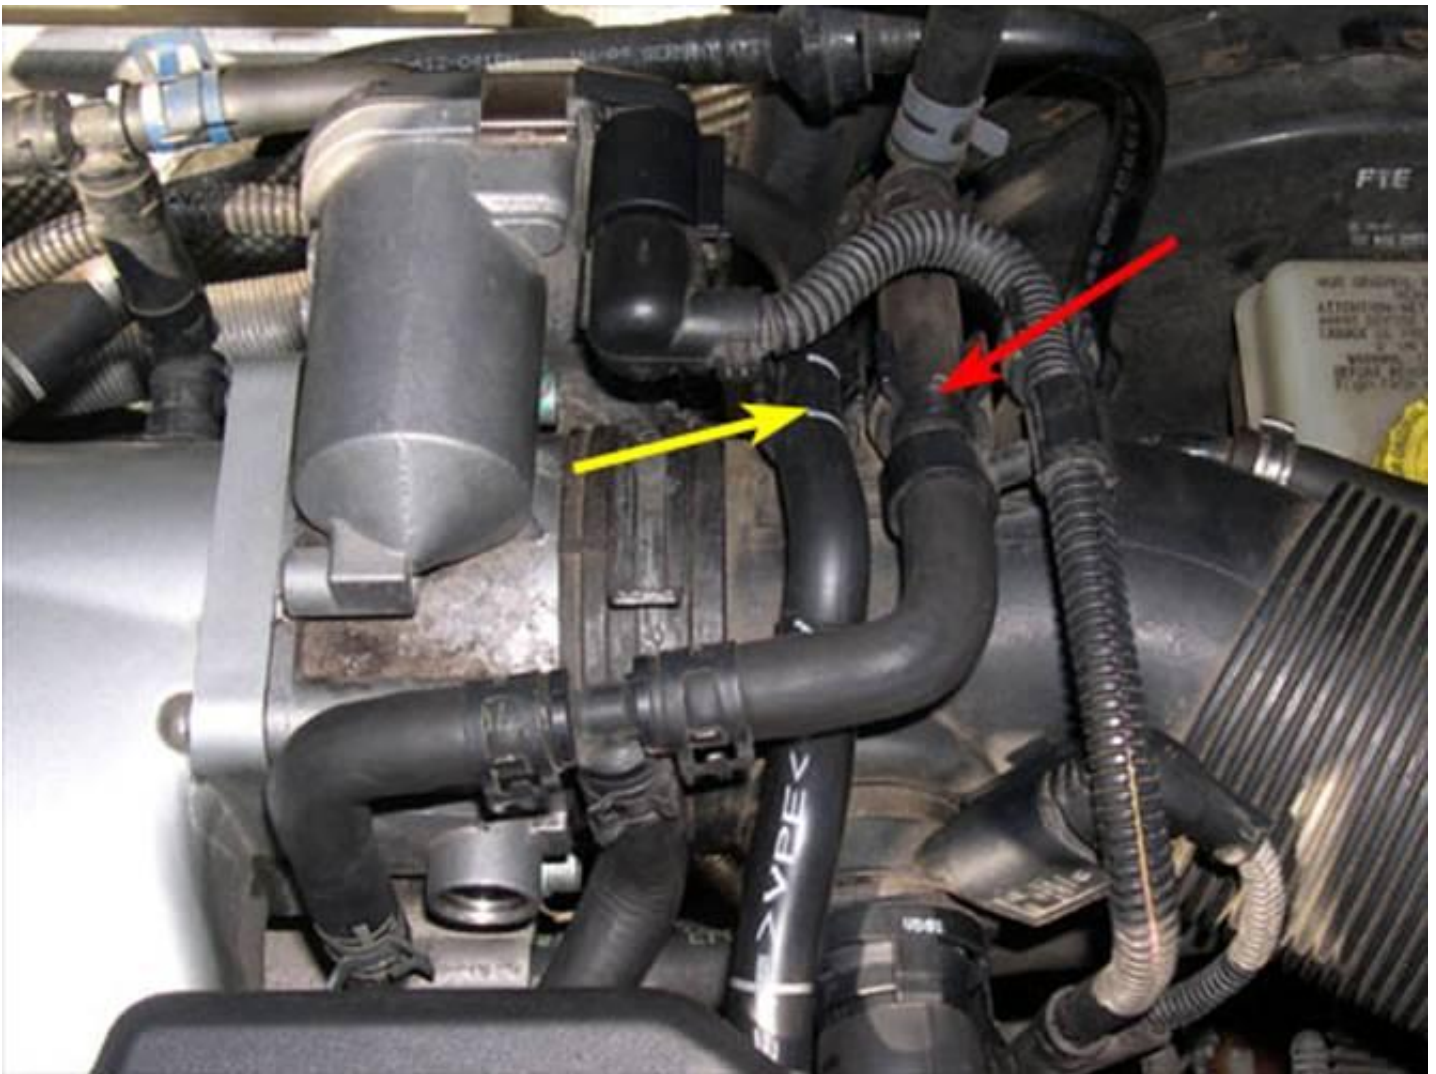
5. Unclip the coolant hose (red arrow in picture below) and the PCV vacuum-assist hose (yellow arrow in picture below) from the top of the air intake tube.

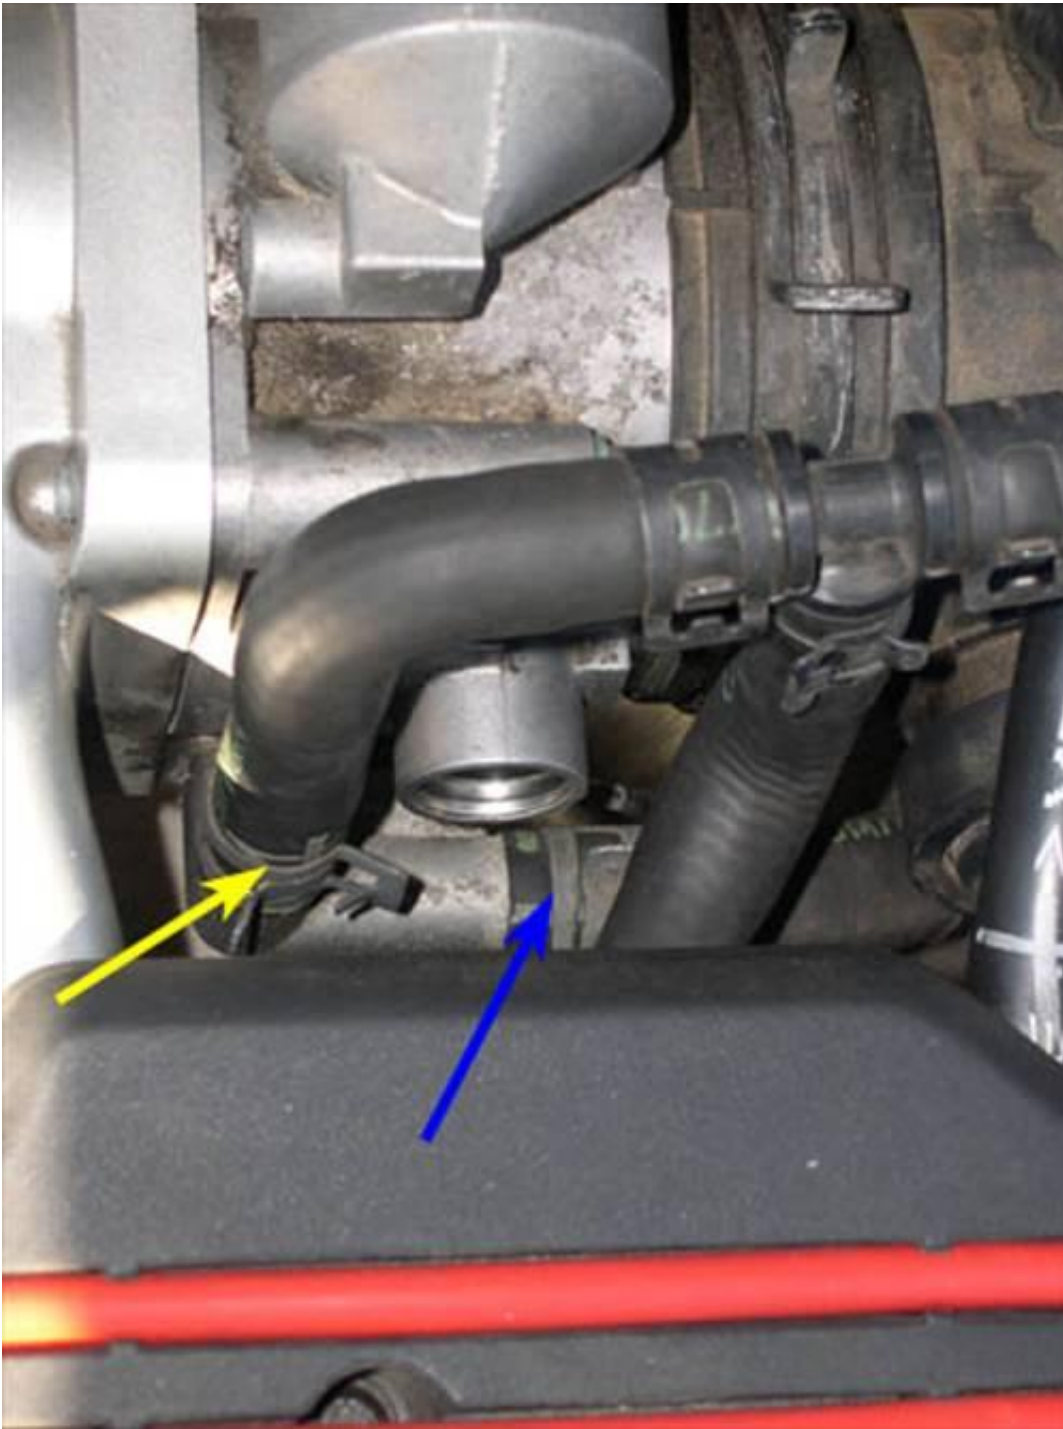
6. Disconnect the upper coolant hose (yellow arrow in picture below) and lower coolant hose (blue arrow in picture below) from the TB. To do this, use the appropriate tool (pliers or screwdriver) to release the tension from the hose clamp, slide the clamp down the hose and out of the way (for spring clamps, make sure the clamp is moved past the end of the nipple inside the hose or the clamp will reapply pressure to the nipple when released), and then pull the hose off of it's nipple.

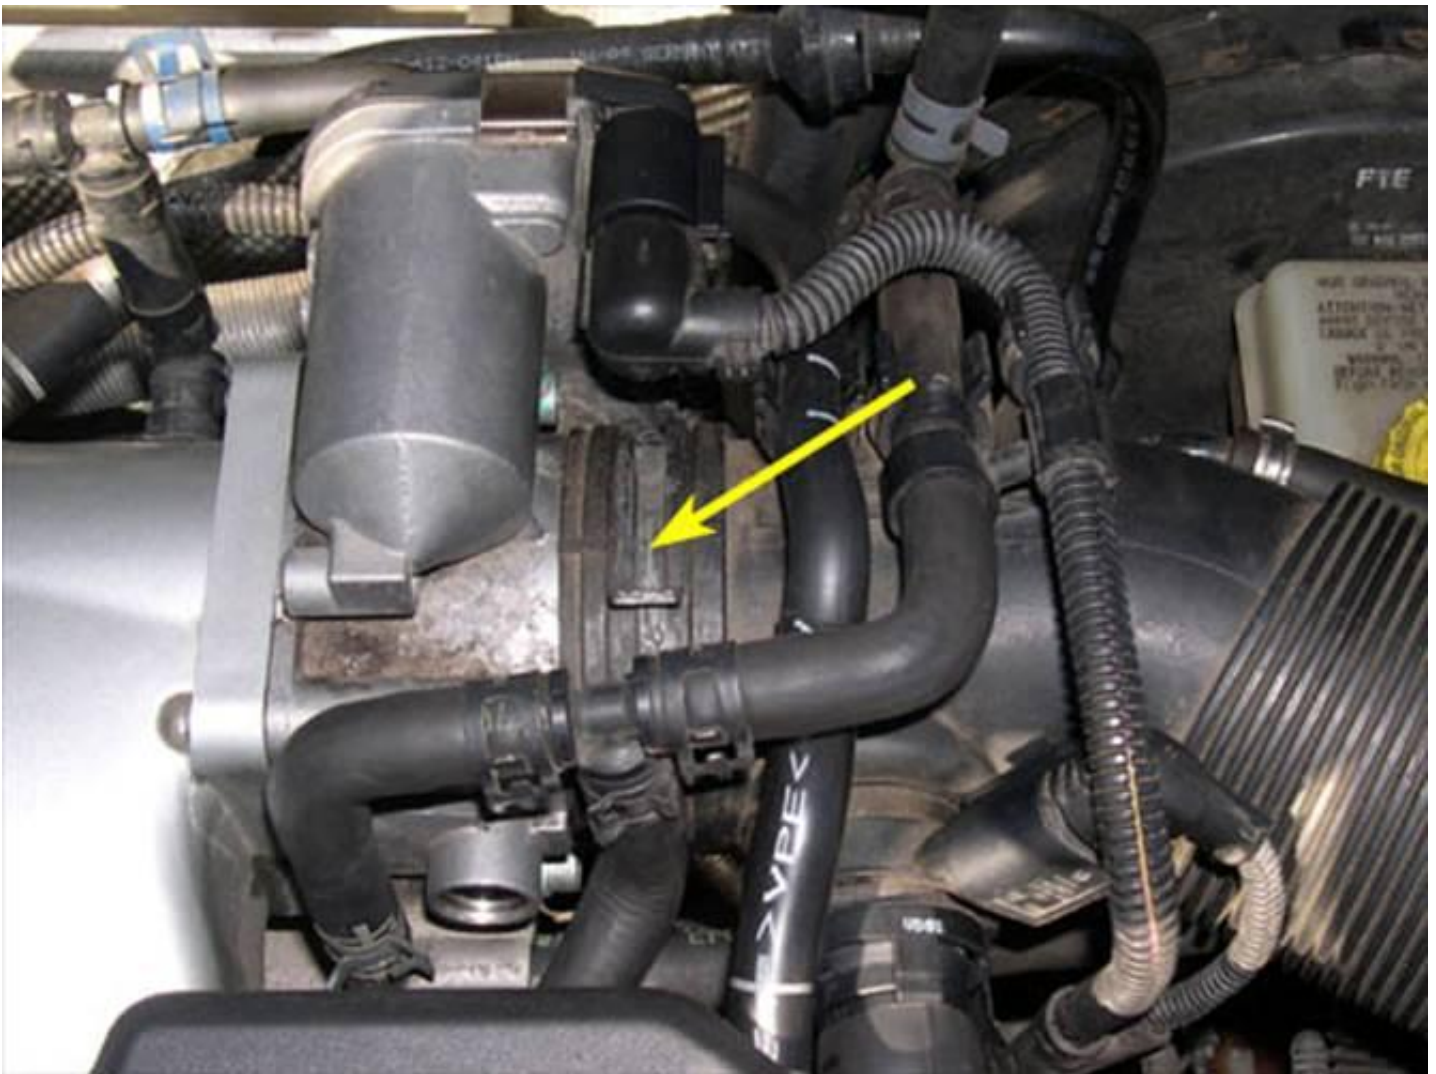
7. Release the tension from the clamp securing the main air intake tube to the TB (indicated by yellow arrow in picture below) and then slide the intake tube off of the TB.

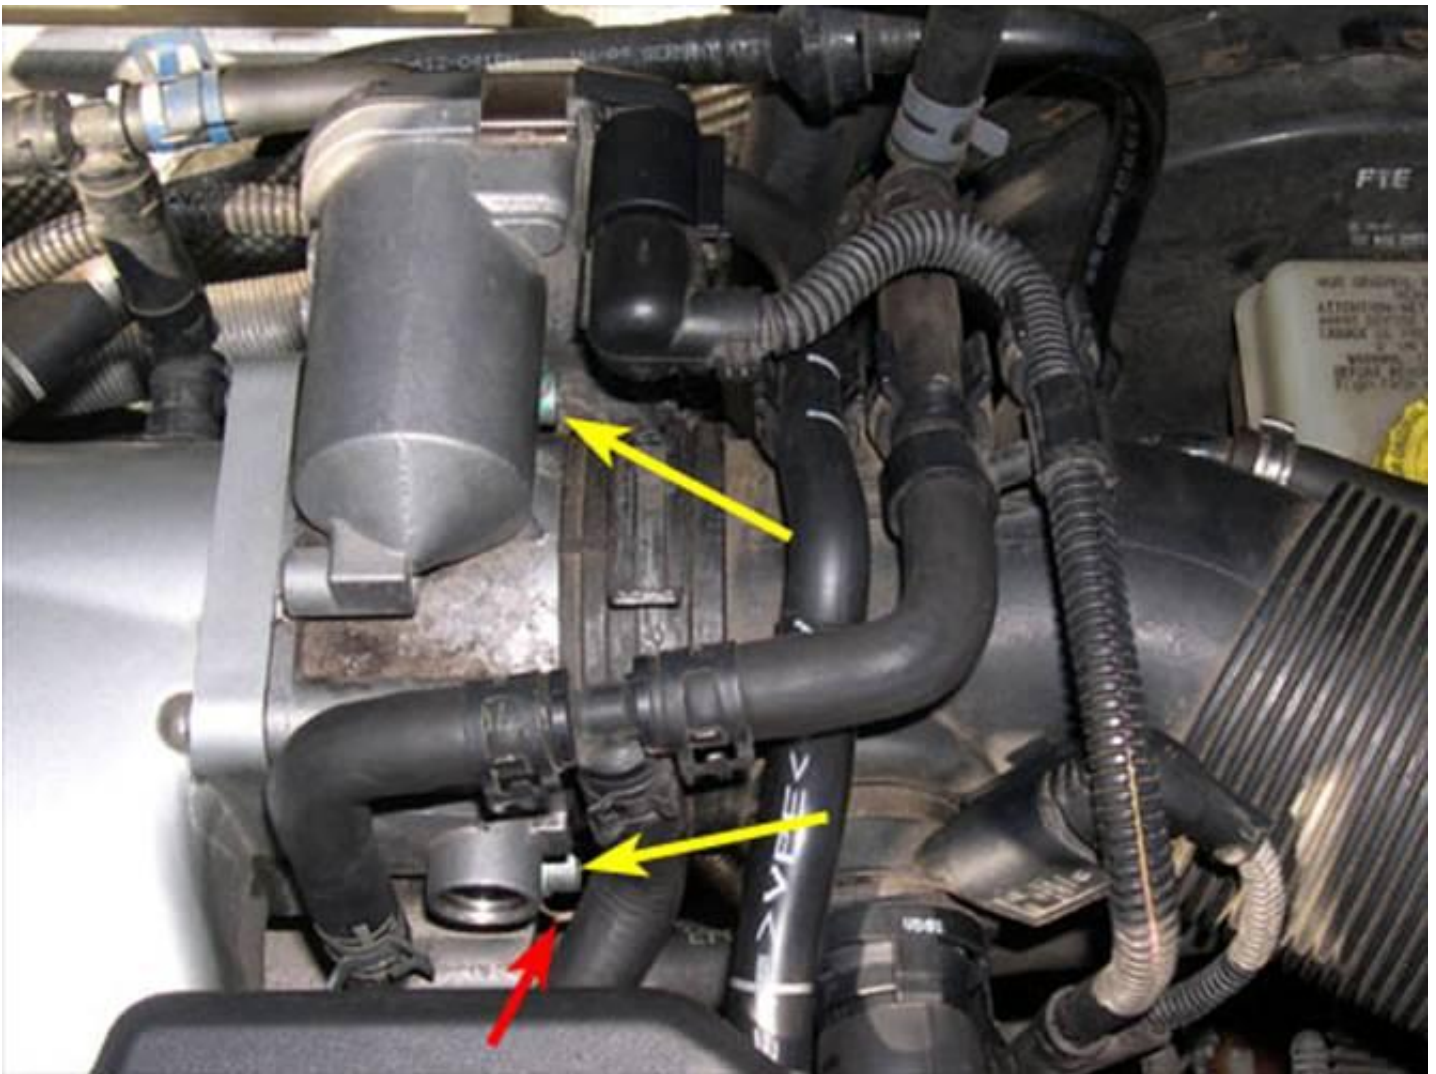
8. Using a 5mm hex/Allen wrench, remove the 4 long bolts that secure the TB to the intake manifold. There is one bolt at each corner of the TB, two of which are indicated by the yellow arrows in the picture below. Support the weight of the TB as you remove the last bolt. You wouldn't want the TB to fall - it is a delicate, high-precision device. Note that one of the bolts also secures a ground wire to the TB (indicated by red arrow in picture below). In my case, the ground wire was secured by the lower, front bolt, but a different bolt may be used in your car. Remember which bolt the wire was attached with so that it can be reinstalled in the same position.

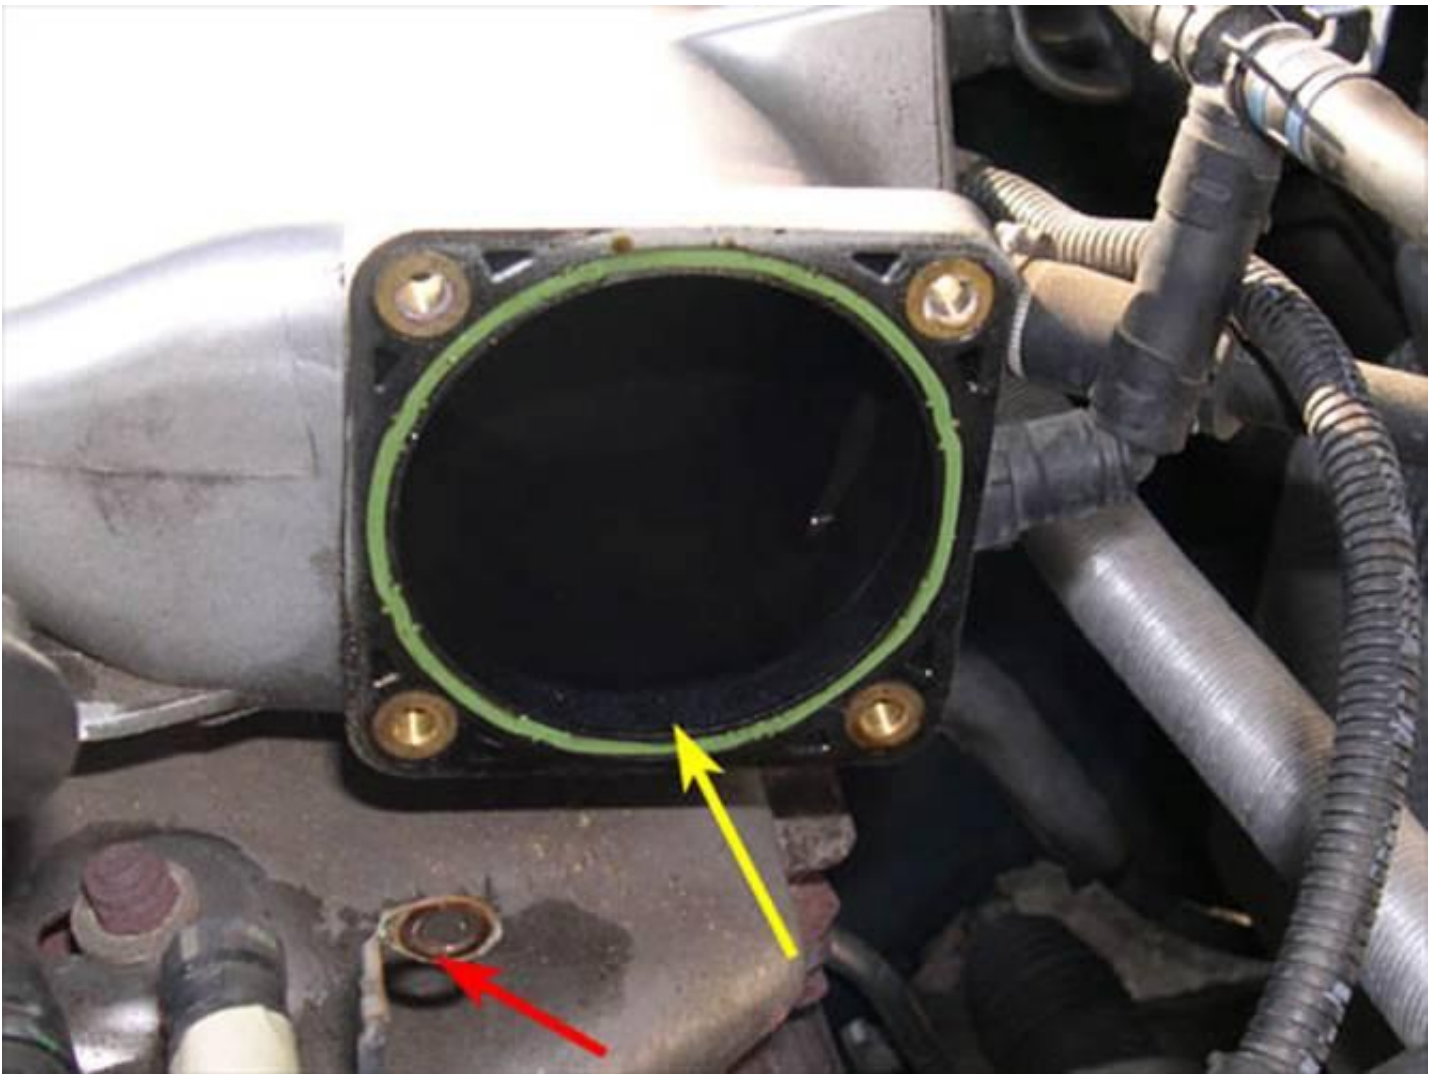
10. The yellow arrow in the picture below indicates the gasket that seals the rear of the TB to the intake manifold. Prior to reinstalling the TB (new or existing), either replace the gasket with a new one or decide to reuse the existing one. If you decide to reuse the existing gasket, make sure to clean it by wiping it with a rag or paper towel to remove any debris or contaminants that may be on the mating surface. (The red arrow in the picture below shows a better view of the ground connection that is secured to the TB by one of its mounting bolts.)

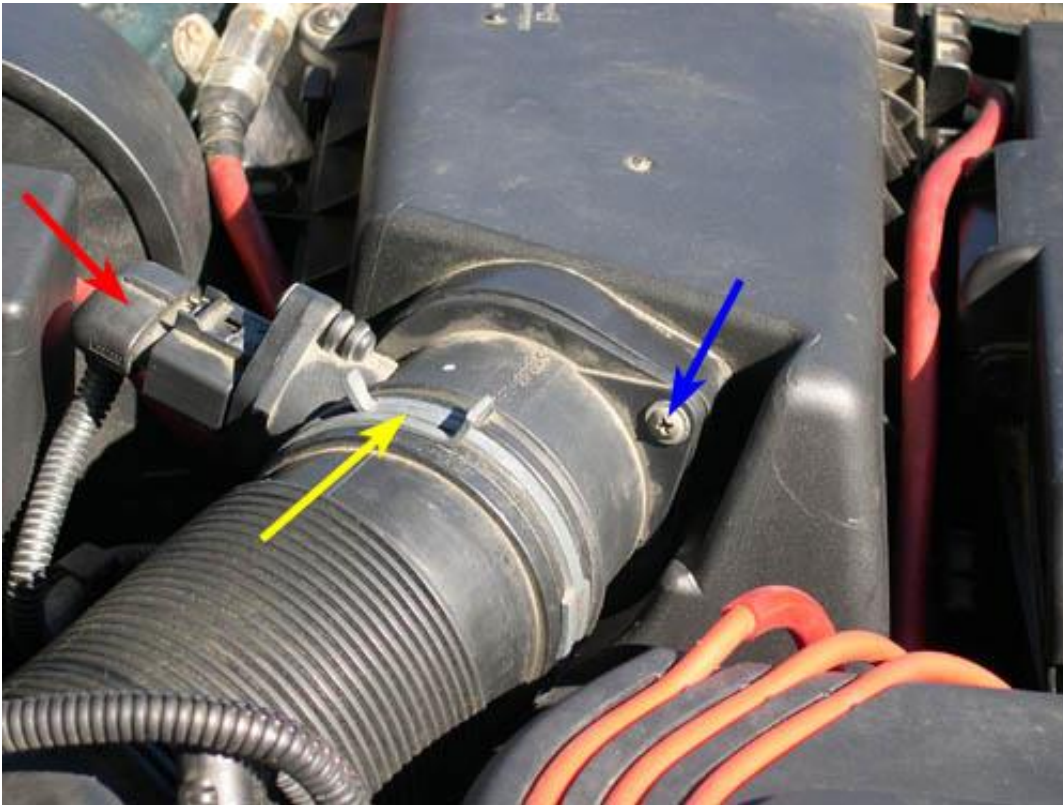
13. Release the tension from the clamp securing the main air intake tube to the MAF housing (indicated by yellow arrow in picture below) and then slide the intake tube off of the housing. If you're like me and are paranoid that anything you do under the hood can potentially harm the poorly-designed MKIV MAFs, you may also want to remove the MAF and put it in a safe place. It is not necessary to do this in order to remove the TB, but you never know with these MAFs. If you want to remove the MAF housing from the air filter box, disconnect the MAF harness connector (red arrow in picture below), remove the two Phillips screws that secure the MAF housing to the air filter box (one of the screws is indicated by the blue arrow) and GENTLY slide the housing out of the filter box. There is a large gasket sealing the two which snaps into the opening in the filter box, so it may require some force to separate them.

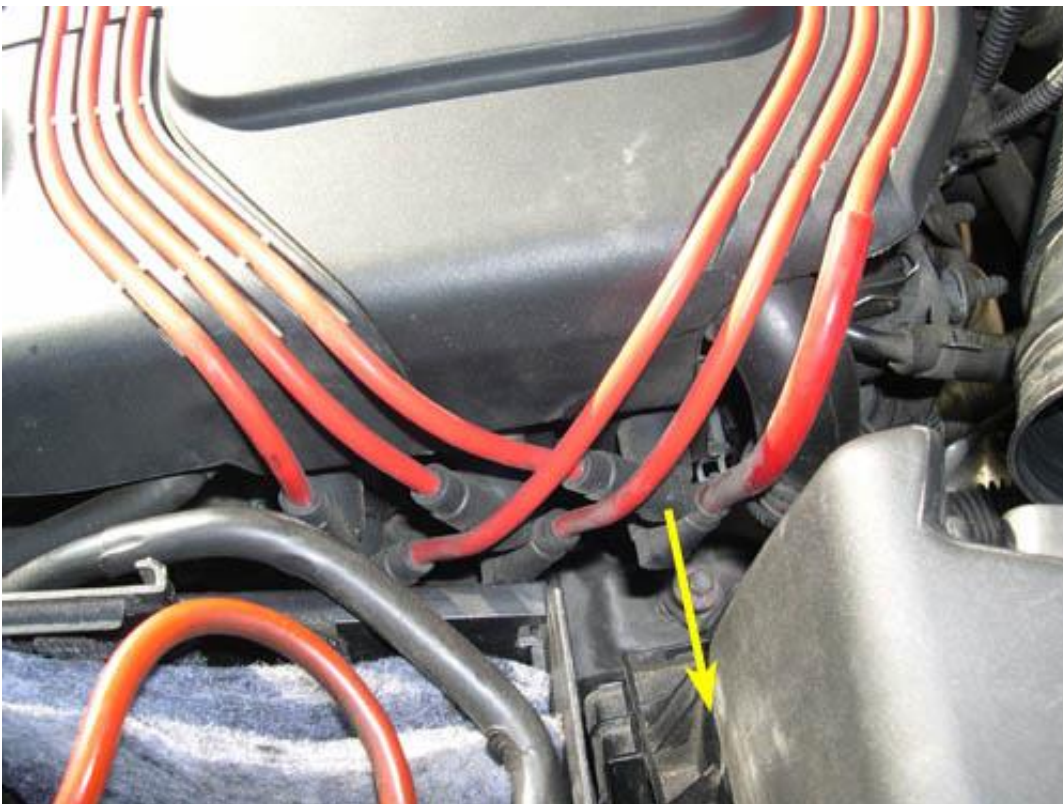
14. Carefully remove the spark plug wires from the ignition coilpack by pulling the rubber wire boots off of the posts on the coilpack, as shown in the picture below. This may be difficult due to the suction created by the seal between the boots and posts. I used a flat blade screw driver to carefully slide the boots off of the posts. (Be careful not to rip the boots if you do this or the engine may misfire when moisture is present.) I recommend that you mark each wire so that it is reinstalled on the correct post later on.

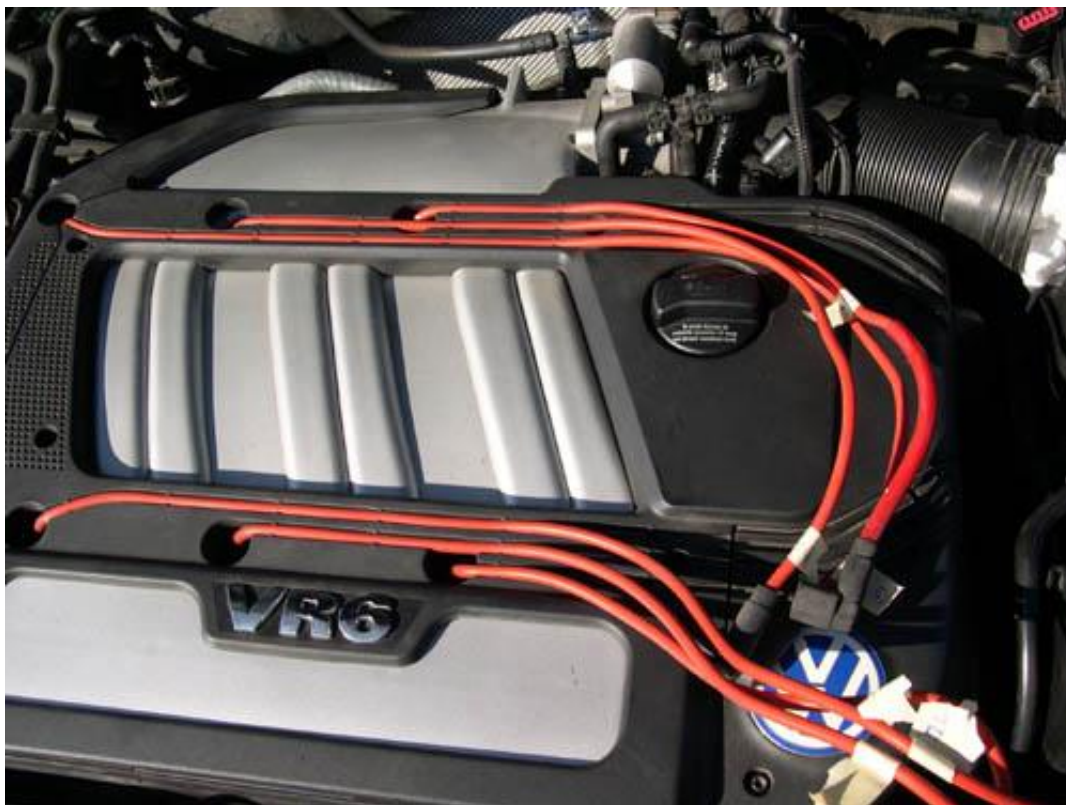
15. Unclip the spark plug wires from the channels in the engine cover, as shown below.

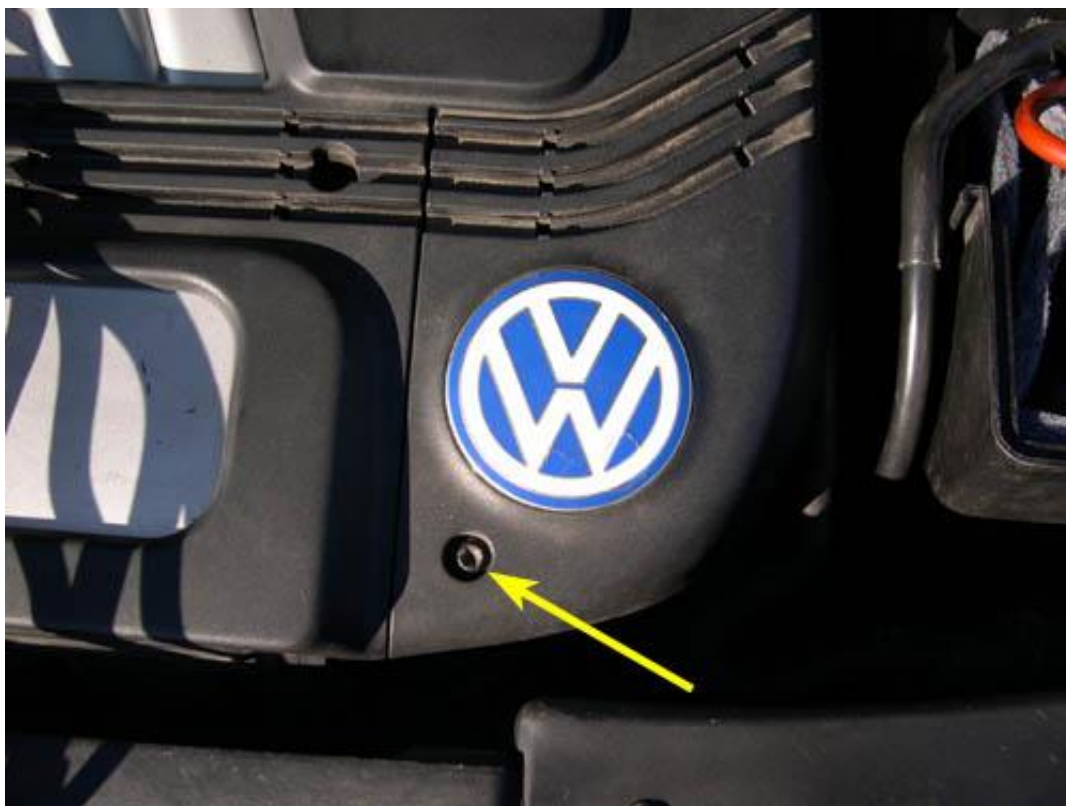
16. Remove the small engine cover piece with the VW logo on it by removing the single T30 Torx screw, indicated by the yellow arrow in the picture below.

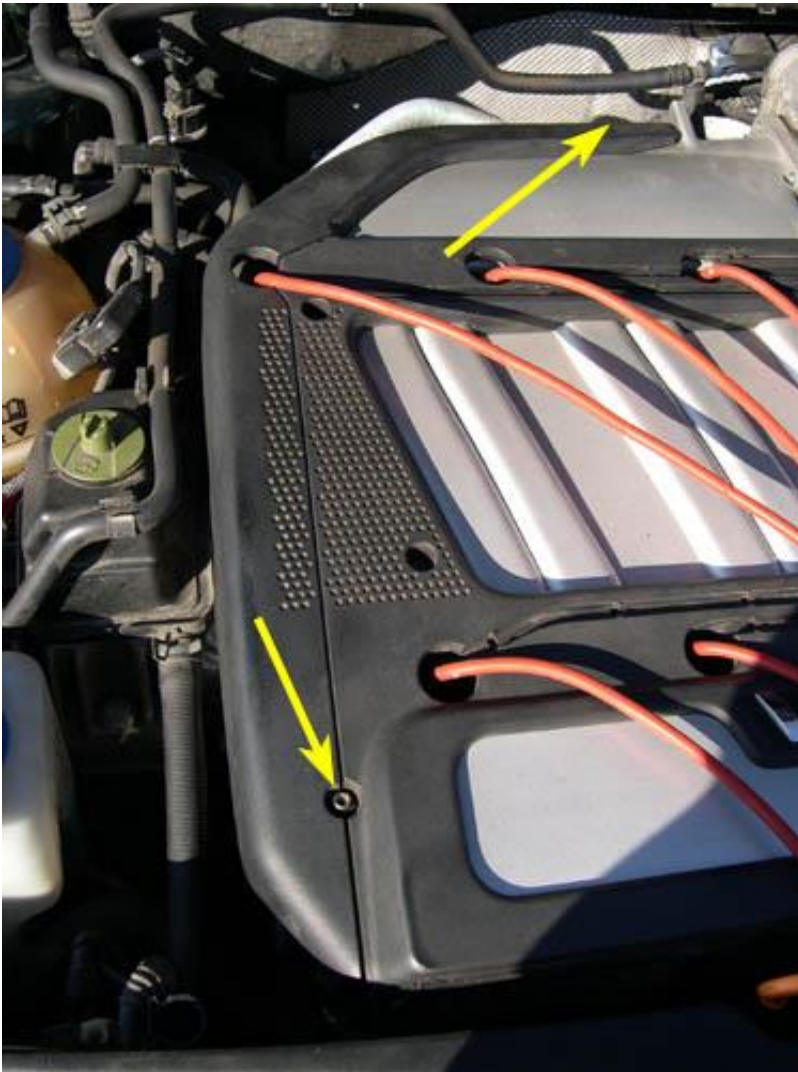
17. Remove the long, thin engine cover piece on the passenger's side of the engine by removing the two (2) T30 Torx screws indicated by the yellow arrows in the picture below.

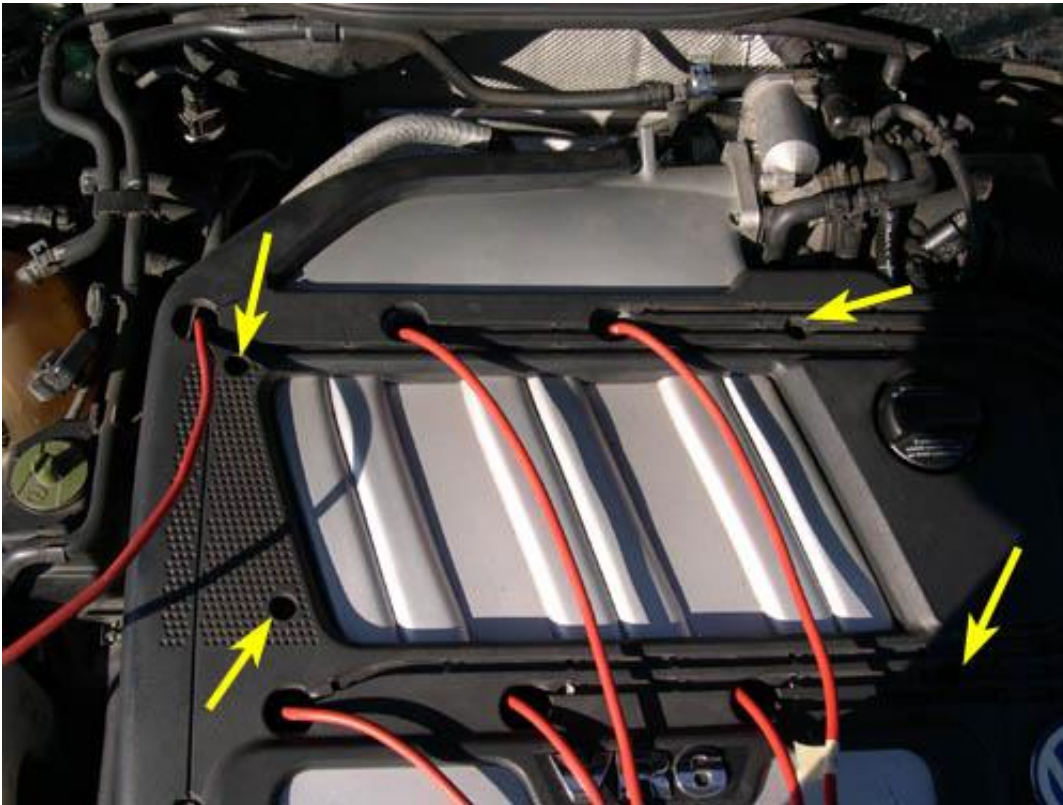
18. Remove the main engine cover piece by removing the four (4) T30 Torx screws indicated by the yellow arrows in the picture below. As you lift up on the cover piece, you will need to thread the spark plug wires through their respective holes in the cover in order to fully remove it.

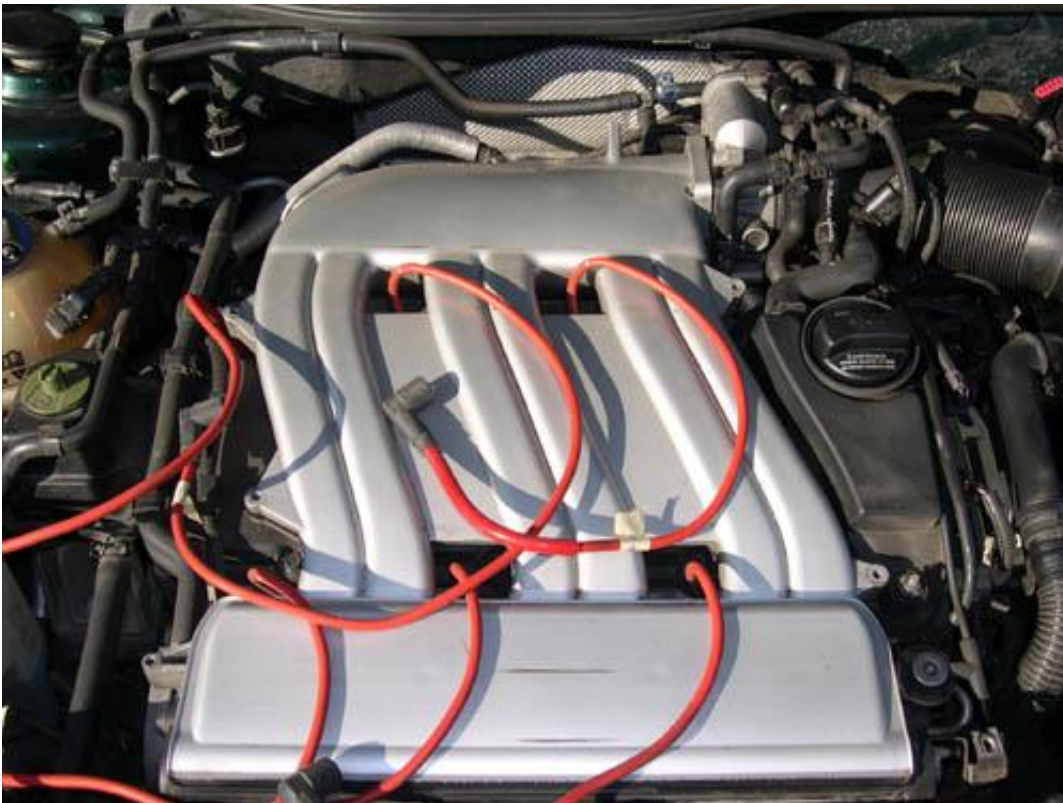
19. The picture below shows how the top of the engine should look with the three engine cover pieces removed.

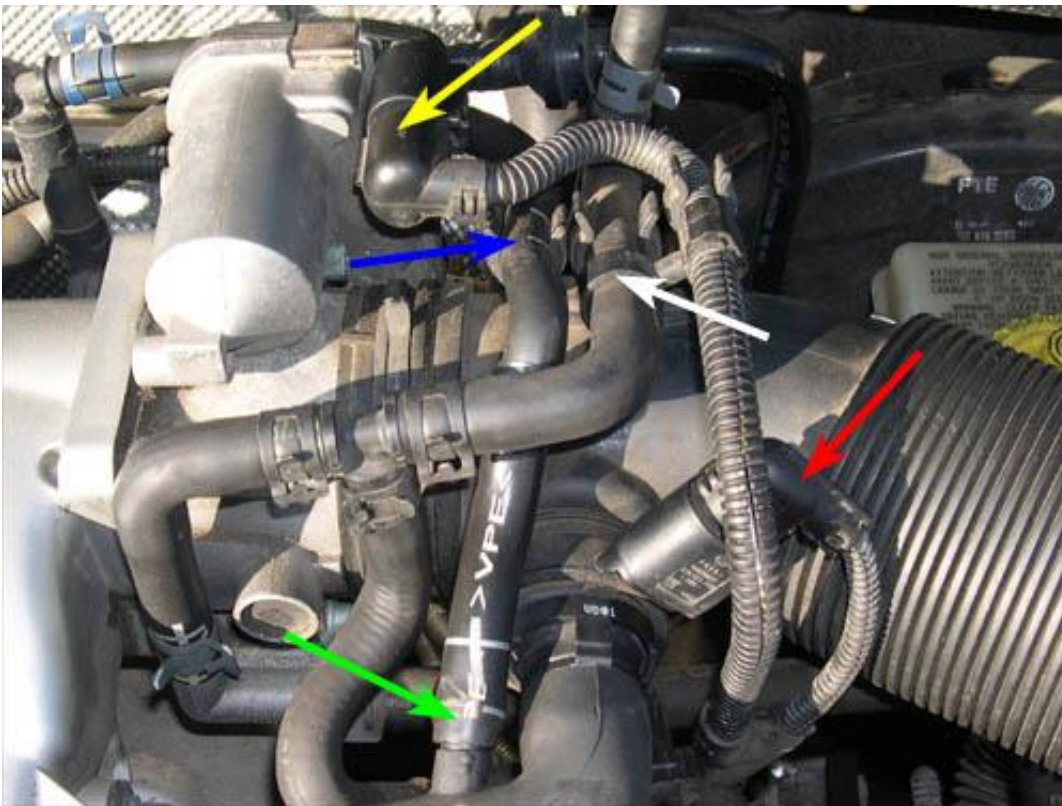
20. Disconnect the electrical harness connectors for the TB (yellow arrow in picture below) and PCV valve heater (red arrow in picture below). Next, unclip the TB harness connector lead from the

top of the coolant hose which passes over top of the main air intake tube (white arrow in the picture below) and move the lead out of the way. Finally, disconnect the vacuum-assist hose (green arrow in picture below) from the PCV valve S-hose (between valve cover and main intake tube), unclip the hose from the top of the main intake tube (blue arrow in picture below) and move the hose out of the way.

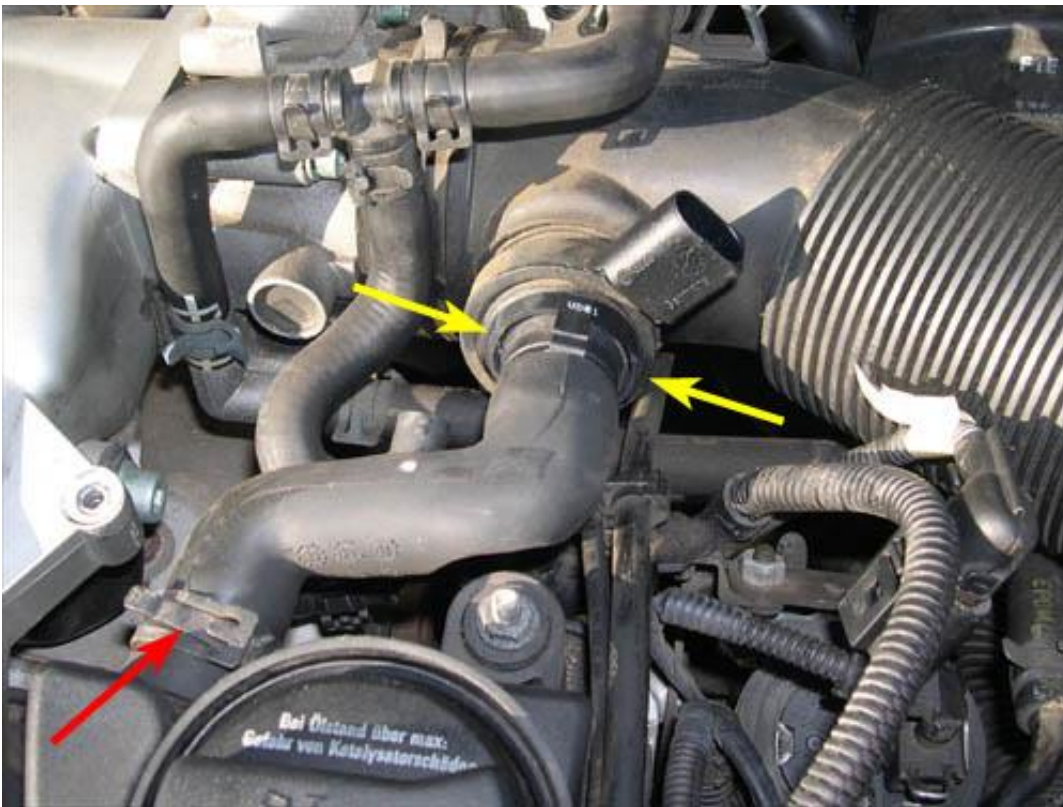
21. Disconnect the PCV S-hose from the PCV valve on the main intake tube by pushing the two serrated tabs together (yellow arrows in picture below) and carefully pulling the hose off. If you want to also clean the inside of the PCV S-hose (there WILL be oil in it), release the tension from the clamp on the other end of the S-hose (red arrow in picture below), slide the clamp up the hose a bit and then pull the hose off of its nipple. (Note the position of the bend in the S-hose relative to the bolt/nut just to the rear of the oil cap. There should be sufficient room between the hose and bolt so that the bolt does not cut into the hose. There is a depression on the underside of the hose at the bend to provide more clearance. Make sure to reinstall the hose in the same position later on so that abrasion does not occur.)

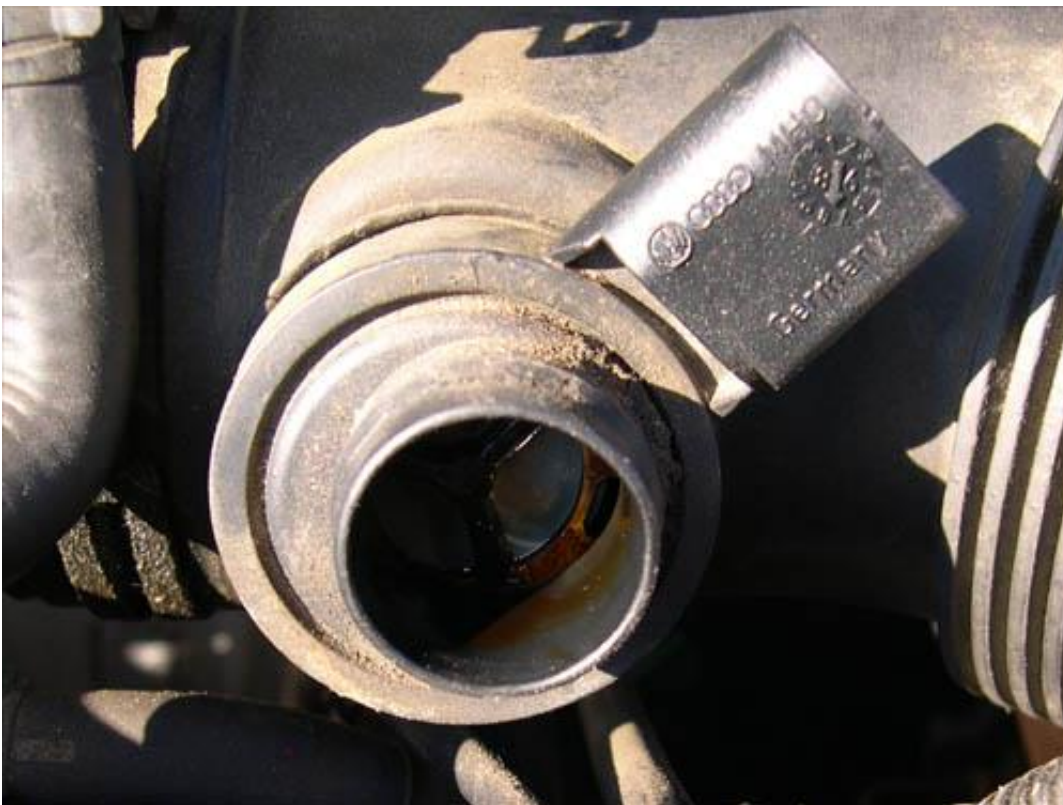
22. The picture below shows the inside of the PCV valve/heater on the main intake tube. If you look closely, you can see the abundance of condensed oil vapors.
