REMOVING AND CLEANING A MKIV THROTTLE BODY (THROTTLE VALVE CONTROL MODULE)

The following outlines the procedure for removing and cleaning the drive-by-wire (DBW) throttle body (officially known as the throttle valve control module) on a MKIV VW. The procedures were based on a 99.5 Jetta GLS VR6 and may be different on MKIV cars with different engines (1.8T, 2.0), body styles (Golf, GTI, New Beetle) and from different model years. Specifically, the

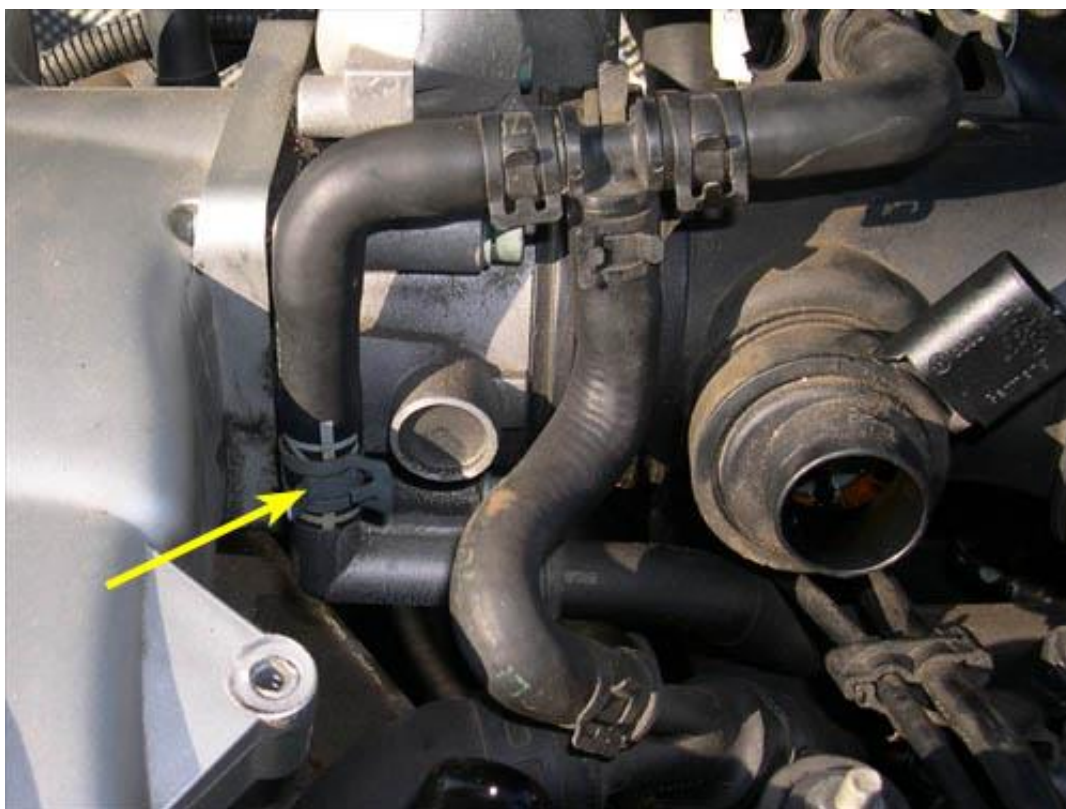
23. Disconnect the upper coolant hose (yellow arrow in picture below) from the TB. The nipple on the TB is approximately 1" long, so the clamp has to be moved up the hose at least that much in

order to remove the hose from the nipple.

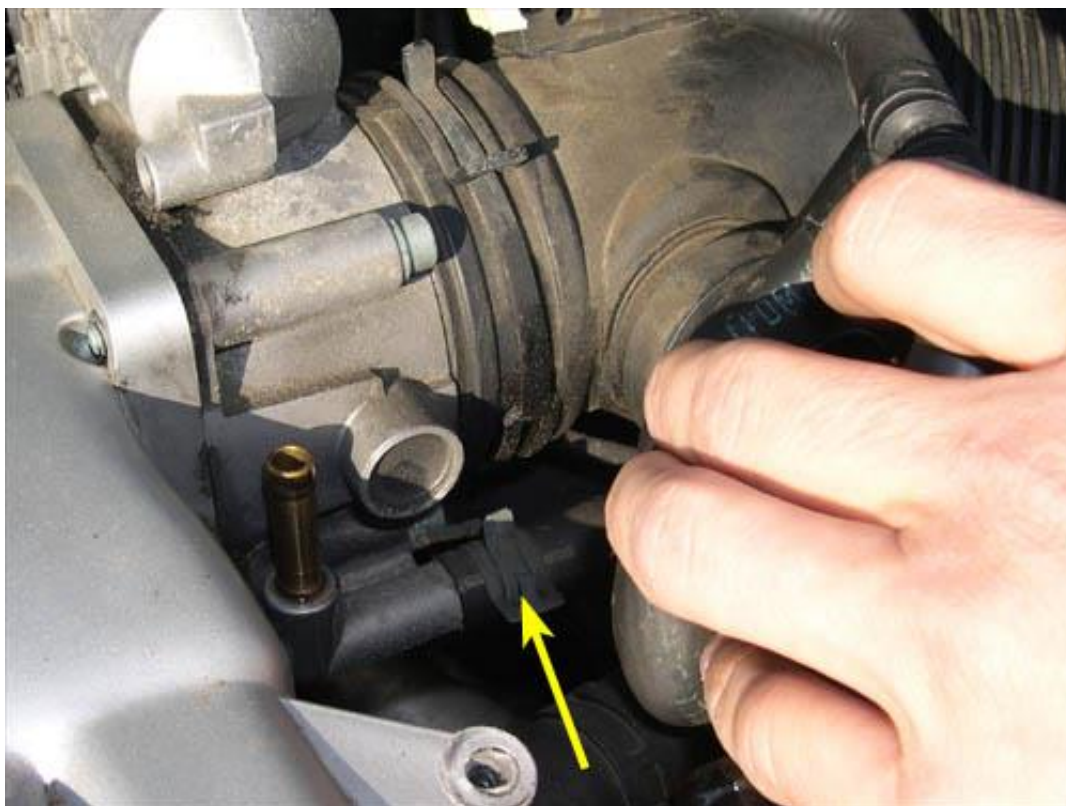
24. Disconnect the lower coolant hose (yellow arrow in picture below) from the TB. Again the nipple on the TB is approximately 1" long, so the clamp has to be moved down the hose at least that much in order to remove the hose from the nipple.

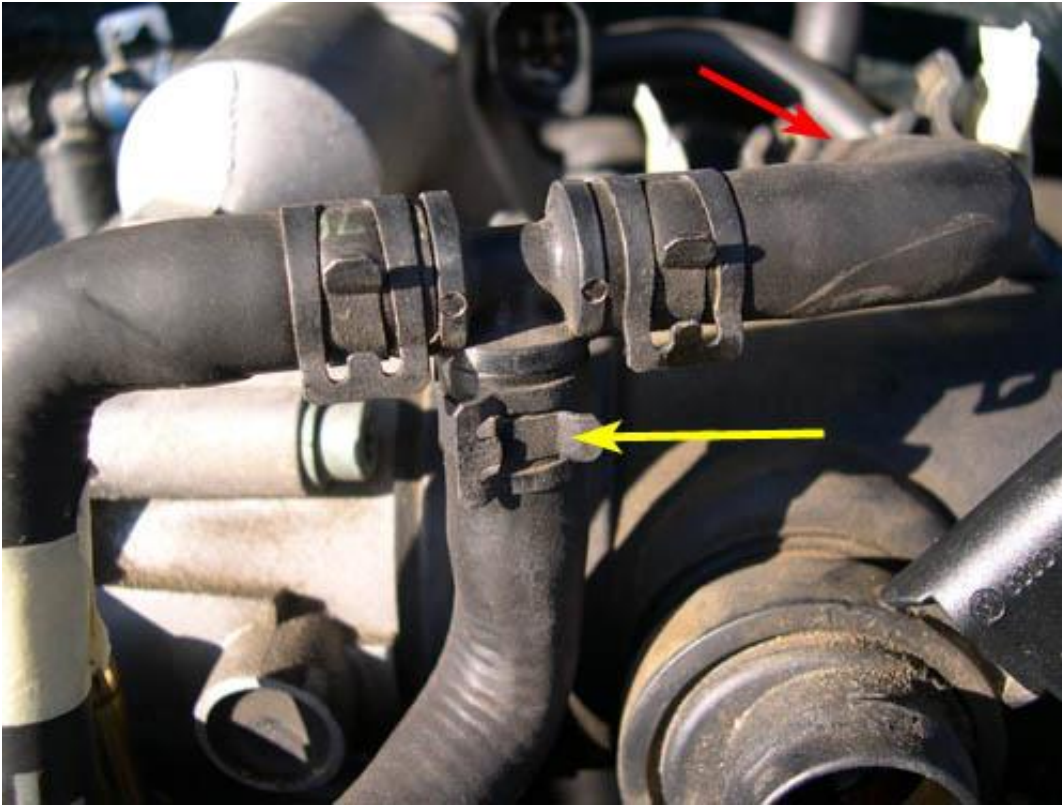
25. Disconnect the vertical coolant hose (yellow arrow in picture below) from the T-junction in front of the TB/main air intake tube. Next, unclip the horizontal portion of the coolant hose T-junction from the top of the main intake tube (red arrow in picture below) and then move the hose out of the way. At this point, there should be no coolant hoses attached to the TB, nor should there be any coolant hoses or electrical leads passing over the top of the main intake tube.

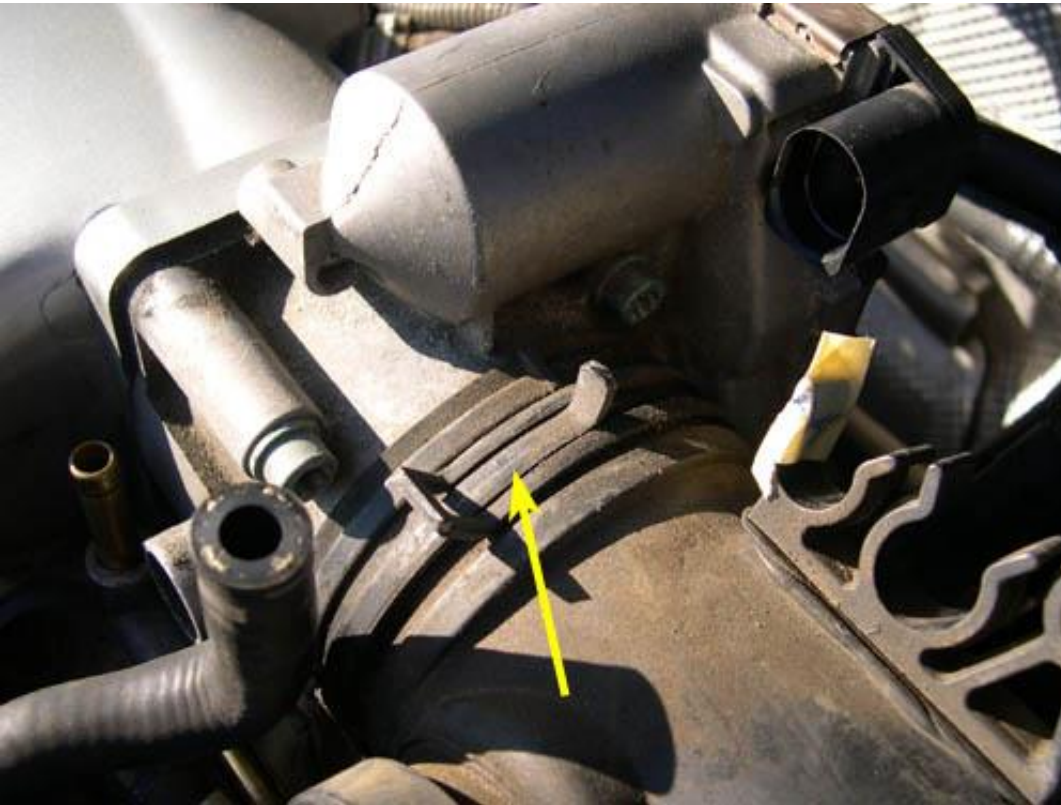
26. Release the tension from the clamp securing the main intake tube to the TB (indicated by yellow arrow in picture below) and then slide the intake tube off of the TB.

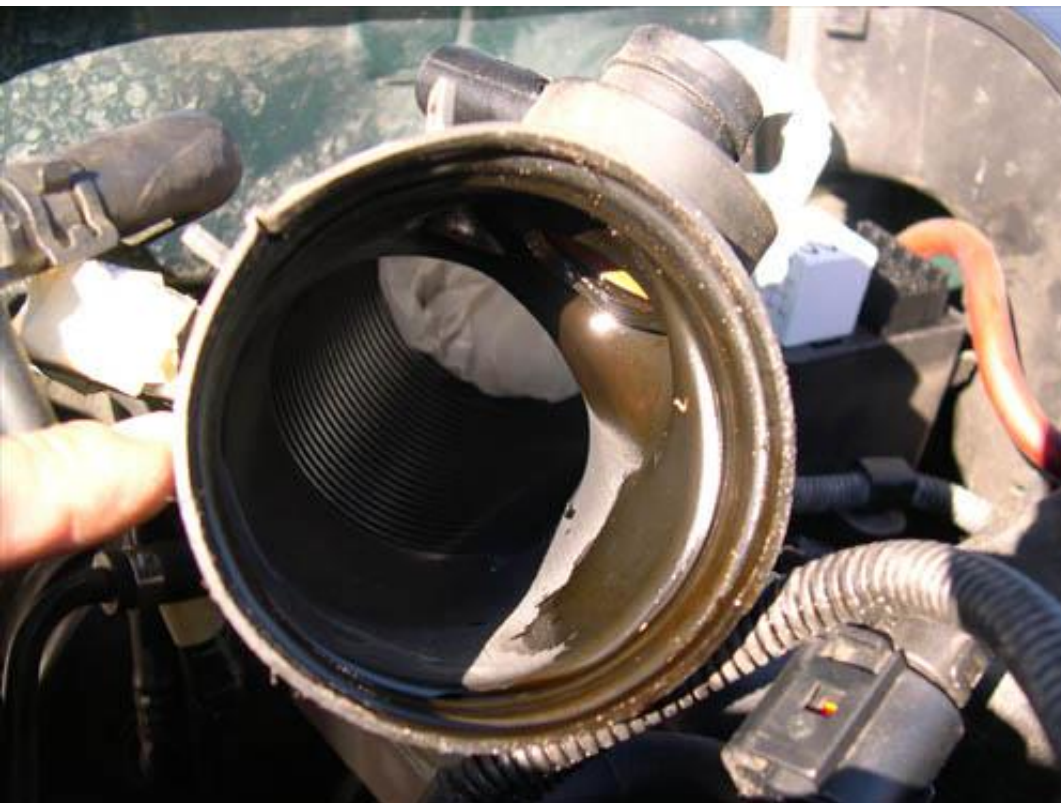
27. The picture below shows the large amount of condensed oil vapor in the main intake tube due to the PCV circuit. I wiped this oil off the inside of the tube with a paper towel. (I can only imagine how much oil is in the intake manifold and elsewhere in the engine. Someday I'll clean it all out.)

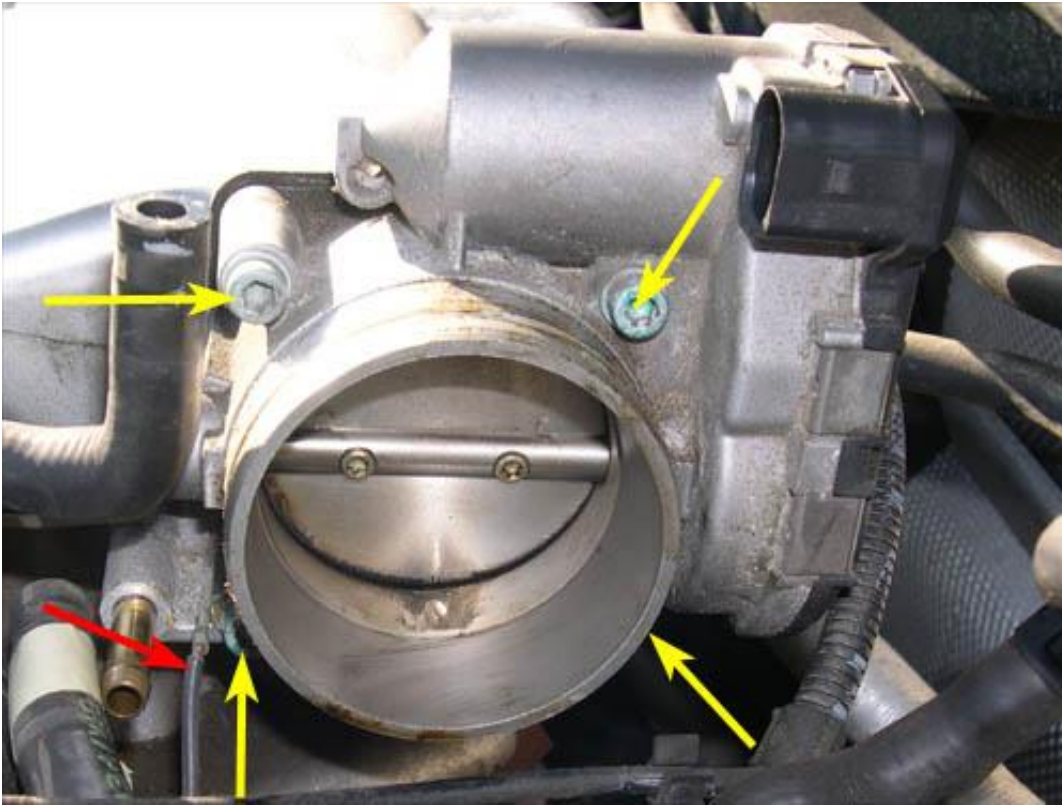
28. Using a 5mm hex/Allen wrench, remove the 4 long bolts that secure the TB to the intake

manifold. There is one bolt at each corner of the TB, as indicated by the yellow arrows in the picture below. Support the weight of the TB as you remove the last bolt. You wouldn't want the TB to fall - it is a delicate, high-precision device. Note that one of the bolts also secures a ground wire to the TB (indicated by red arrow in picture below). In my case, the ground wire was secured by the lower, front bolt, but a different bolt may be used in your car. Remember which bolt the wire was attached with so that it can be reinstalled in the same position.

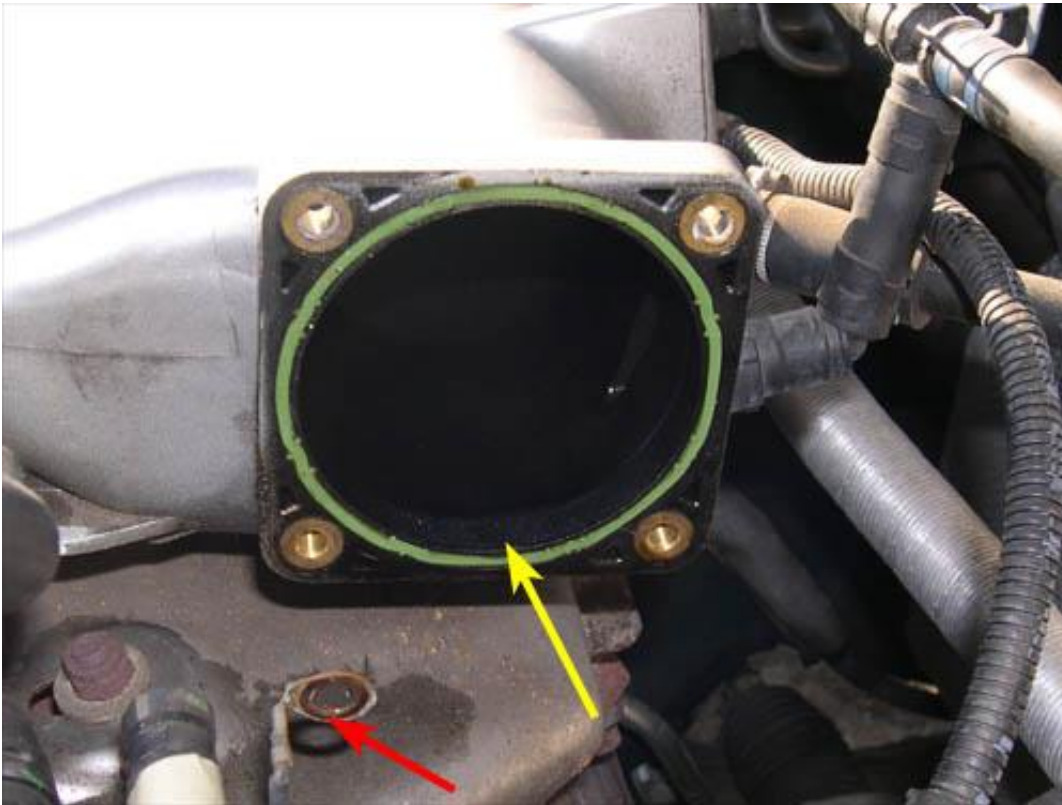
29. The yellow arrow in the picture below indicates the gasket that seals the rear of the TB to the intake manifold. Prior to reinstalling the TB (new or existing), either replace the gasket with a new one or decide to reuse the existing one. If you decide to reuse the existing gasket, make sure to clean it by wiping it with a rag or paper towel to remove any debris or contaminants that may be on the mating surface. I determined that the gasket in my car was in good enough shape to be reused, so that's what I did. No biggie. (The red arrow in the picture below shows a better view of the ground connection that is secured to the TB by one of its mounting bolts.)

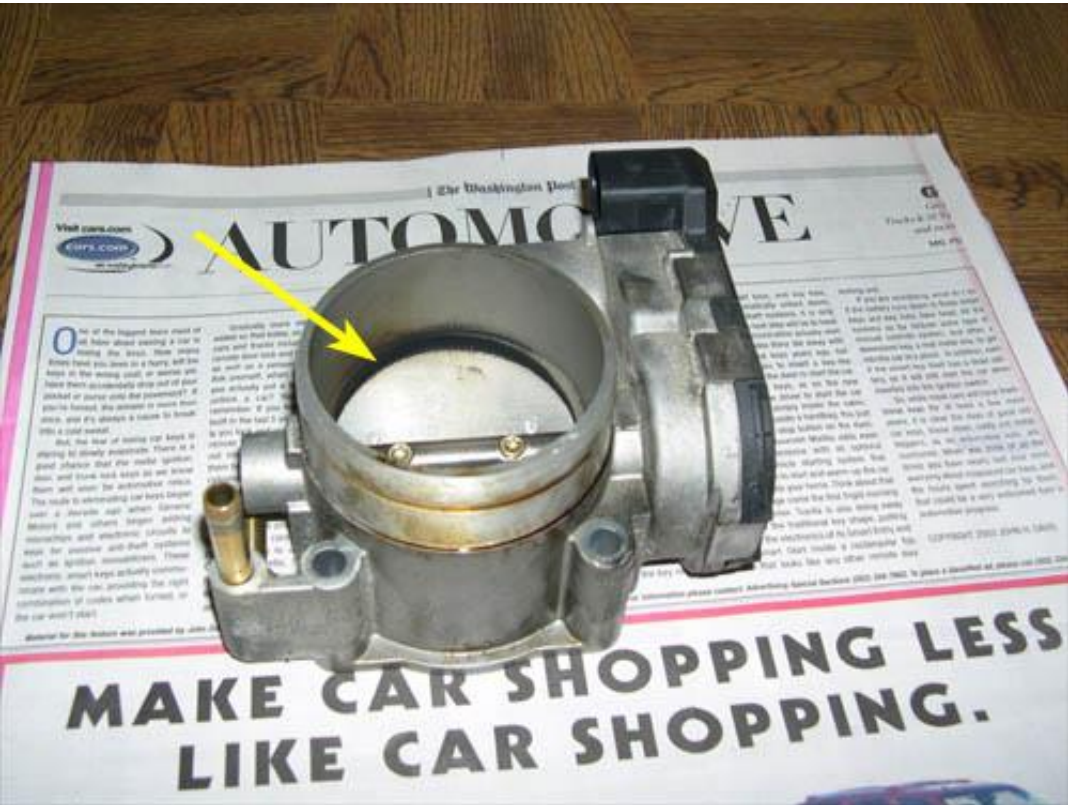
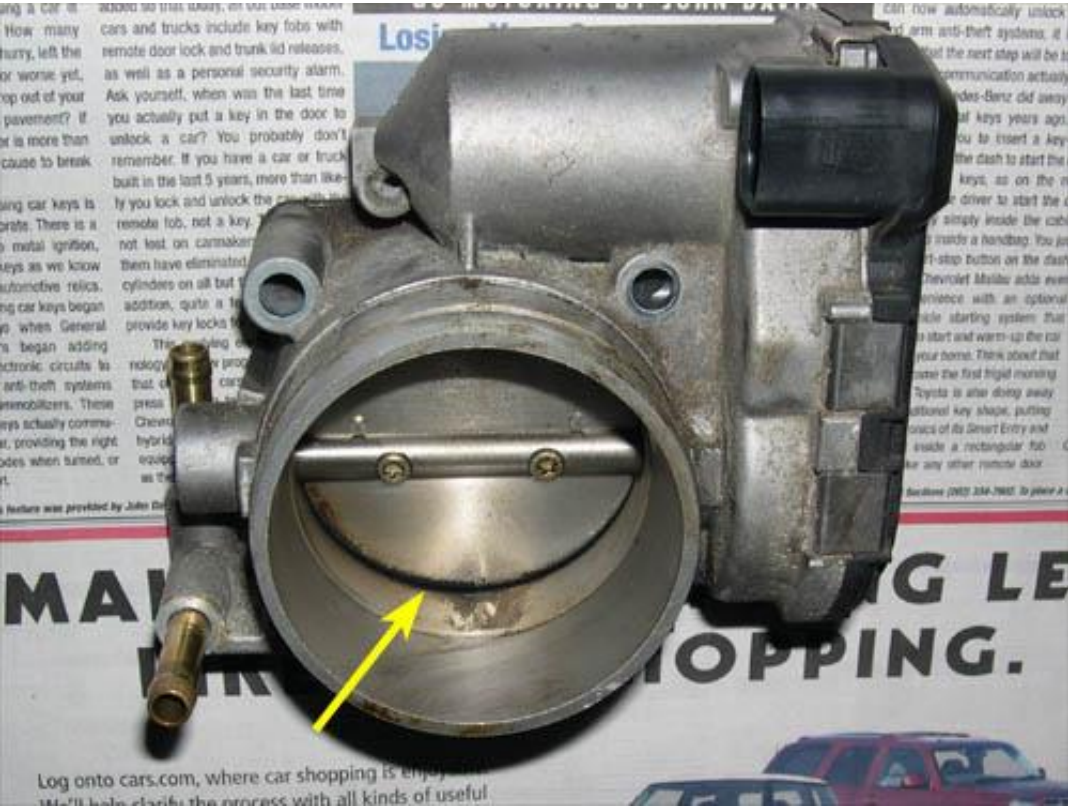
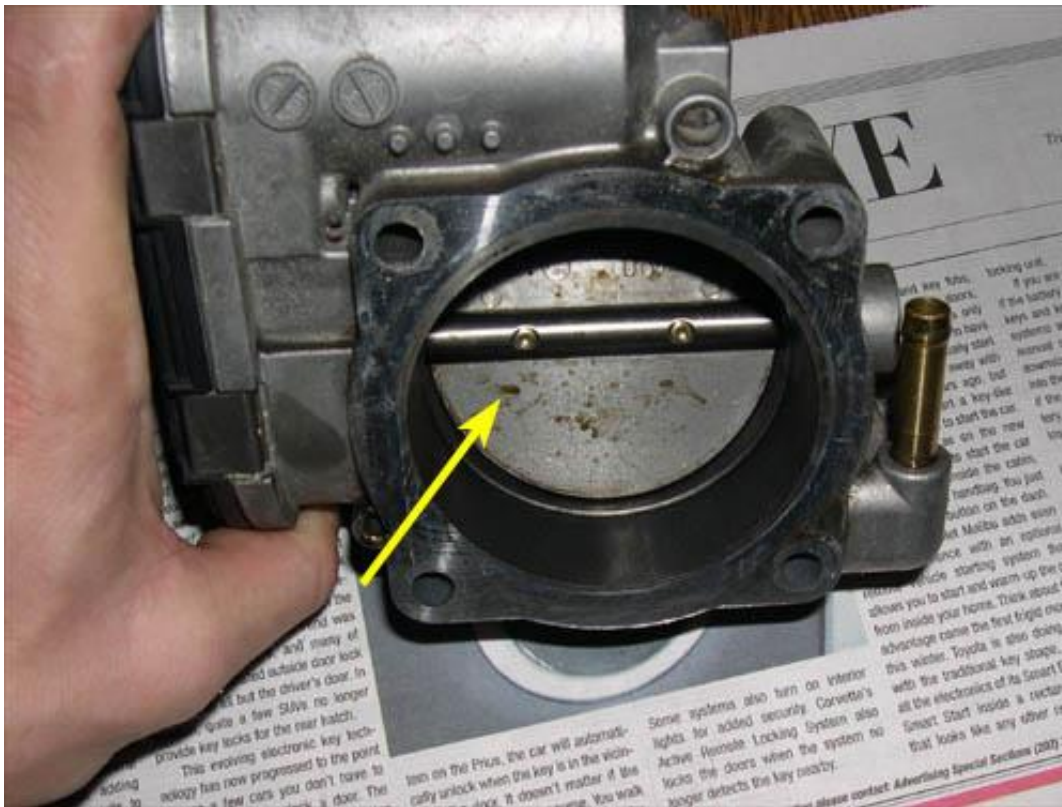
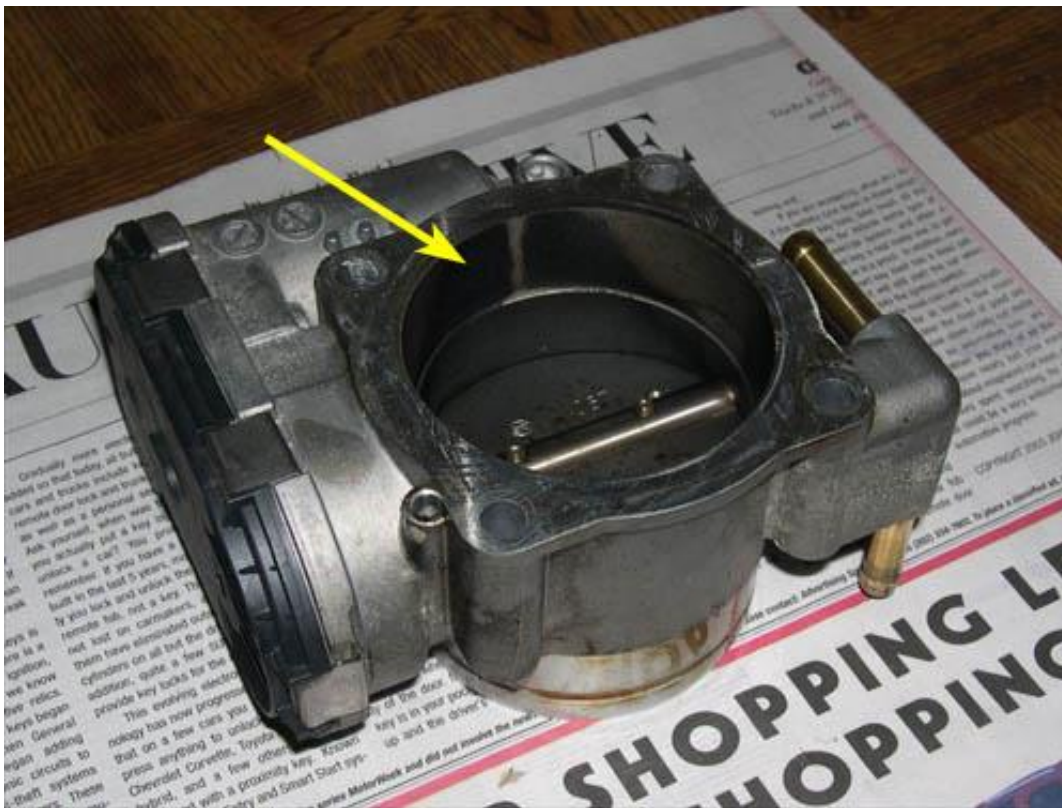
1. The four pictures below show different views of the inside of the throttle body. The yellow arrows in these pictures point to the oil, gum, varnish and other crap that deposits itself inside the TB over time. In my case, most of the deposits were located between the edge of the throttle valve and the TB wall (valve at idle position or fully closed) and on the roof of the TB wall behind the throttle valve.

2. To insure the proper operation of the TB, it is imperative that the deposits in the above pictures be removed. IMO, the most critical of these deposits are those which lie between the edge of the throttle valve and the TB wall. Normally there is a small 1-2mm gap between the edge of the valve and the wall. At idle, the valve remains fully closed and the air passing through this gap allows the engine to idle smoothly. As deposits build up in this gap, the amount of air that can pass through decreases and the ECM/DBW system must compensate by resetting the idle position of the valve

from fully closed to open a few degrees or so. Naturally, as the amount of deposits increases, an increasing larger compensation must be made by the ECM. At some point, the ECM cannot compensate by opening up the valve any further and the following OBDII code is commonly stored:

17990 - Idle Adaptation Limit Reached
P1582 - 35-00 - -

5. To clean the TB, spray the TB cleaner onto the deposits inside the TB, allow it to soak in for a few seconds and then gently scrub away the deposits with the Q-tips and/or paper towels. Using this method, you should be able to remove all of the deposits EXCEPT for those between the edge of the throttle valve and TB wall. We'll get to those deposits shortly. First, here are some VERY important warnings.

6. Since the throttle valve will not move freely due to stepper motor used by the DBW throttle valve controller, you cannot simply move the throttle valve out of the way to remove the deposits that collect between the edge of the throttle valve and the TB wall. Instead, I recommend that you use the small strips of paper to clean this area. Spray a little TB cleaner into the gap between the edge of the throttle valve and the TB wall and use the corner of one of the strips of paper to carefully scrape the deposits out of the gap. Once the deposits have been removed from a small area of the gap, slide the paper into the gap completely and move it back and forth to scrape the deposits out of the gap, similar to using dental floss to remove food from between your teeth. Spray additional cleaner into the gap as needed during this procedure. Using this method, it should be possible to remove virtually all of the deposits from the gap. Most likely, the gap near the axle for the throttle valve will be too narrow to get the paper into it, so there may be a very small amount of deposit left remaining in the gap near the axle. This is not a big deal.

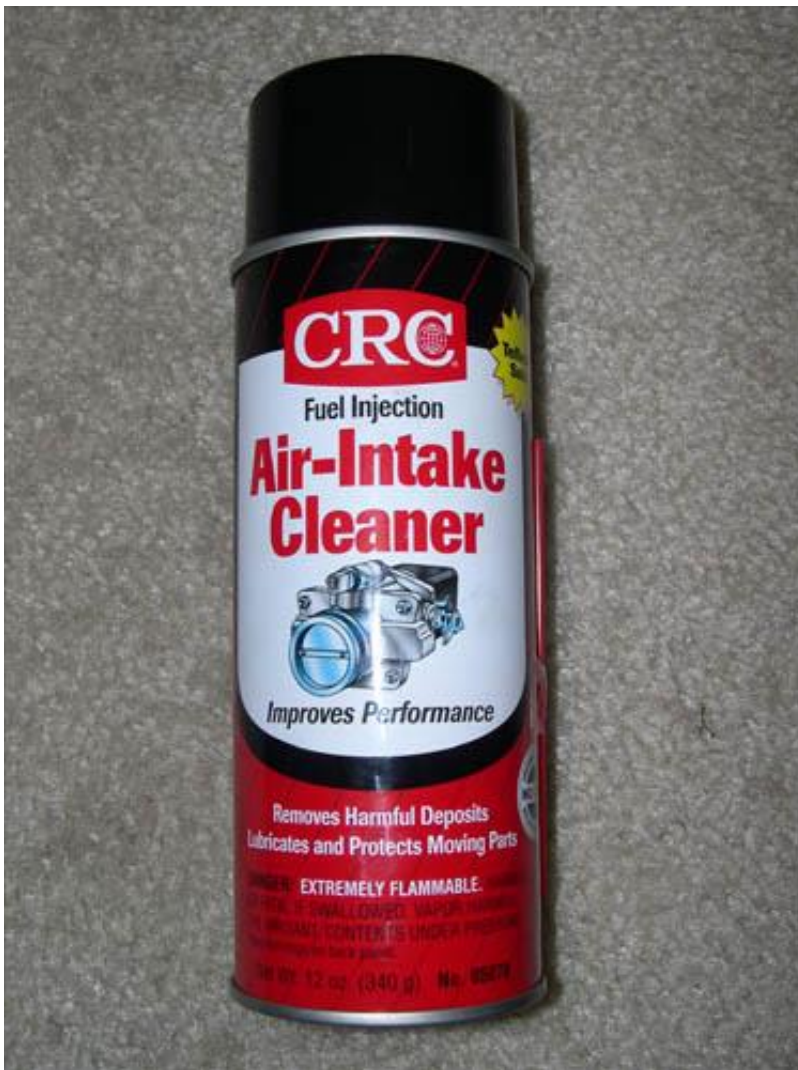
3. In order to safely clean the inside of the TB, you will need a can of intake/TB cleaner (the stuff I used is shown in the picture below - make sure to choose something that is relatively gentle and will not harm DBW TBs - some carb-type cleaners are not), something to gently scrub off the deposits on the throttle valve and on the TB wall (I used Q-tips and paper towels) and a sheet of ordinary white paper.

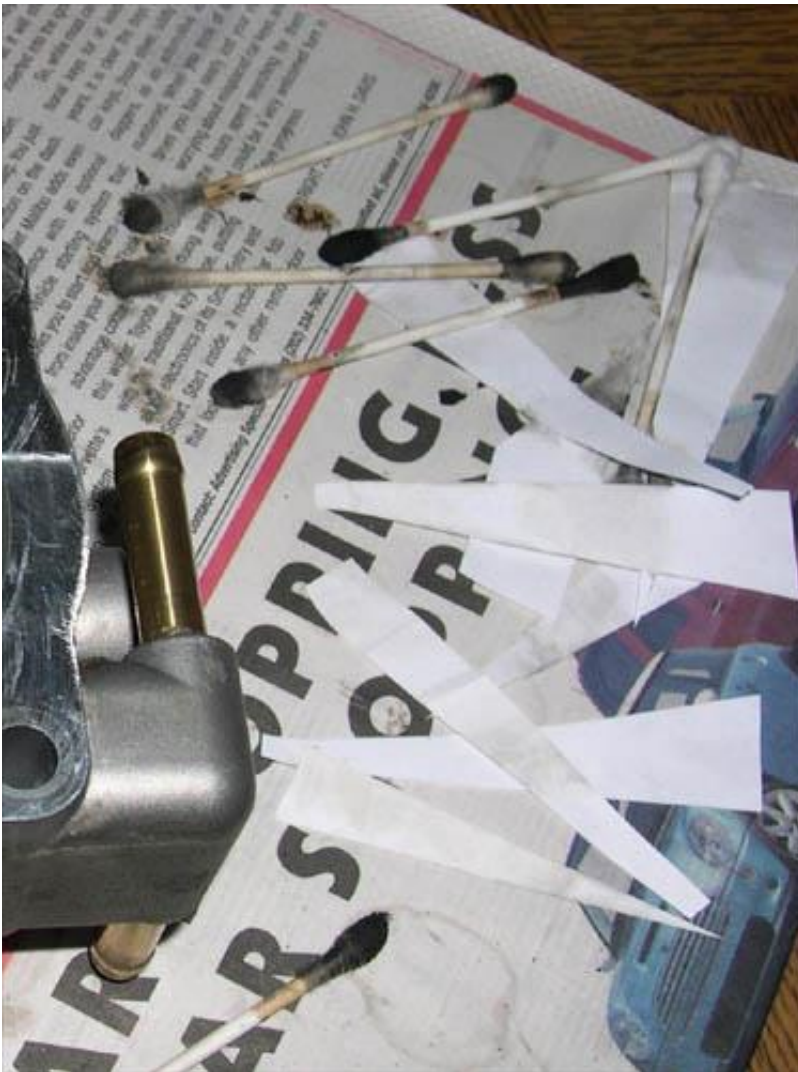
4. Cut the paper into thin, triangular pieces approximately 1" x 4" (size is not critical), as shown in the picture below. Also shown are some EXTREMELY dirty Q-tips that had already gone at the deposits in the TB by the time I took this picture.

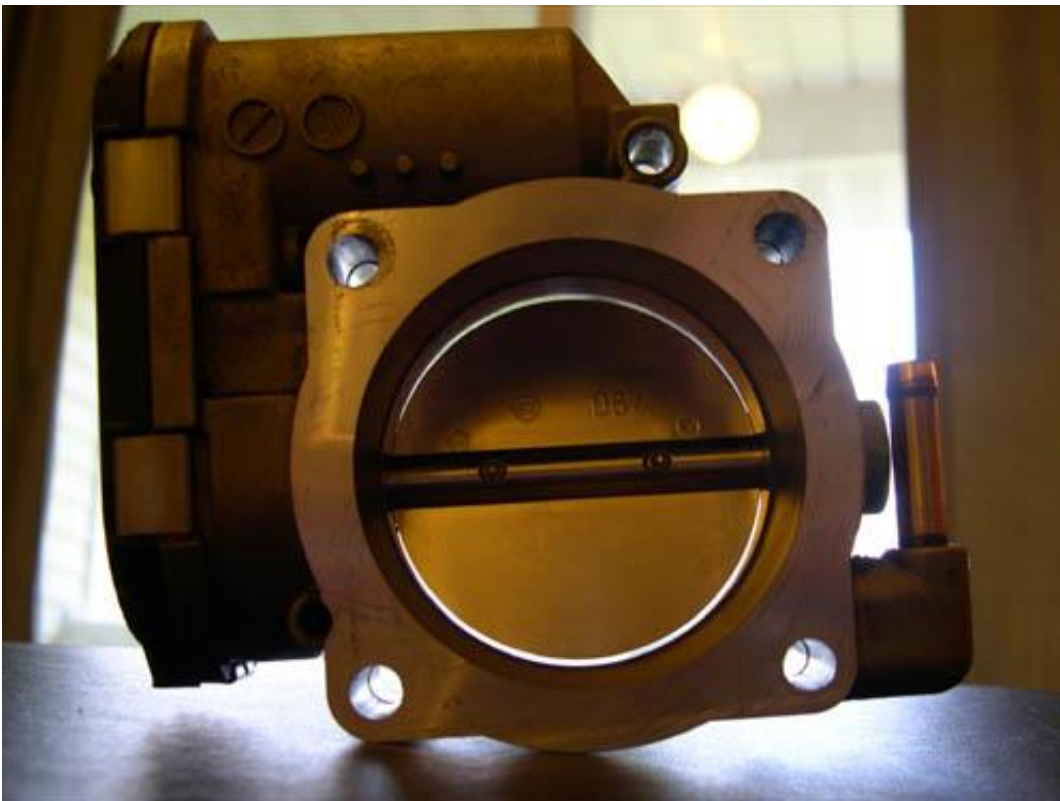
7. The picture below show how the gap between the edge of the throttle valve (in the fully closed position) and the TB wall should look once the deposits are removed from it.

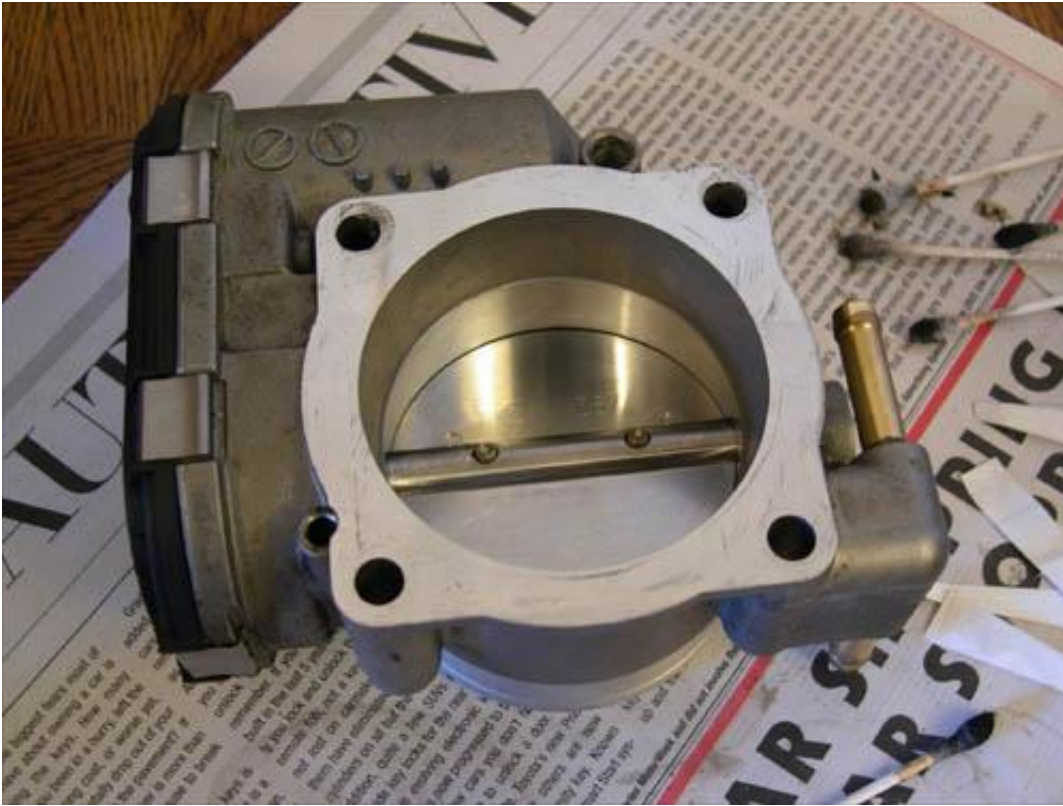
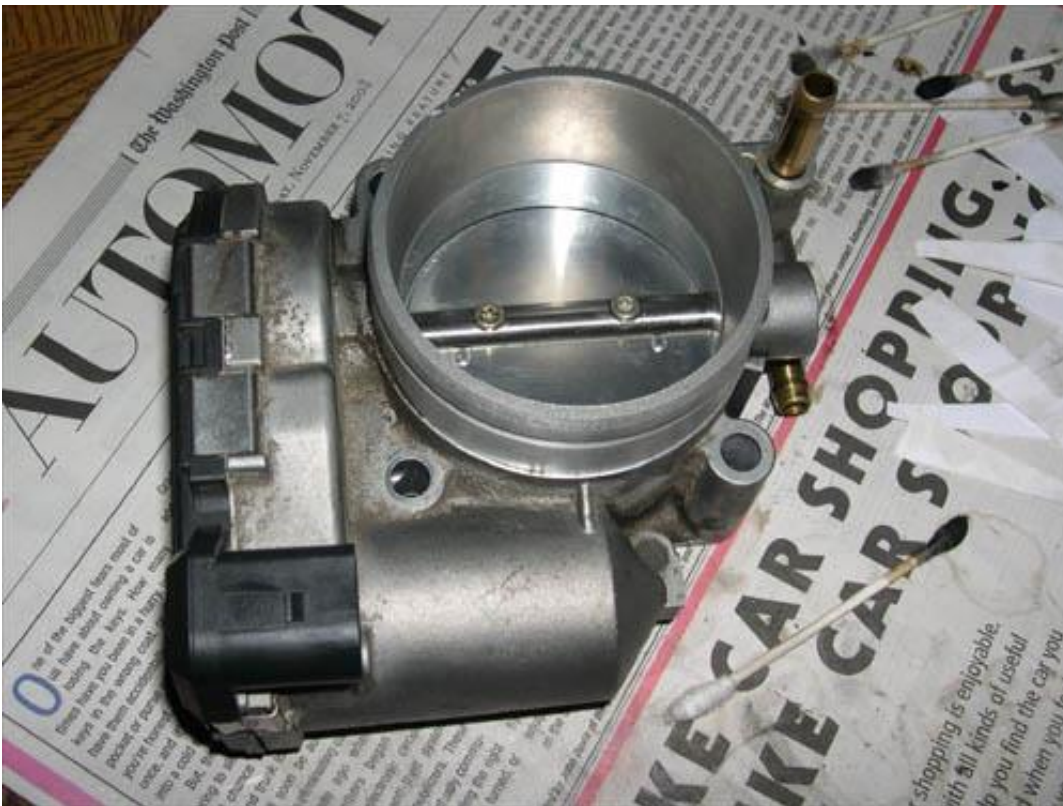
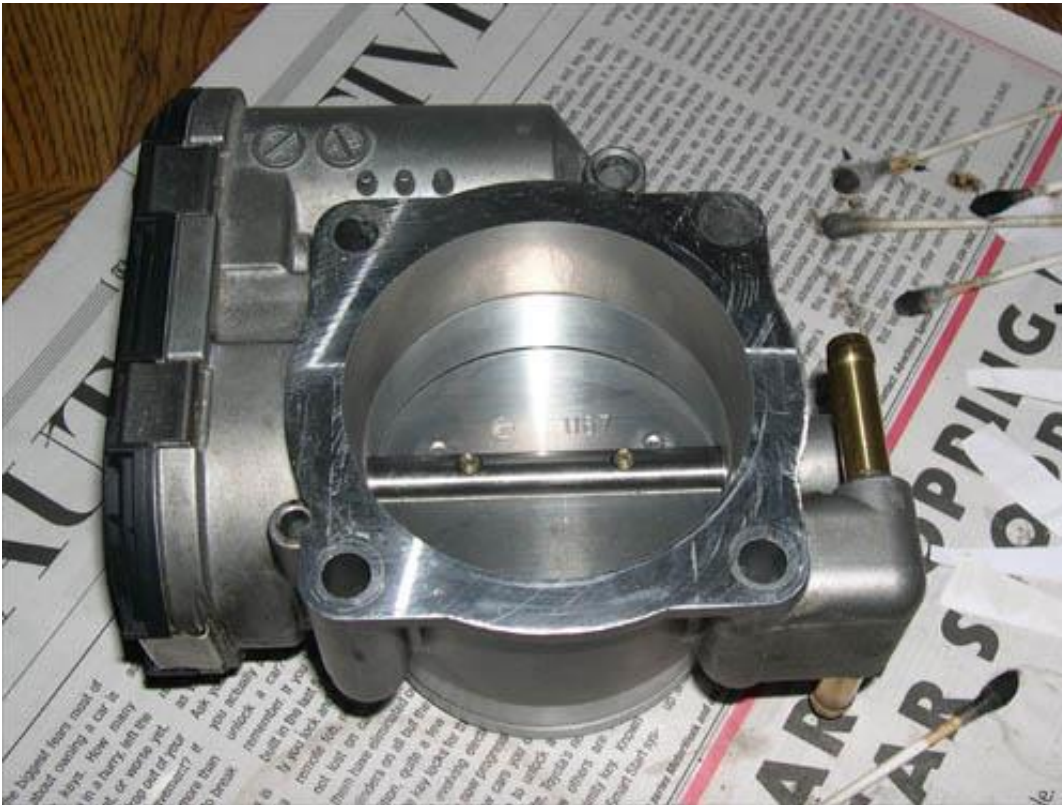
8. The pictures below show various views of the TB following the cleaning procedure. No big

surprise that it looks much better than it did prior to the cleaning.

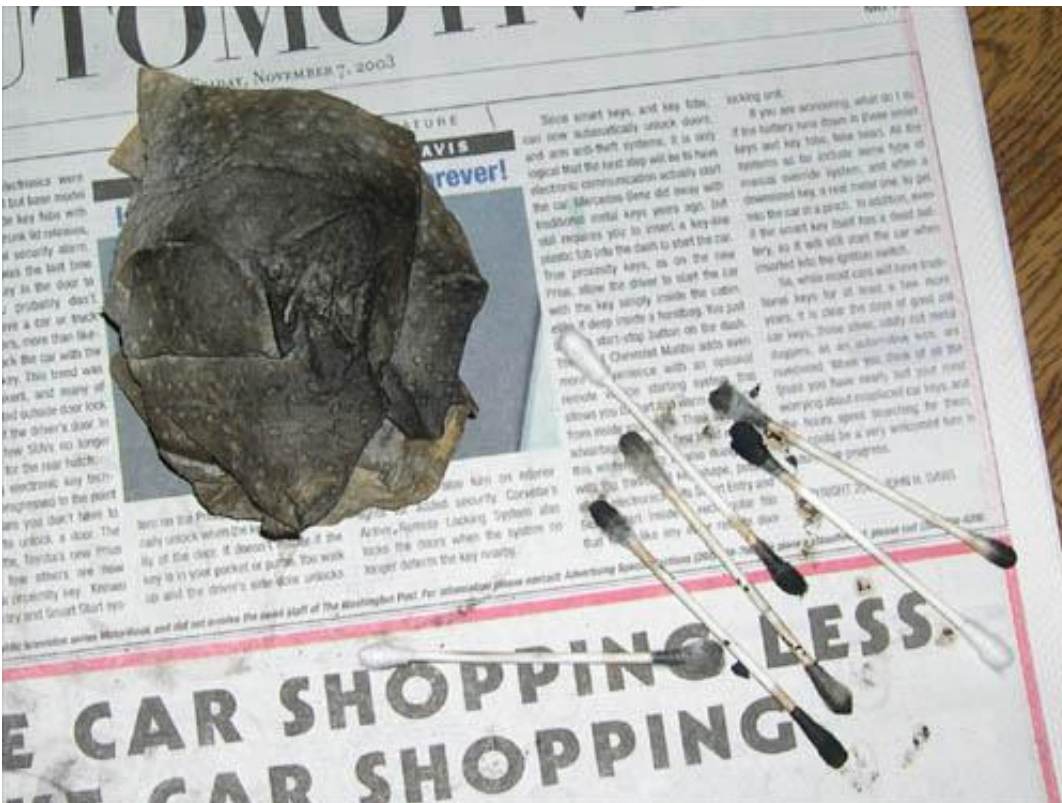
9. The pictures below of paper towels and Q-tips used during the cleaning procedure illustrate that while the TB did not look that dirty, quite a bit of deposits were removed during the cleaning process.

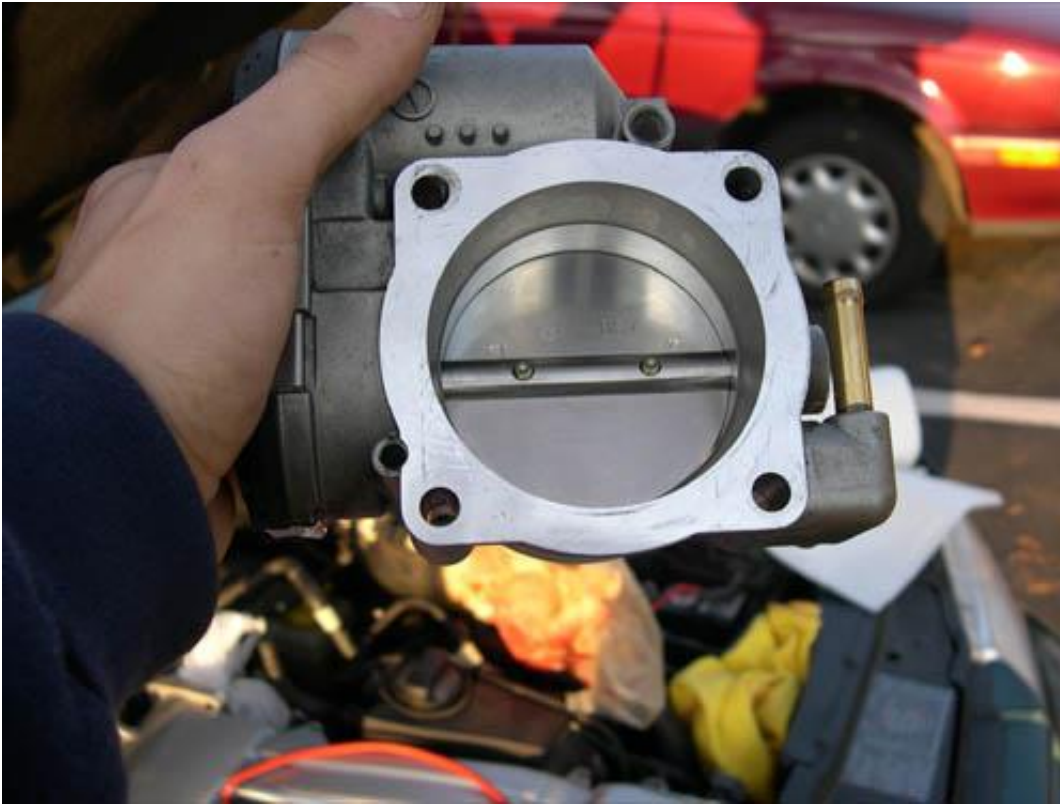
10. The picture below shows the cleaned TB ready to be reinstalled.
