Driver's Side Mirror Repair

**These instructions pertain to the 2014-2018 GM Sierra trucks with the standard power fold mirrors (not tow).

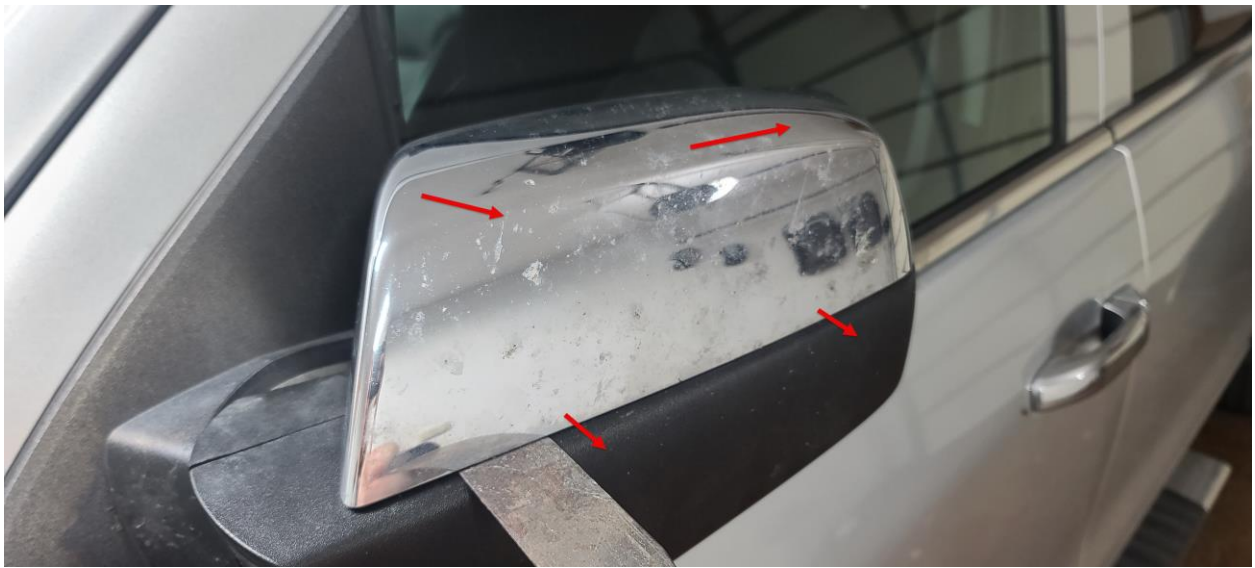
Slide a paint scraper or trim tool under the mirror cover and pull outward to remove the bottom latches. To remove the top latches, start from the area closest to the door and push the cover out away from the vehicle. Slowly wiggle the cover and the latches should remove while pulling out.

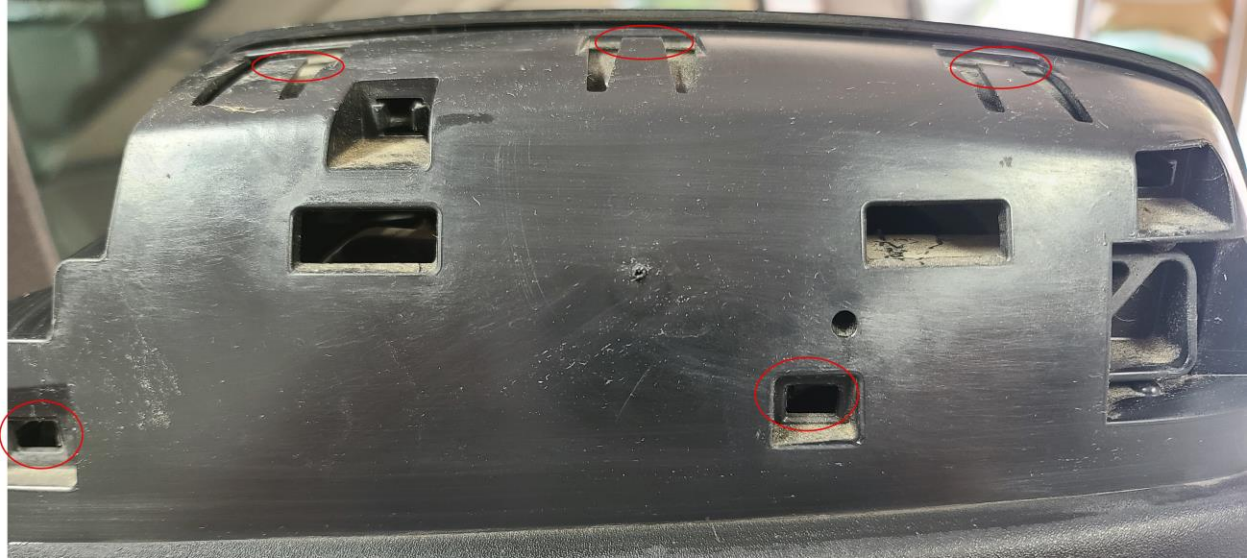
Latches are located by the red circles

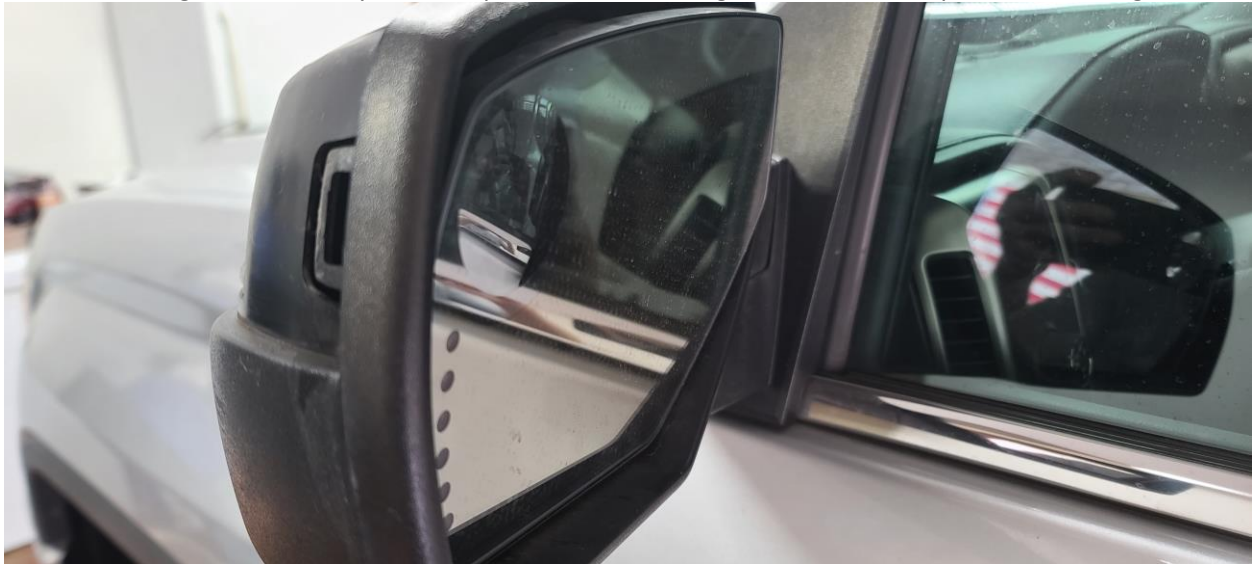
Tilt the mirror glass all the way down to provide the best angle to attack the top latches of the glass

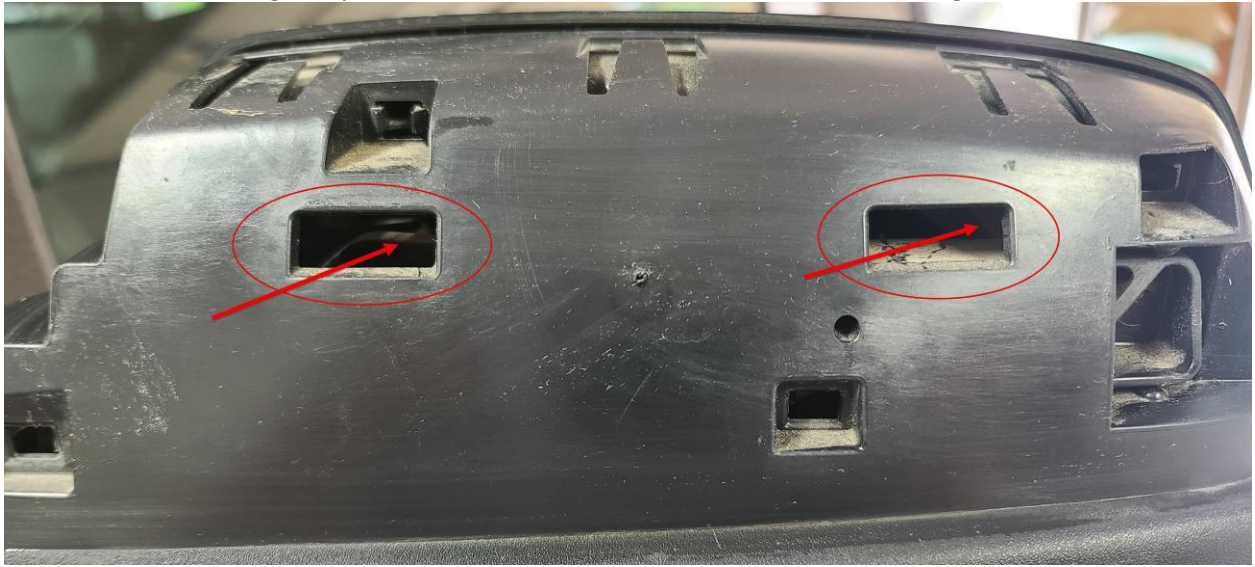
To remove the mirror glass, you will need to look into these two holes at the angle shown

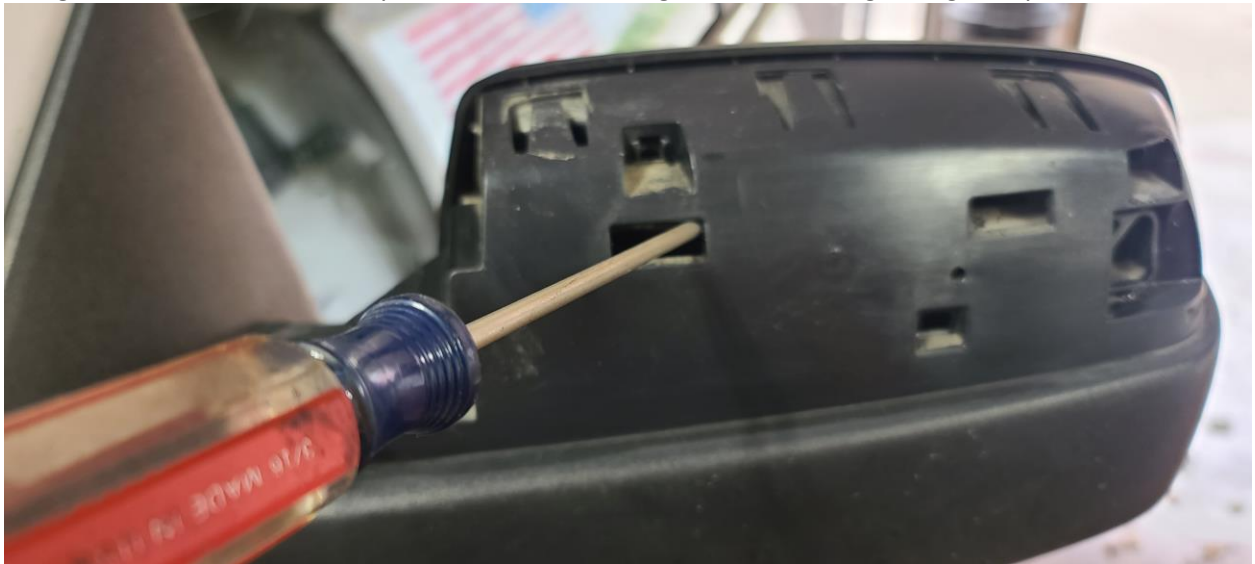
Using a flat bladed screwdriver you want to use twisting action to leverage the glass up off the hooks.

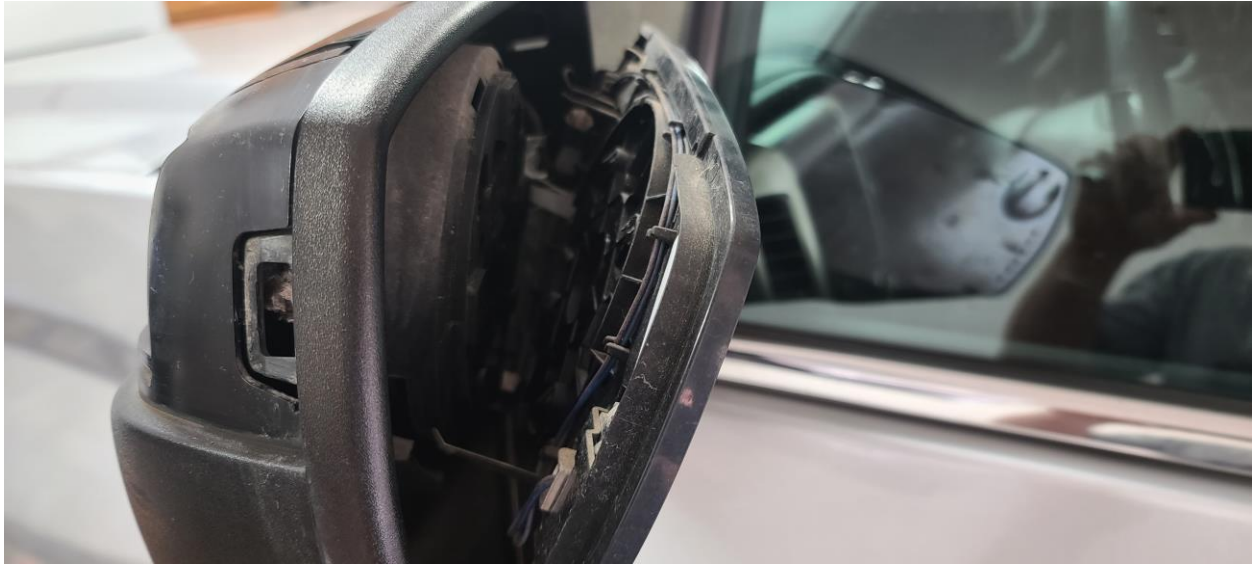
Once you remove the second latch, keep your hand close to the glass to catch it

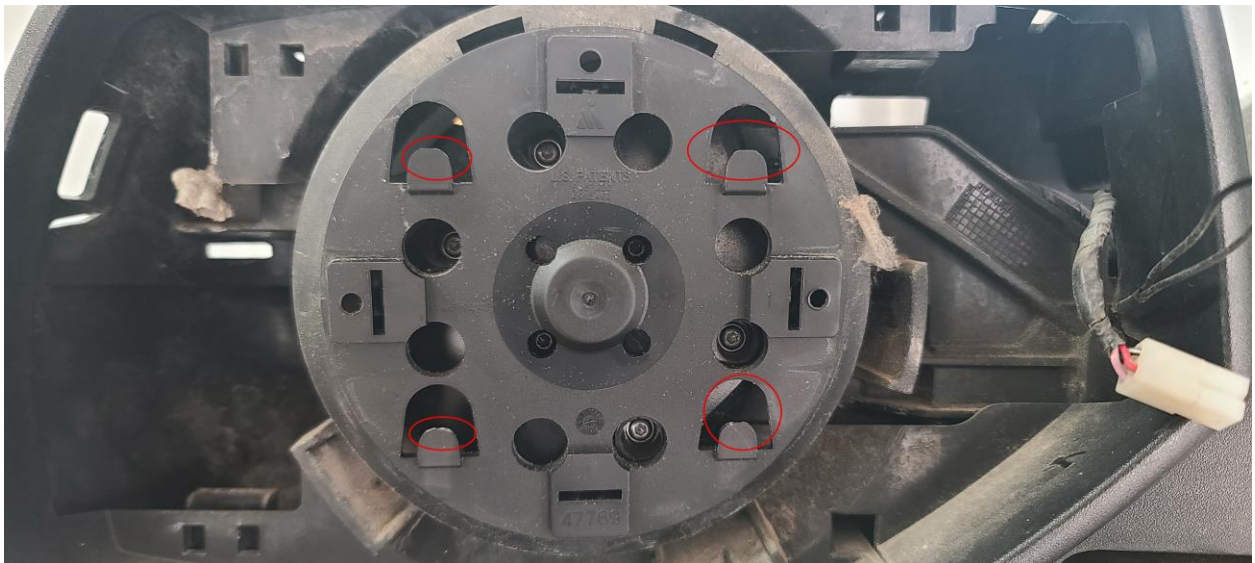
Glass hooks to these 4 latches

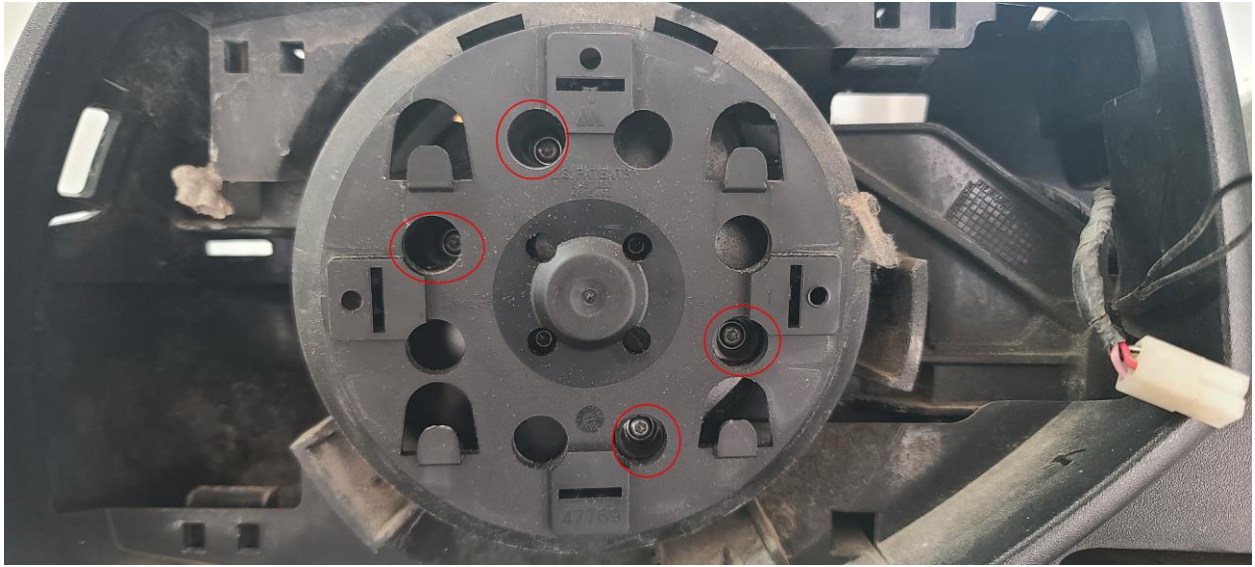
Remove the 4 T10 torx screws to remove the mirror motor

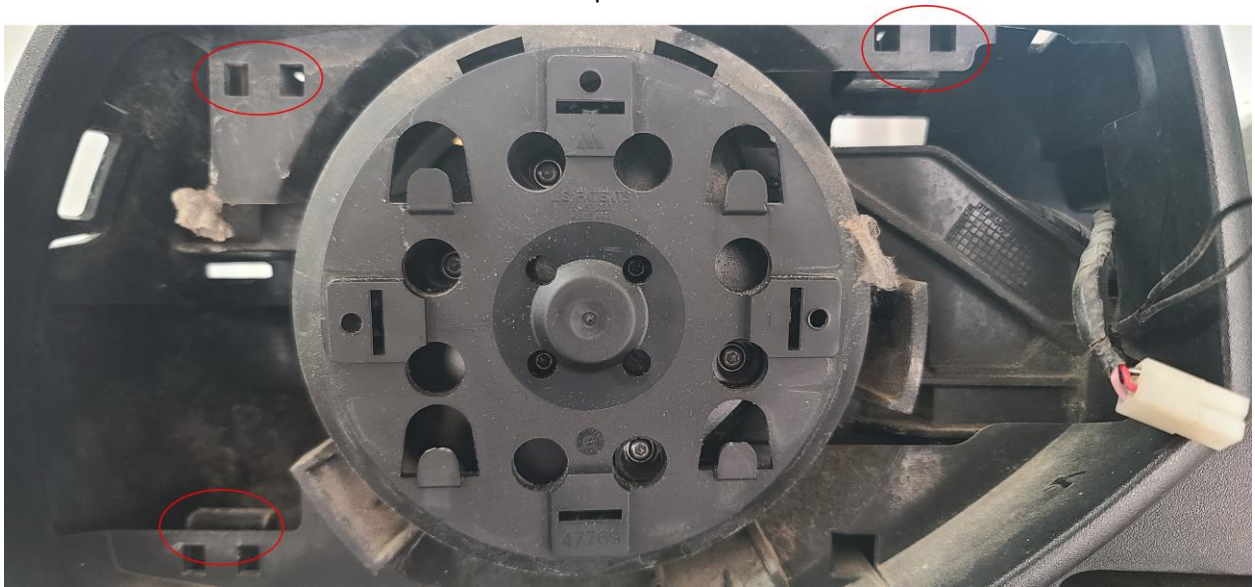
Unlatch these 3 connections to remove the inner plastic shroud

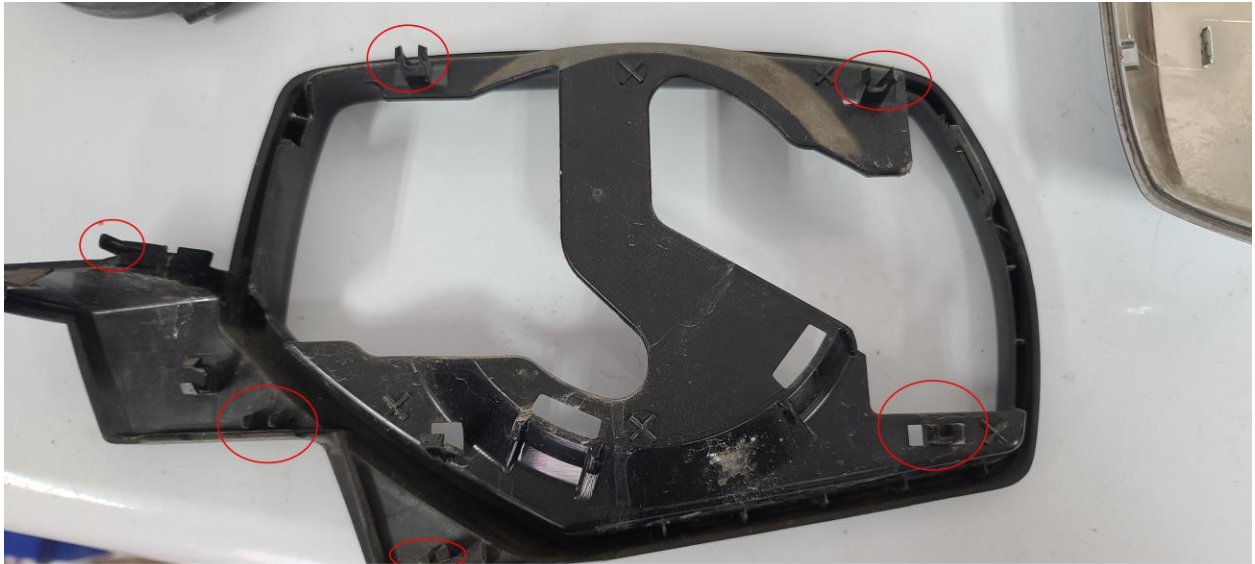
The 3 latches closest to the motor disconnect pretty easily with a trim tool and some wiggling

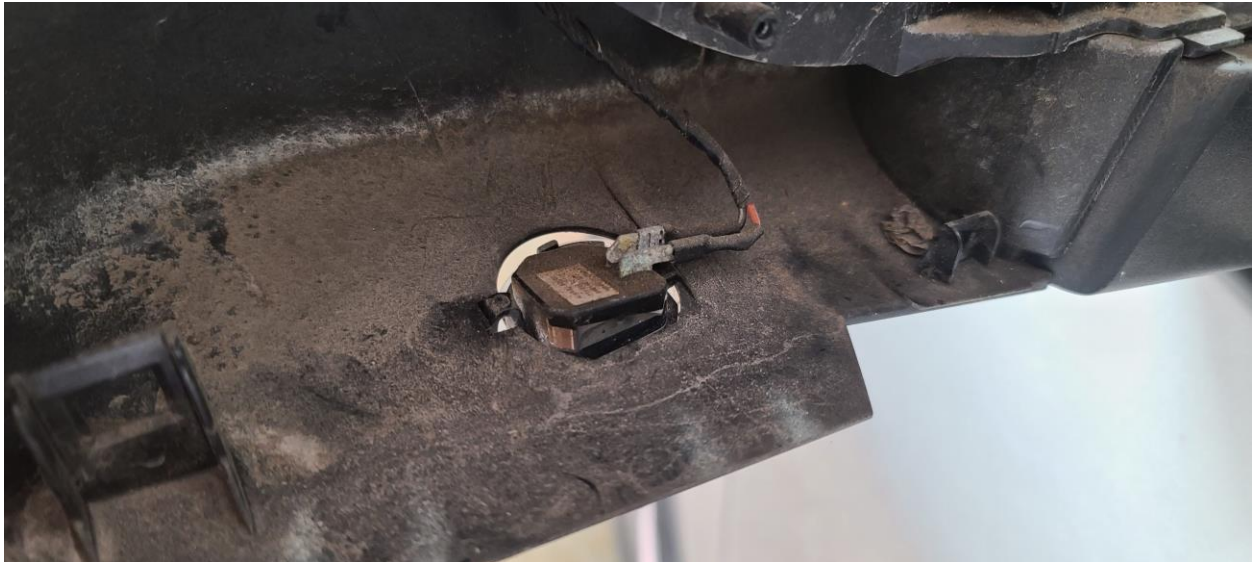
Unlatch the mirror puddle light and remove the connections

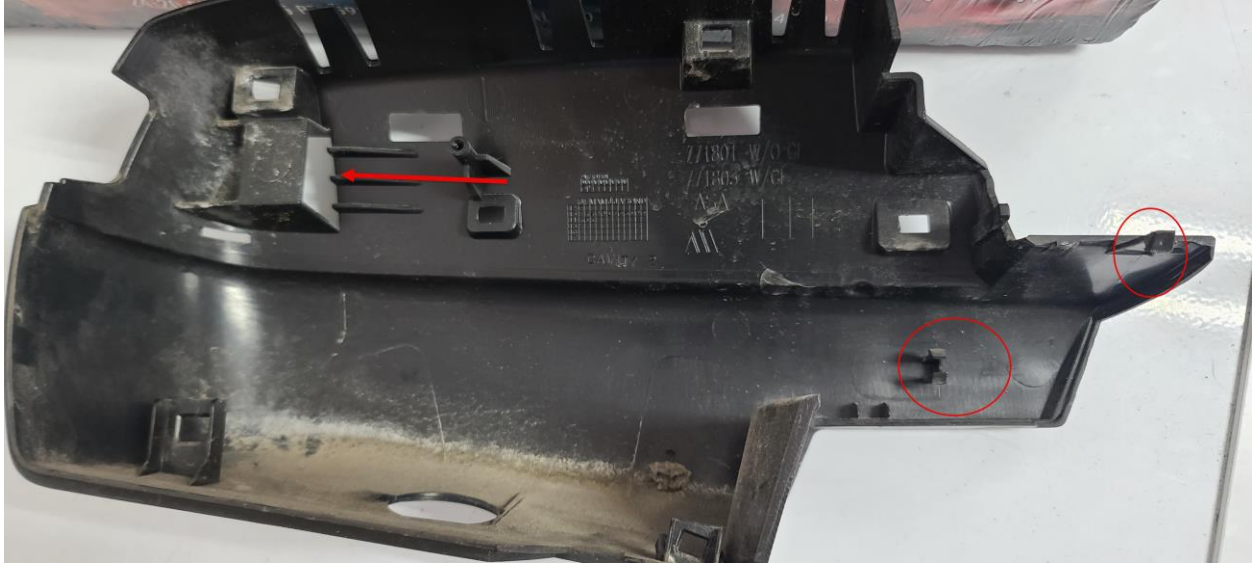
The back cover is held on by 2 latches and slides over the rigid mirror frame through the opening labeled with the arrow

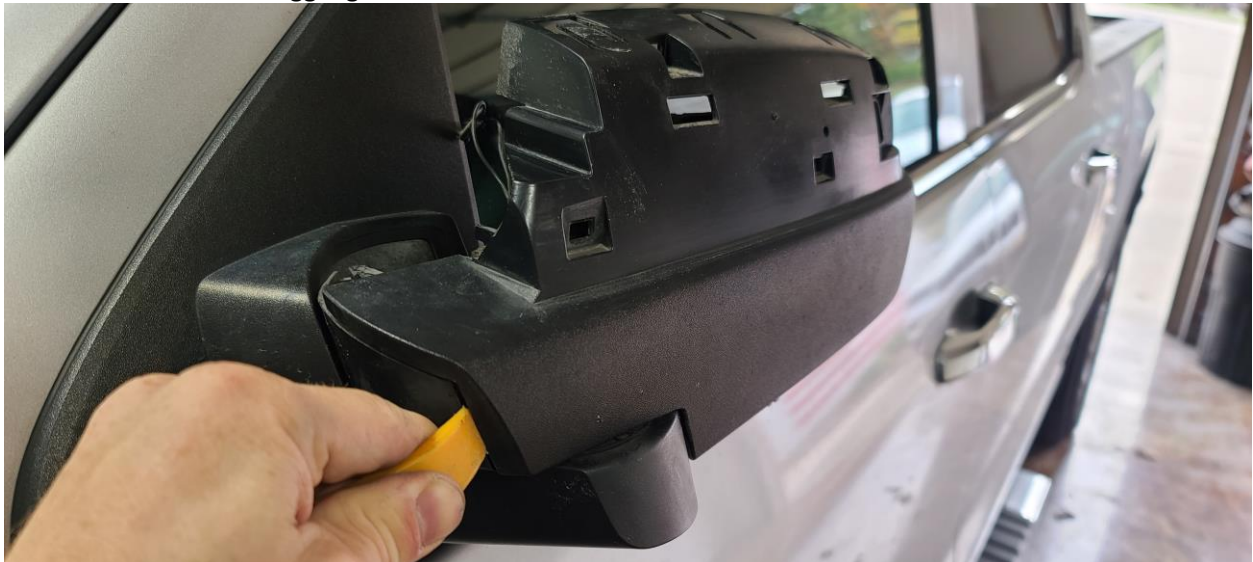
A trim tool and some wiggling will release the latches closest to the mirror motor

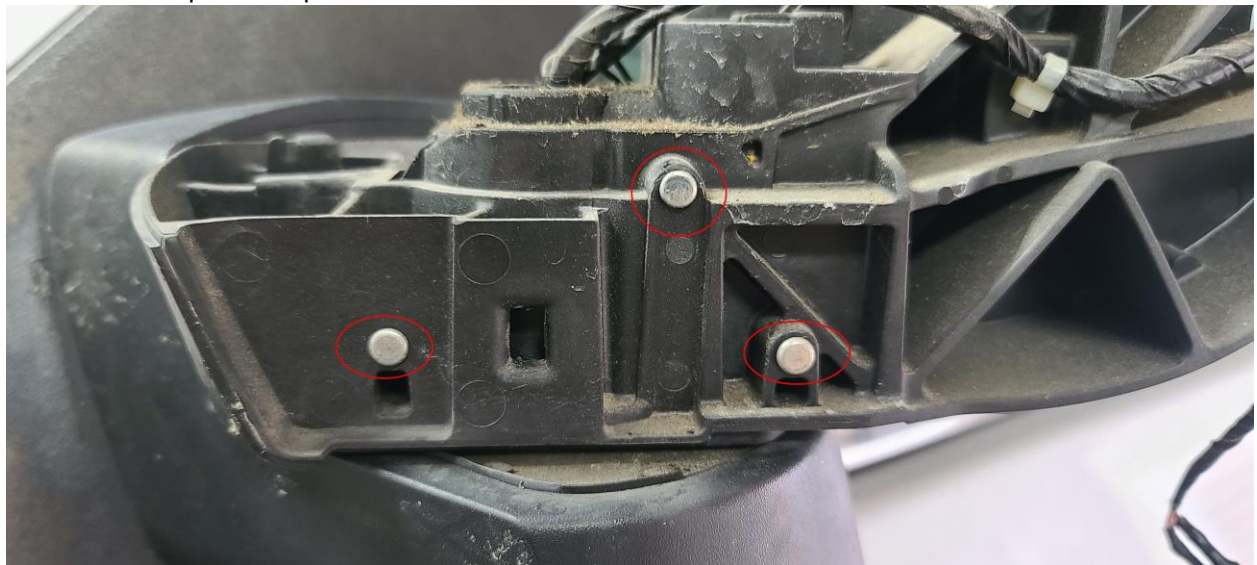
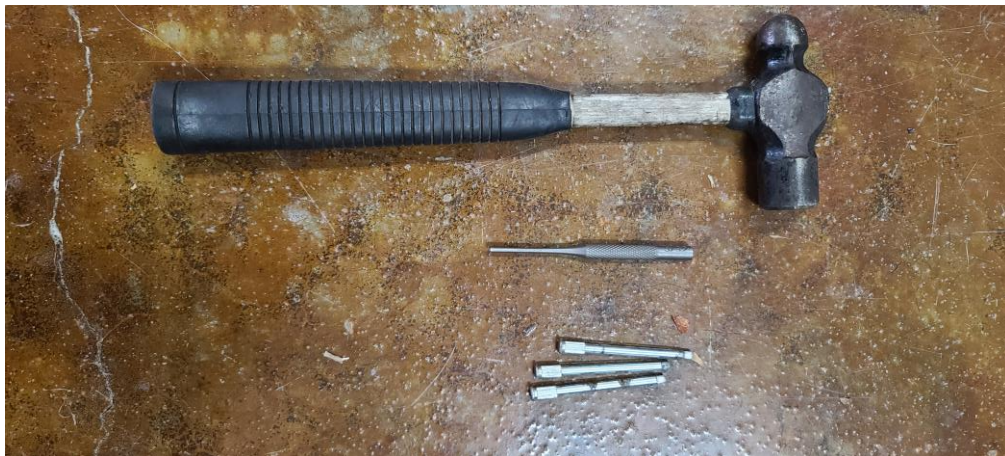
Remove frame pins with punch and hammer

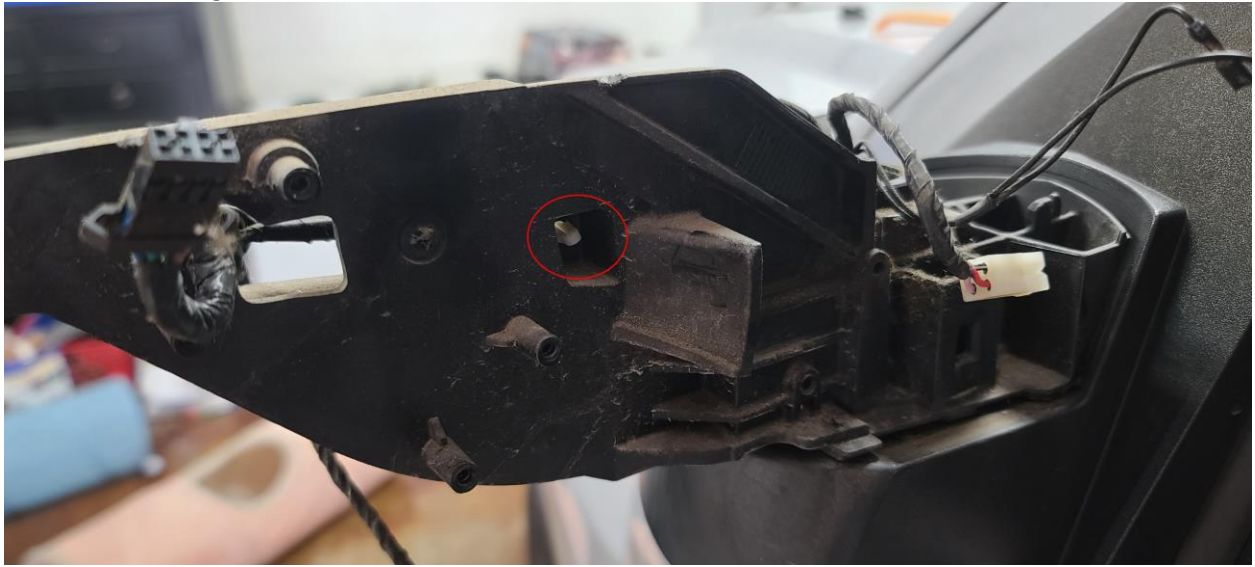
Unlatch the wiring harness retainer

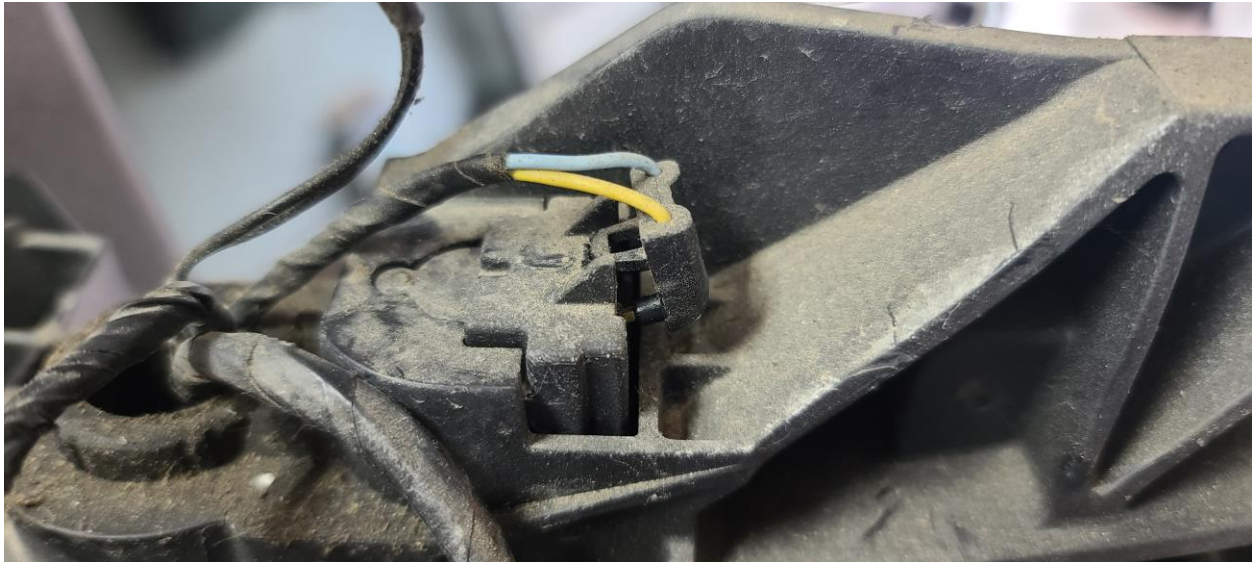
Remove the motor connector

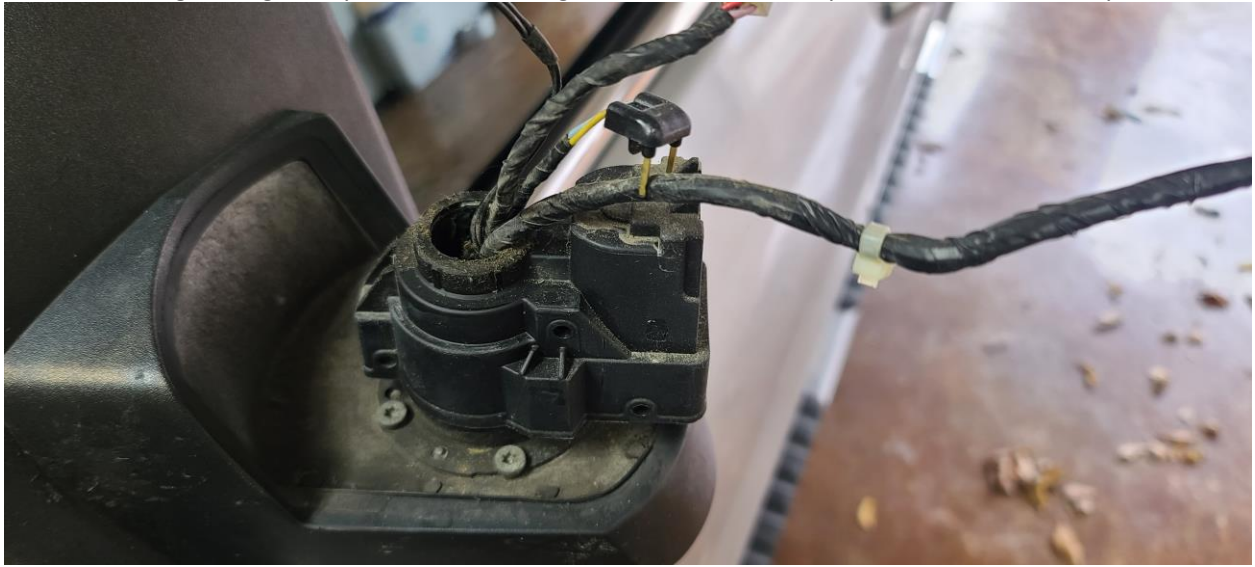
Slide the wiring through the plastic frame being careful not to bend up the motor connector pins

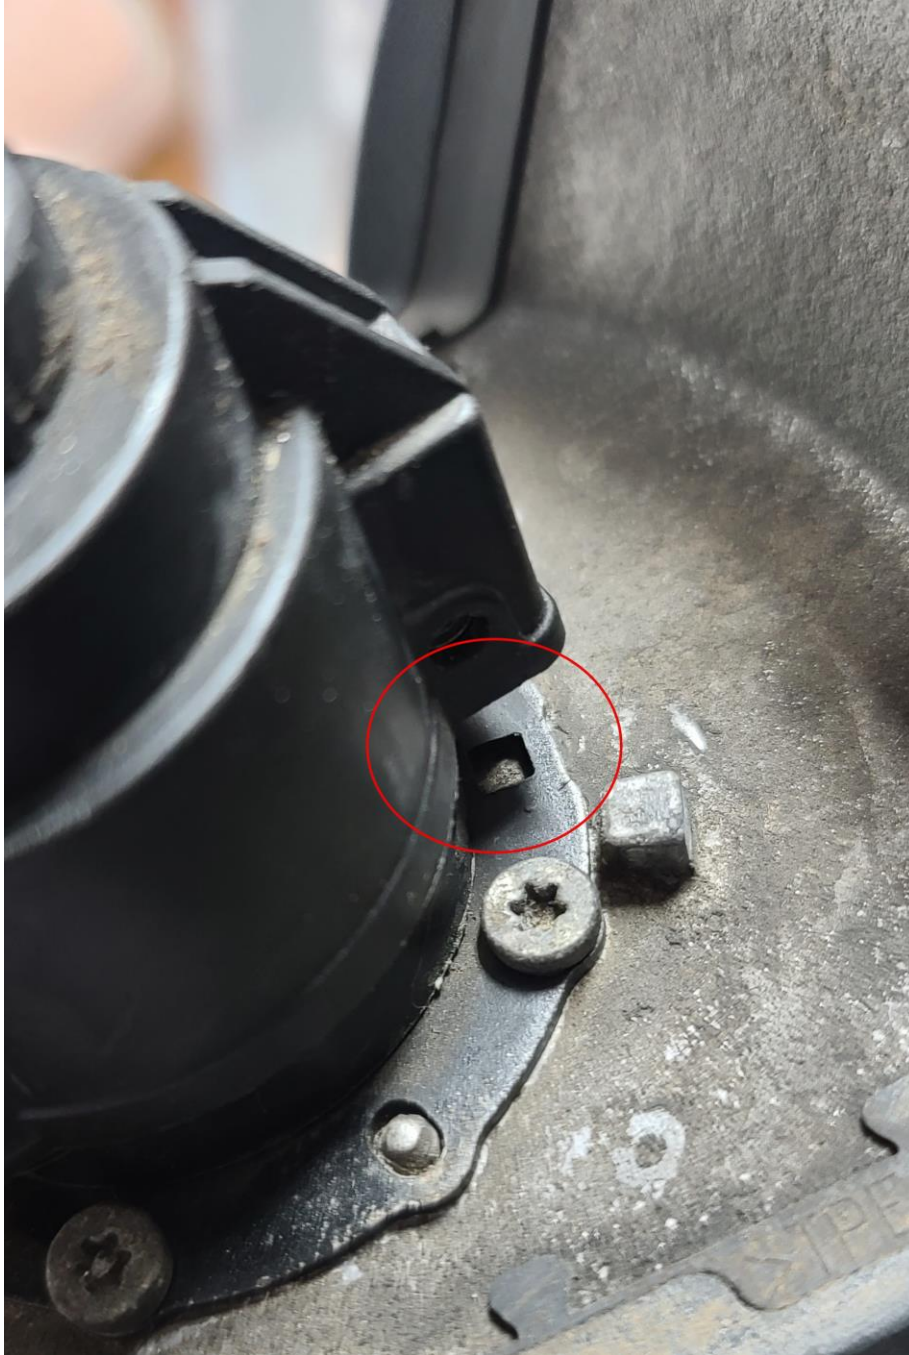
Note the location of the square in the lower motor housing in relation to the motor position and mirror mount

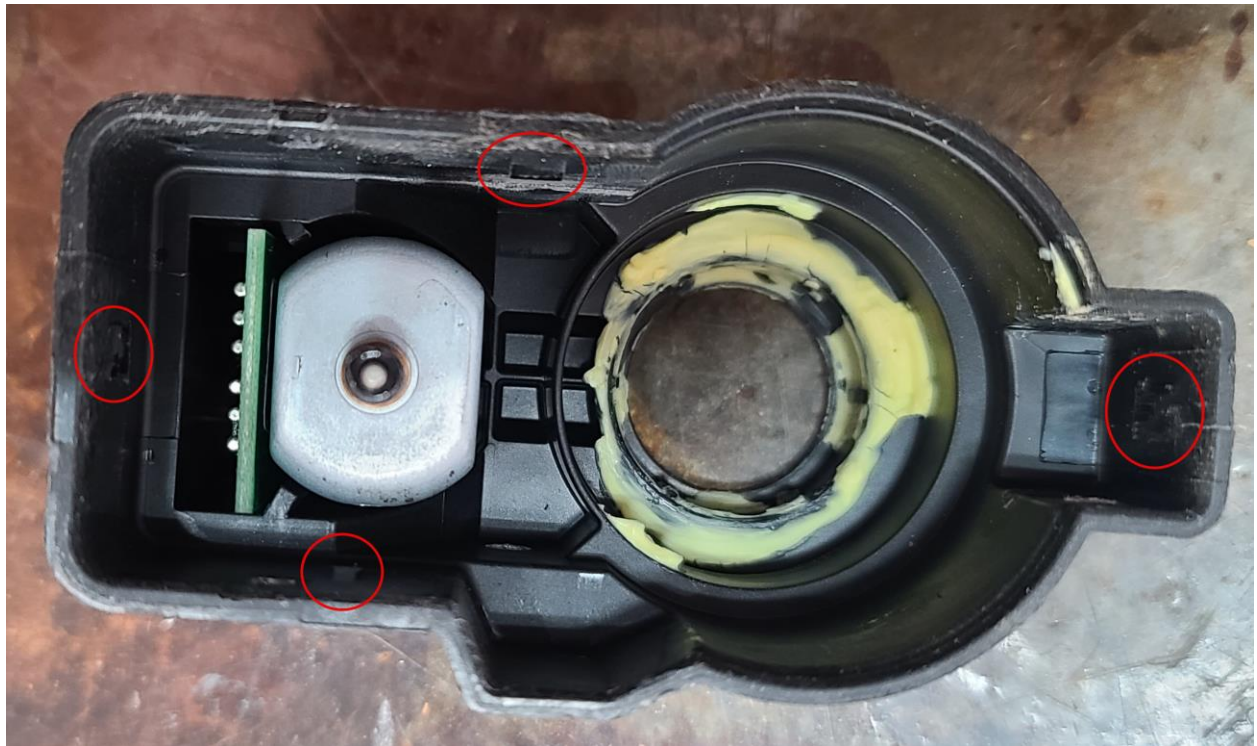
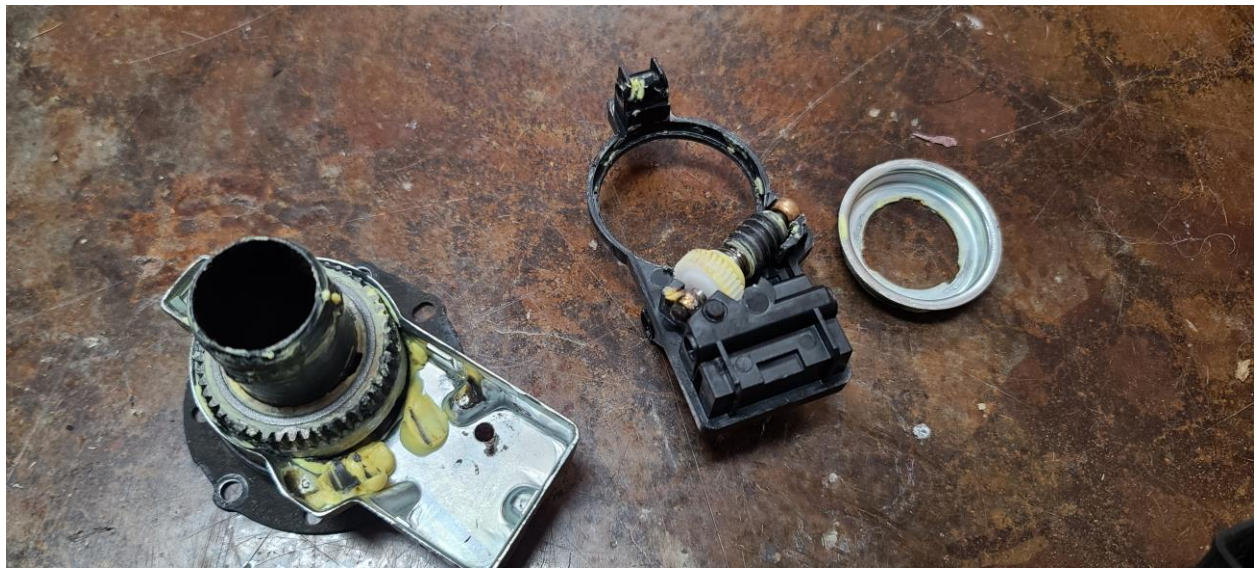
The motor cover is plastic and held on by 4 latches. I find it easier to clamp the lower motor mount in the vice and use small screw drivers to gently lift the latches while pulling upward
