**GruvenParts.com 2009-2018 RAM 2500/3500 Power Folding / Flip Up Towing Mirror Gear Replacement Instructions**

**This DIY covers the 4<sup>th</sup> Gen Rams with the power fold / manual flip up towing mirrors from 2009-2018. Please order the parts required to fix these towing mirrors here :**

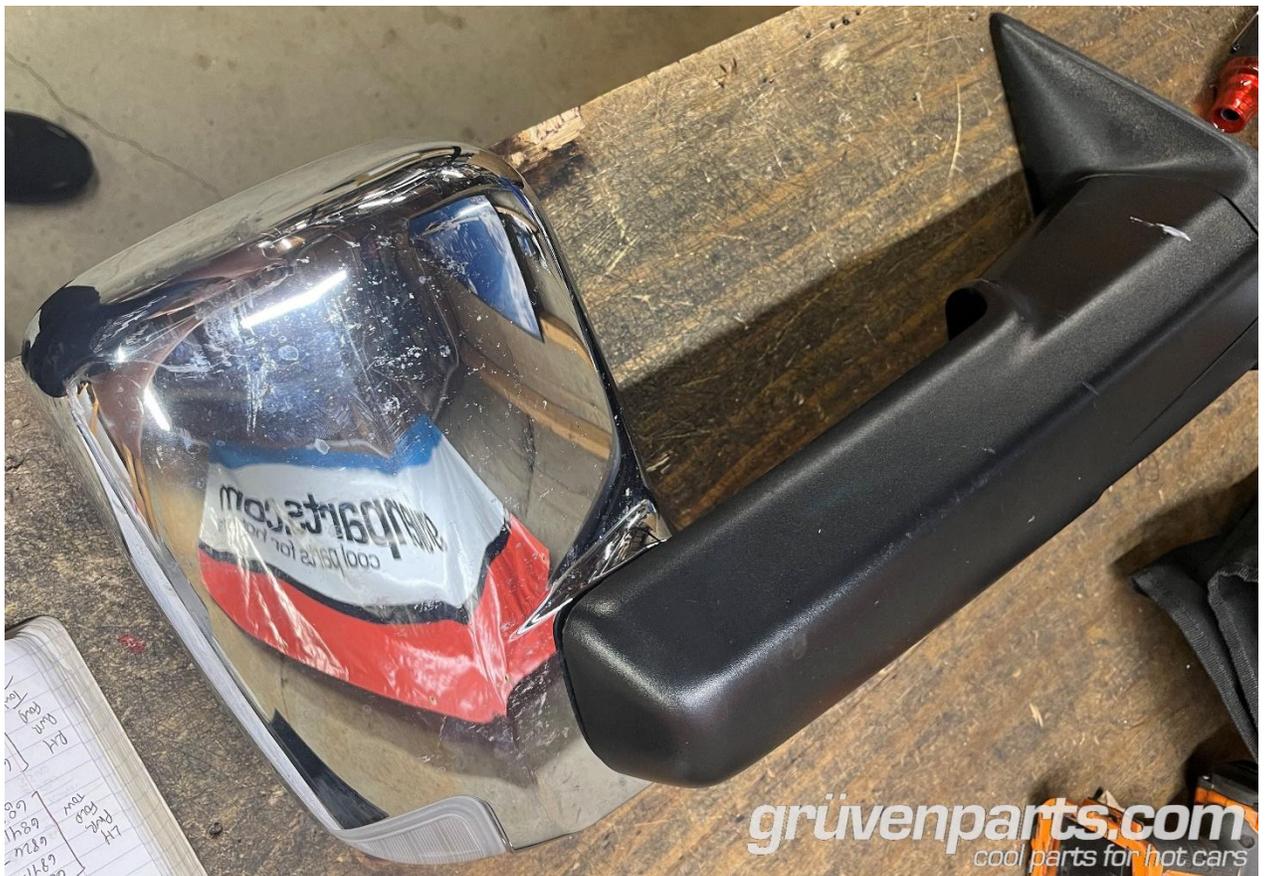
The Passenger Side 4<sup>th</sup> Gen Ram Towing Power Fold Manual Flip Mirror Assy shown below in Figure 1 removed from vehicle (not necessary to remove mirror from vehicle). This view is looking aft with the manual flip mirror deployed.

**Figure 1 – 4<sup>th</sup> Gen Ram Tow Flip Up Mirror, Passenger Side, Looking Aft**

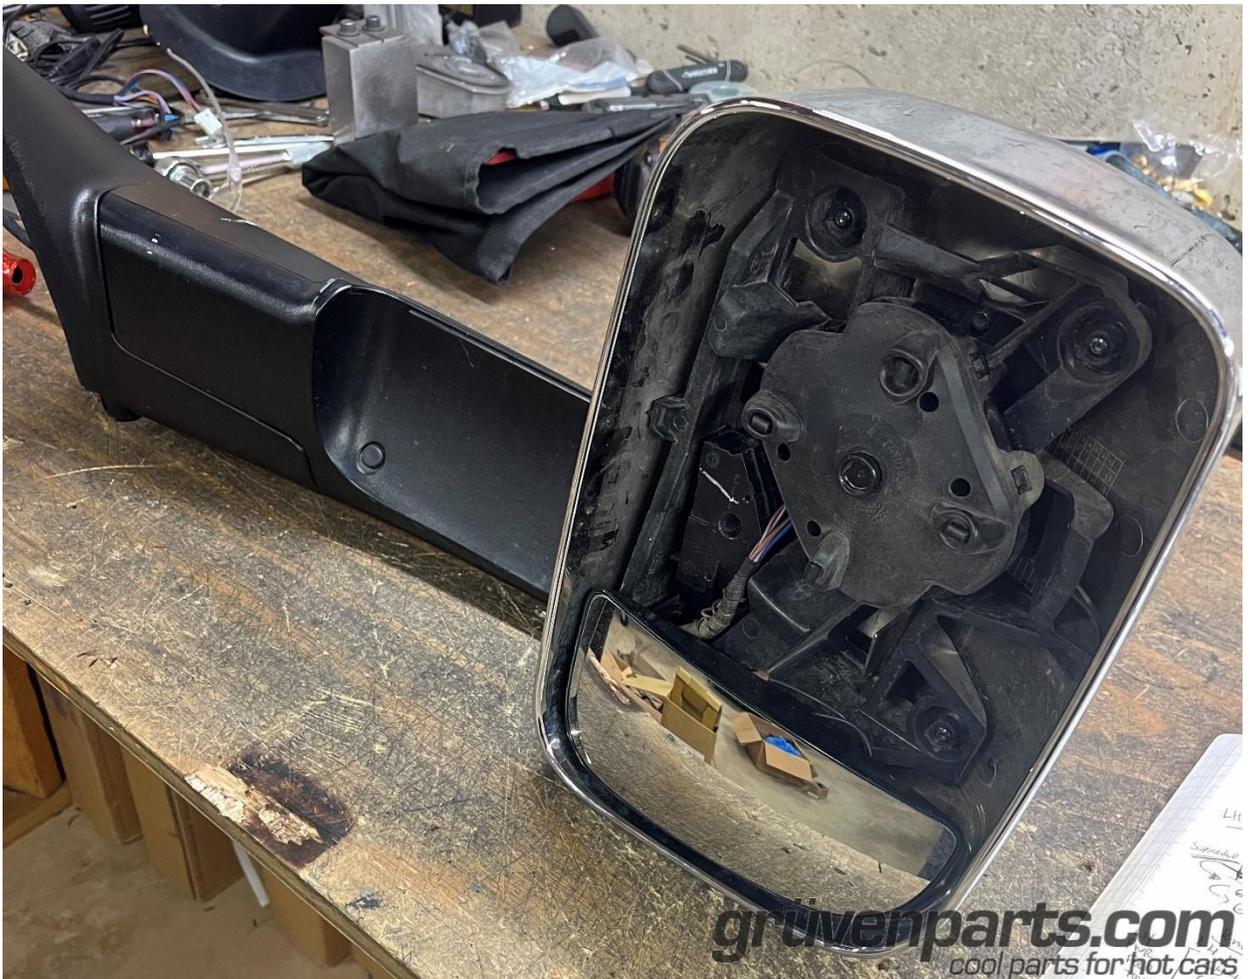
Figure 2 shows the same mirror assembly looking forward. Please disregard the mirror glass being removed. That is **NOT** necessary.

**Figure 2 – 4<sup>th</sup> Gen Ram Tow Flip Up Mirror, Passenger Side, Looking Forward**

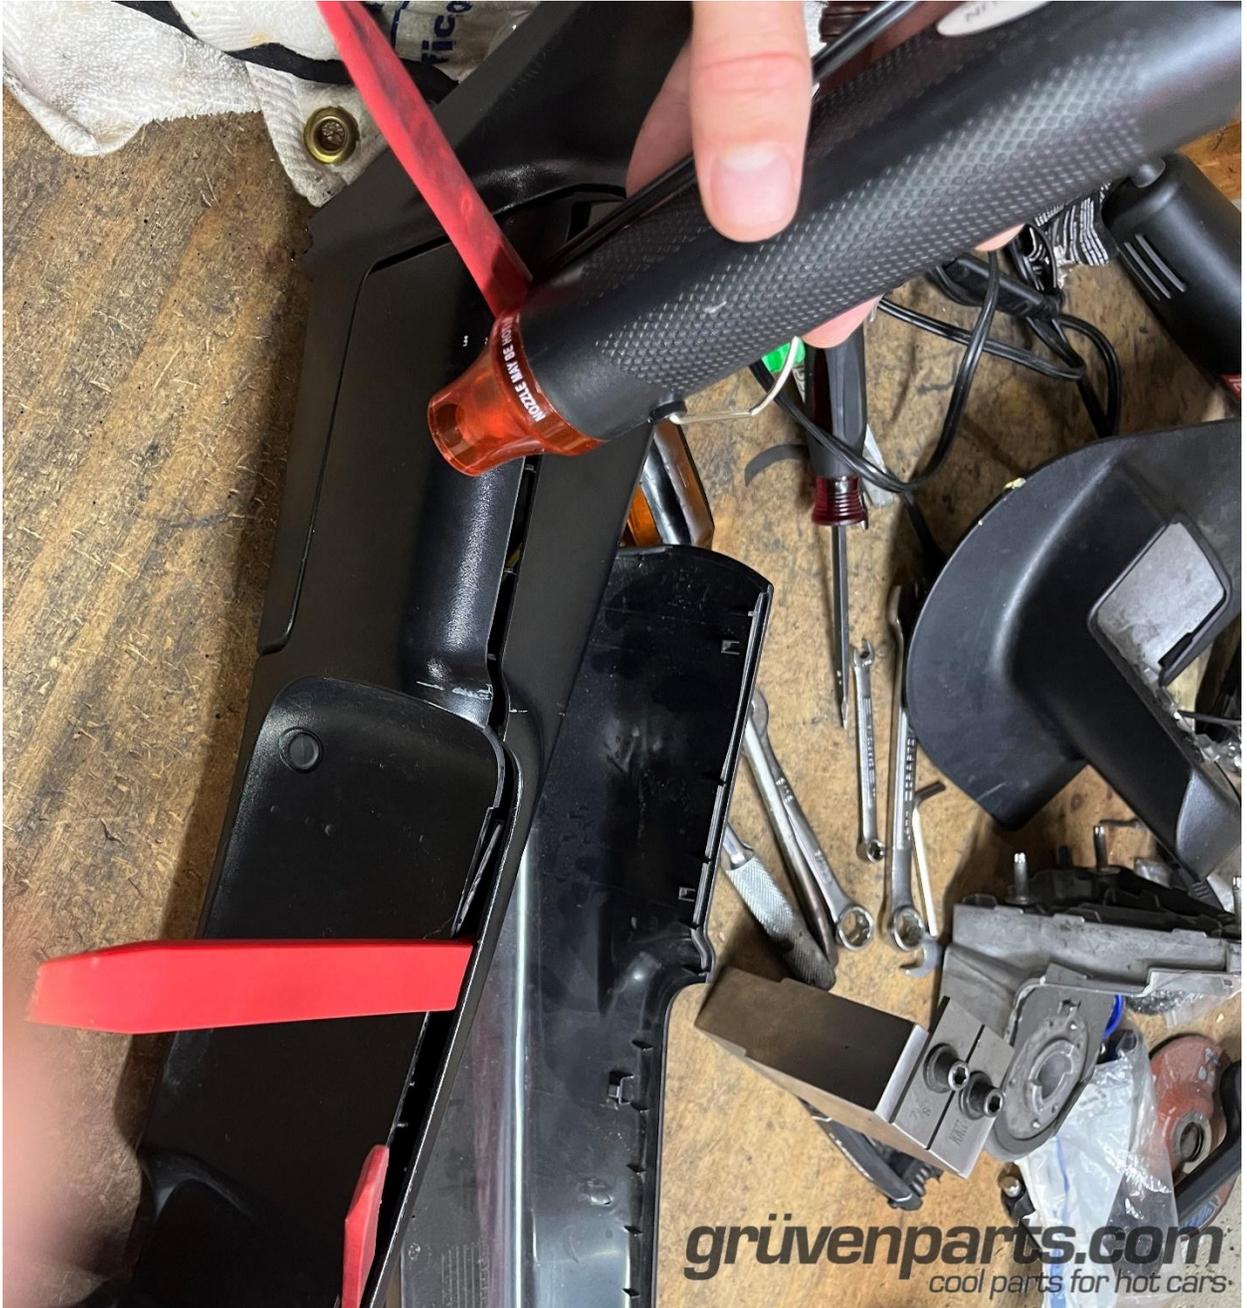
**Figure 3 – Using Plastic Pry Tool to Disassemble Mirror Trim**

2. Apply soft heat from a hairdryer or other small air heating device to the forward trim piece that runs along the side of mirror from inboard to outboard along its top surface as shown. Figure 3 is looking forward. Use a PLASTIC (not metal) trim pry tool to gently loosen and remove the front trim panel.

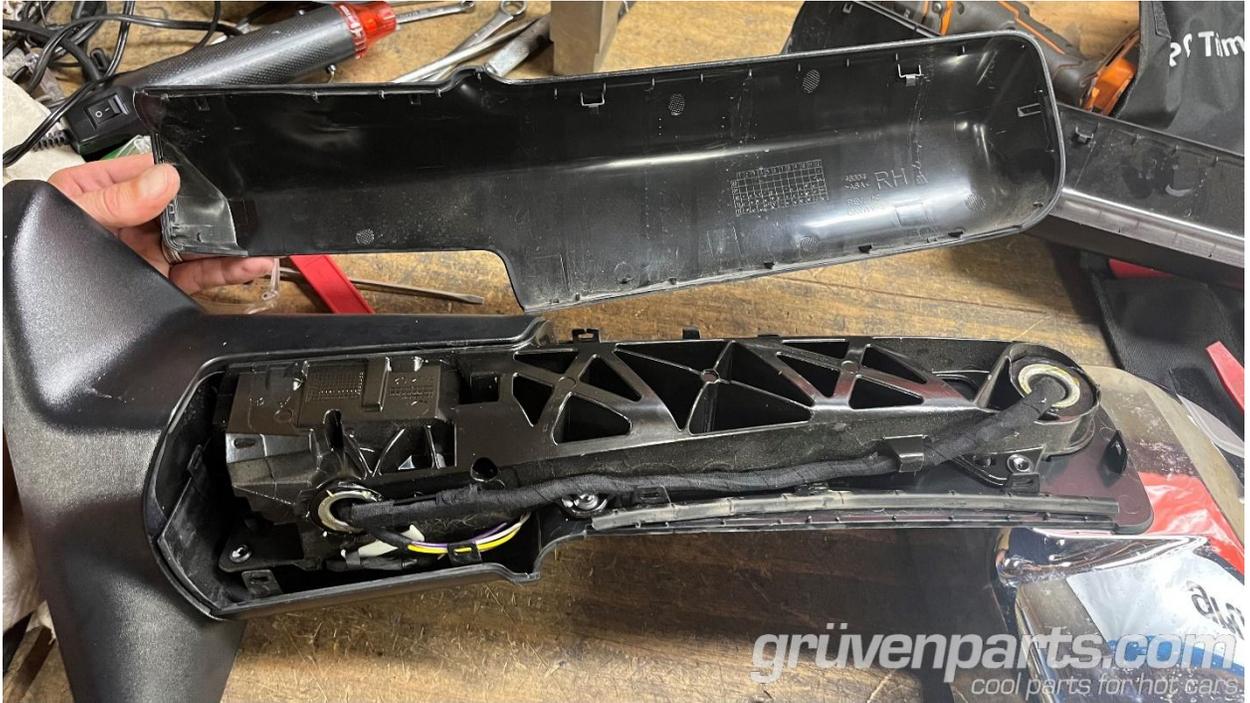
Figure 4 – Front Trim Panel Removed

3. Remove front trim panel as shown in Figure 4. Now the wiring harness is exposed and you can see it running down thru the hollow mirror power fold pivot tube. On the outboard side it runs thru another pivot tube for the manual flip up towing mirror - we will **NOT** be touching the outboard tube area.

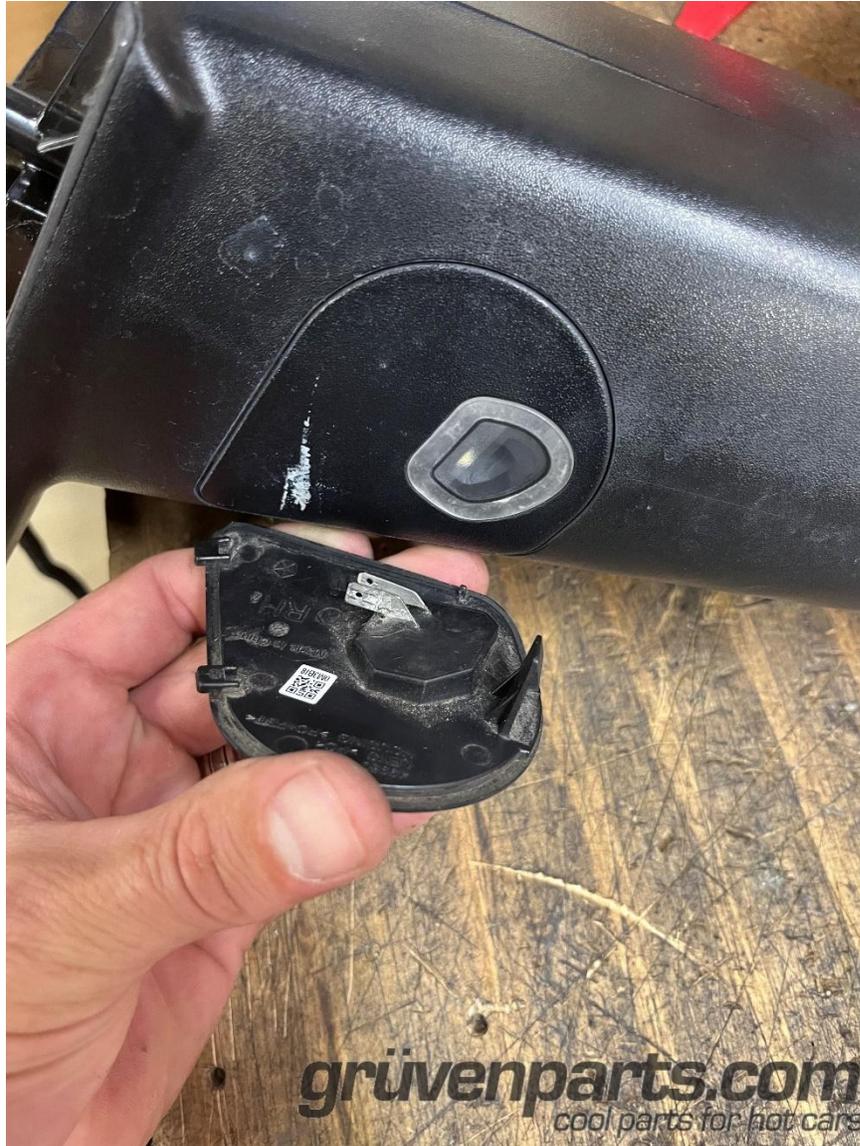
**Figure 5 – Lower Access Panel Removal**

4. On the bottom of mirror frame, remove the access panel (which houses the puddle lamp on some models) as shown in Figures 5-7. The access panel pivots on 2 tabs located on the inboard end of the cover and should be removed using a small plastic pry tool on the outboard side of the panel. Disconnect the wiring to the puddle lamp if present, noting the wire locations for reassembly.

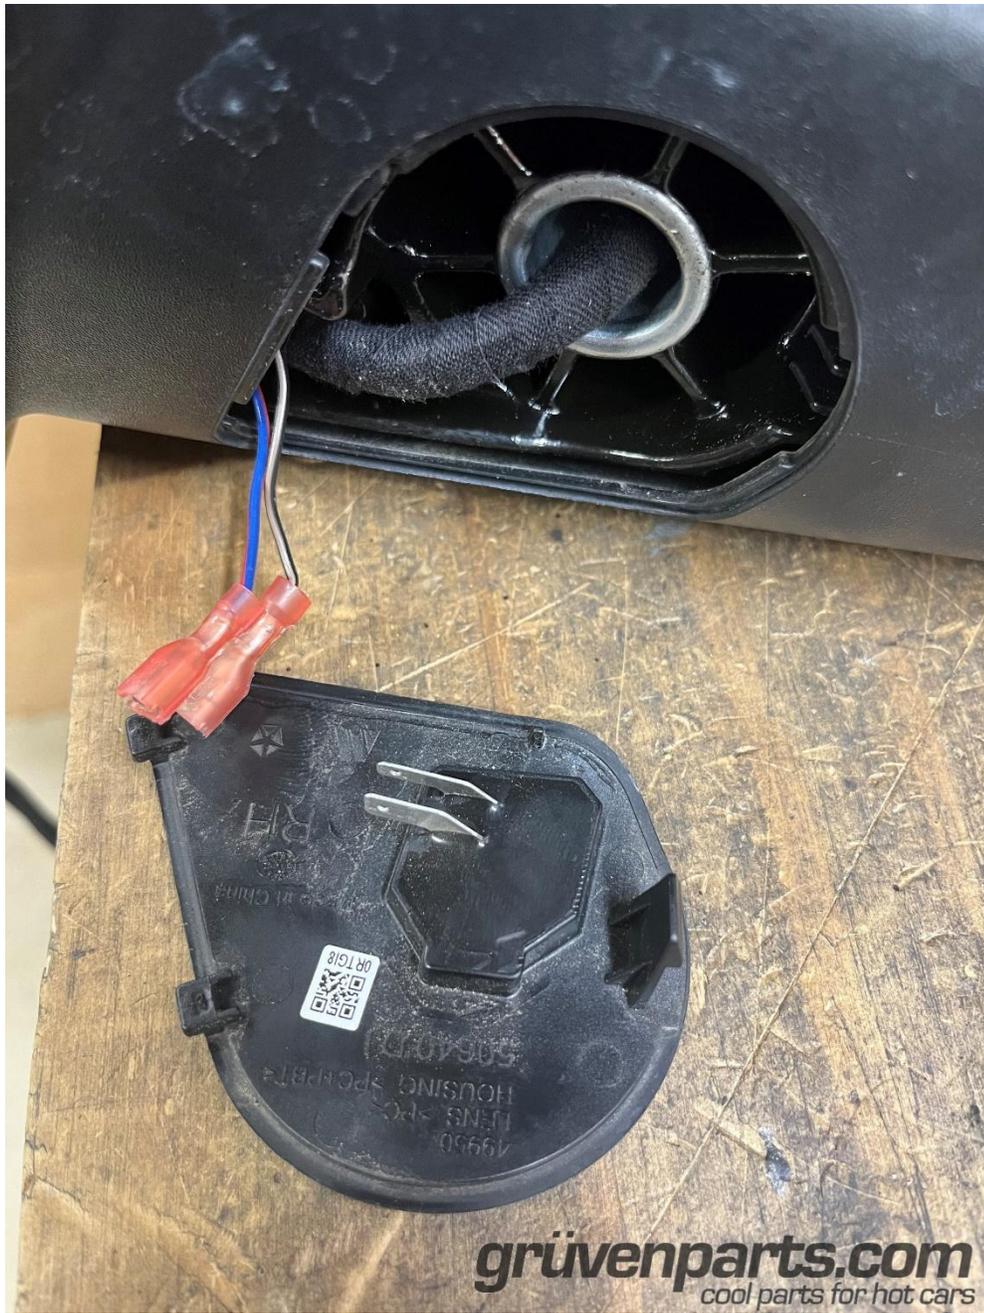
**Figure 6 – Disconnect the puddle lamp wires (if puddle lamp is present)**

Pull the wiring harness connectors (disconnected from the interior) thru the main power fold pivot tube so that tube is free of any wiring. Figure 6 shows a close up view of the wire harness as it goes thru the inboard mirror pivot tube. It is this location where we must pull the wire harness back through.

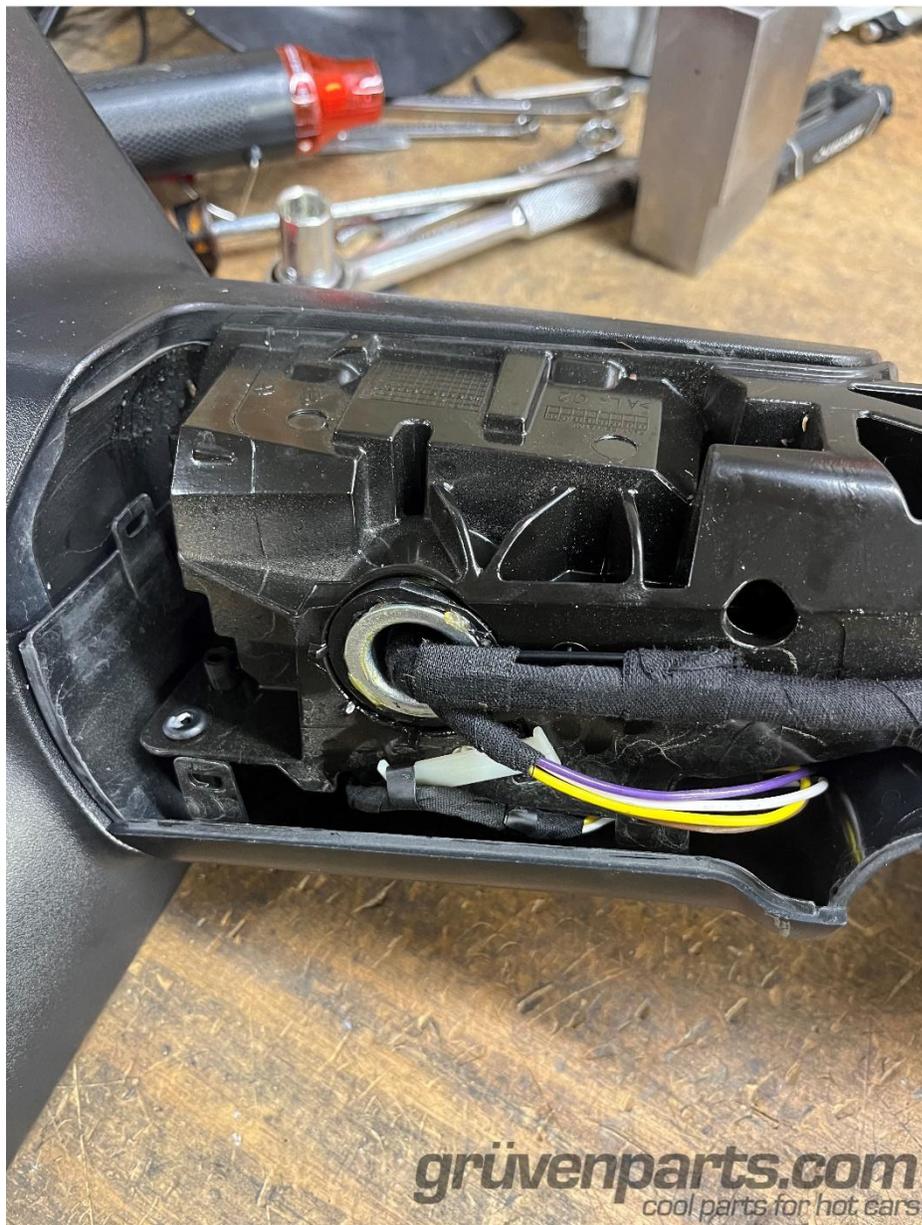
**Figure 7 – Main Wiring Running Thru the Power Fold Pivot Tube**

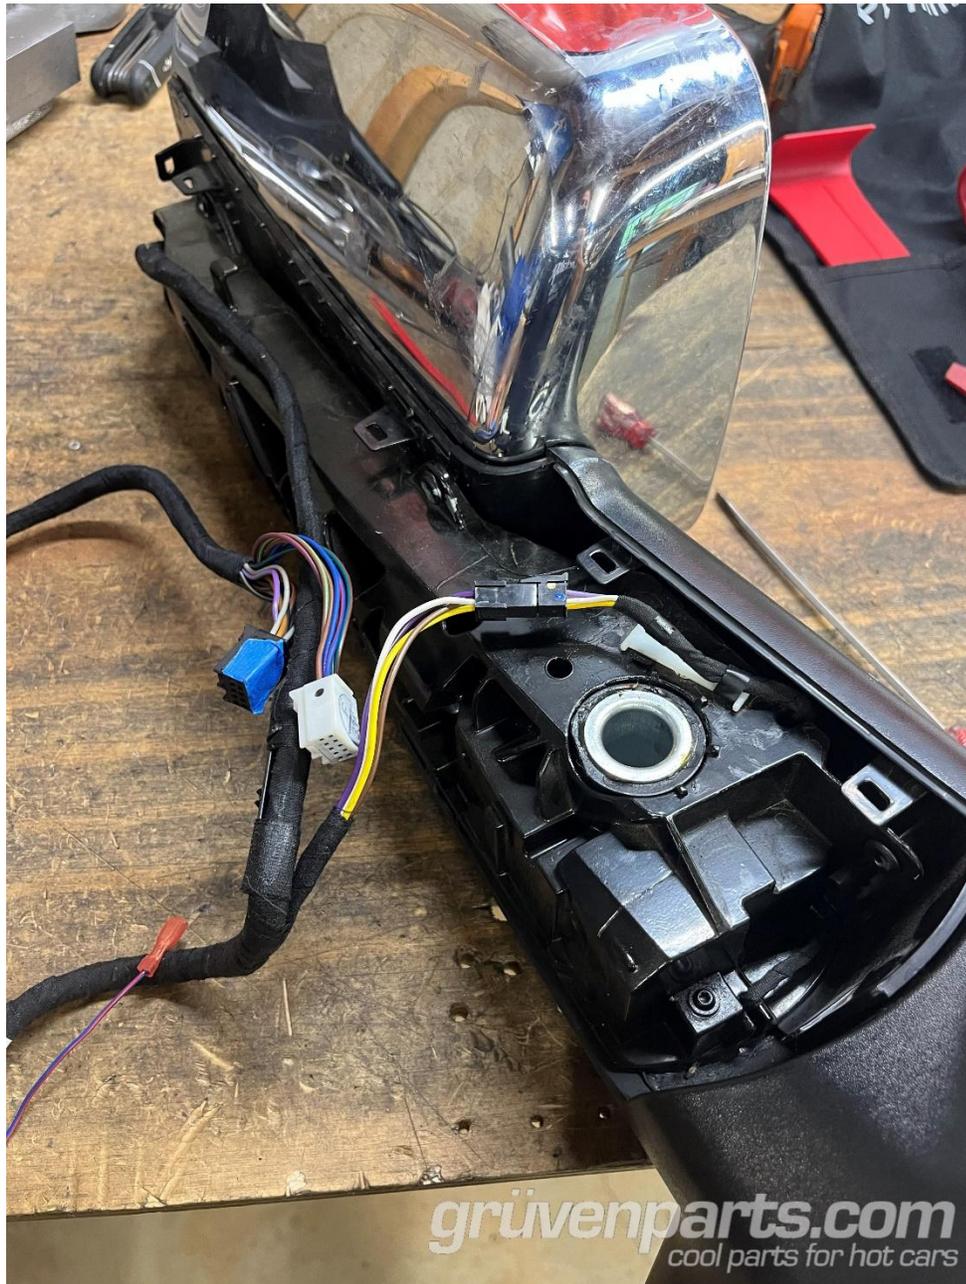
**Figure 8 – Wiring Harness Pulled Back Thru Mirror Power Fold Pivot Tube**

5. Once the lower access panel has been removed, gently pull the unplugged wire harness thru from the inboard side of the mirror assy, or inside the vehicle if mirror was left attached to vehicle for repair process. You may need to stagger the wire plug connectors so they don't get stuck in the pivot tube. Figure 8 shows the wire harness pulled thru the pivot tube and safely out of the way.

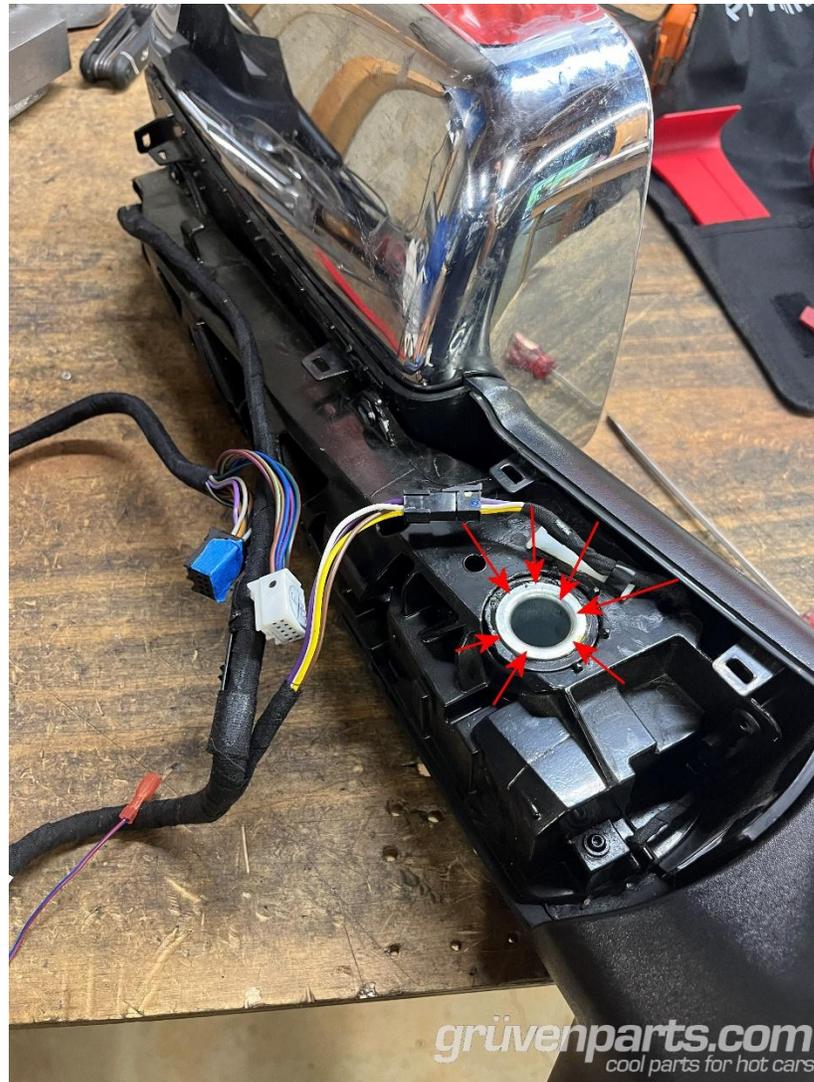
**Figure 9 – Location of Small Cuts to the Return Flange on the Power Fold Pivot Tube**

6. Once the main wire harness is pulled thru the pivot tube and safely out of the way, use a small cutting tool like a Dremel too to cut small incisions at the Red Arrow locations shown in Figure 9 in the return flange (swaged end) on the top side of the mirror power fold pivot tube. Don't worry about the plastic washer under the tube flange as that will get replaced. Once several cuts have been made, pry the swaged tube flange up to release the plastic black washer and spring under it. To prevent the spring below the flange from flying out, you can use a thin wire and tie it thru the tube to prevent the spring from flying out when the tension is released.

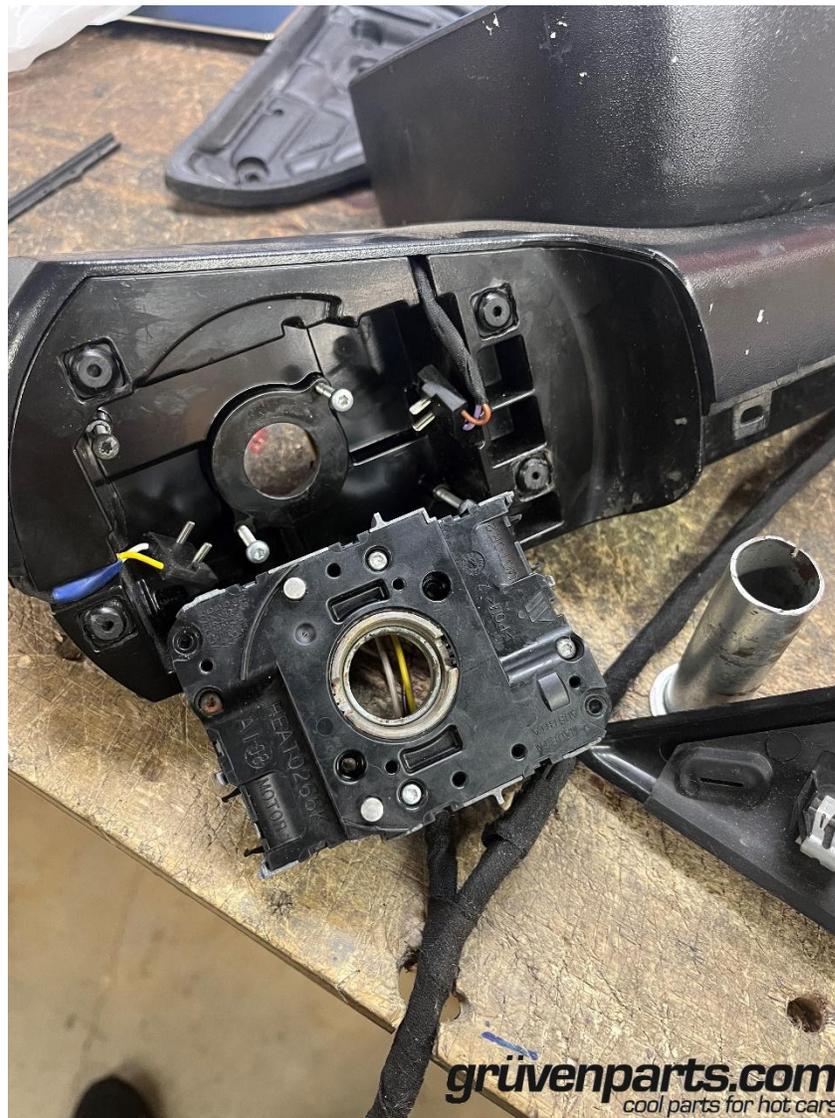
Figure 10 shows the mirror head assy and the gearbox we are after. Its bolted into the top of the mirror housing from the bottom side using 4 small torx screws. It has 2 plugs for the 2 motors within it. Once you unbolt the small 4 torx screws you can lift the drive box out of the mirror head and unplug the 2 motor connections.

**Figure 10 – Gearbox Drive Unit Removed**

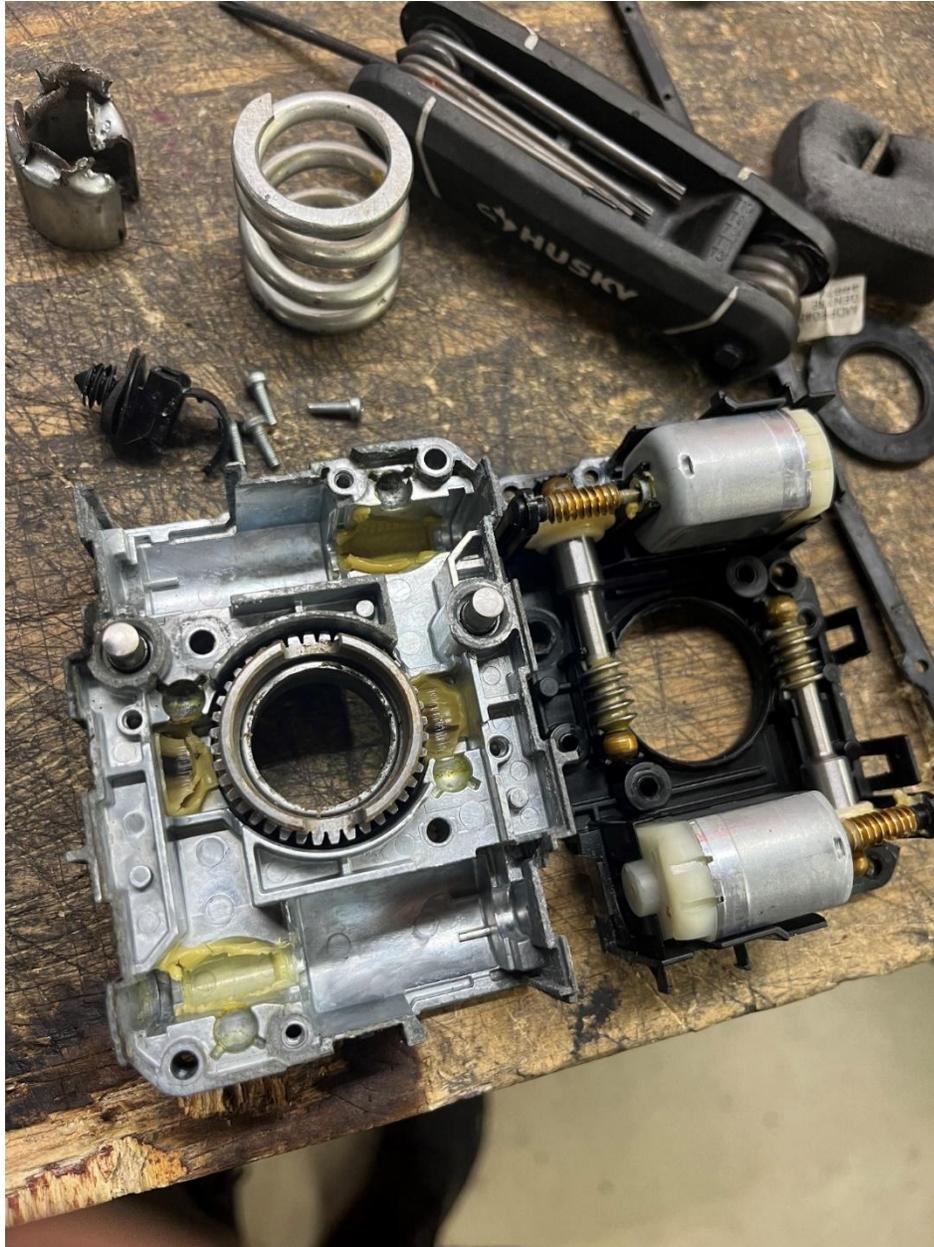
**Figure 11 – Gearbox Drive Unit Disassembled**

8. The drive box itself is bolted together with small torx screws and has some plastic clips. You will need to remove the screws and separate the plastic clips then gently separate the drive box halves. This exposes the 2 gears and motors in the drive unit that Ram never wanted you to find.

You will re-use the OEM motors and replace the plastic gears with the GruvenParts steel integral gears. Figure 11 below shows the drive unit disassembled.

9. Reassemble gearbox using the (2) GruvenParts high strength steel integral gear shafts and lightly lubricate all gears and internals with a plastic safe grease such as lithium grease. Once the gearbox is reassembled, plug in the unit and test the power fold cycle to ensure its working as it should. The drive unit case screws do not need to be super tight and that can cause jamming if over tightened. Hand tight, light tension is all that's needed on the drive box torx screws.
10. Reinstall the gearbox and bolt into place using the torx screws.
11. Install new pivot tube with flanged end at the bottom. You may need to gently persuade the replacement pivot tube thru the mirror frame with love taps from a mallet. Seat the bottom, flanged end of the replacement pivot tube fully into the bottom of the mirror frame.

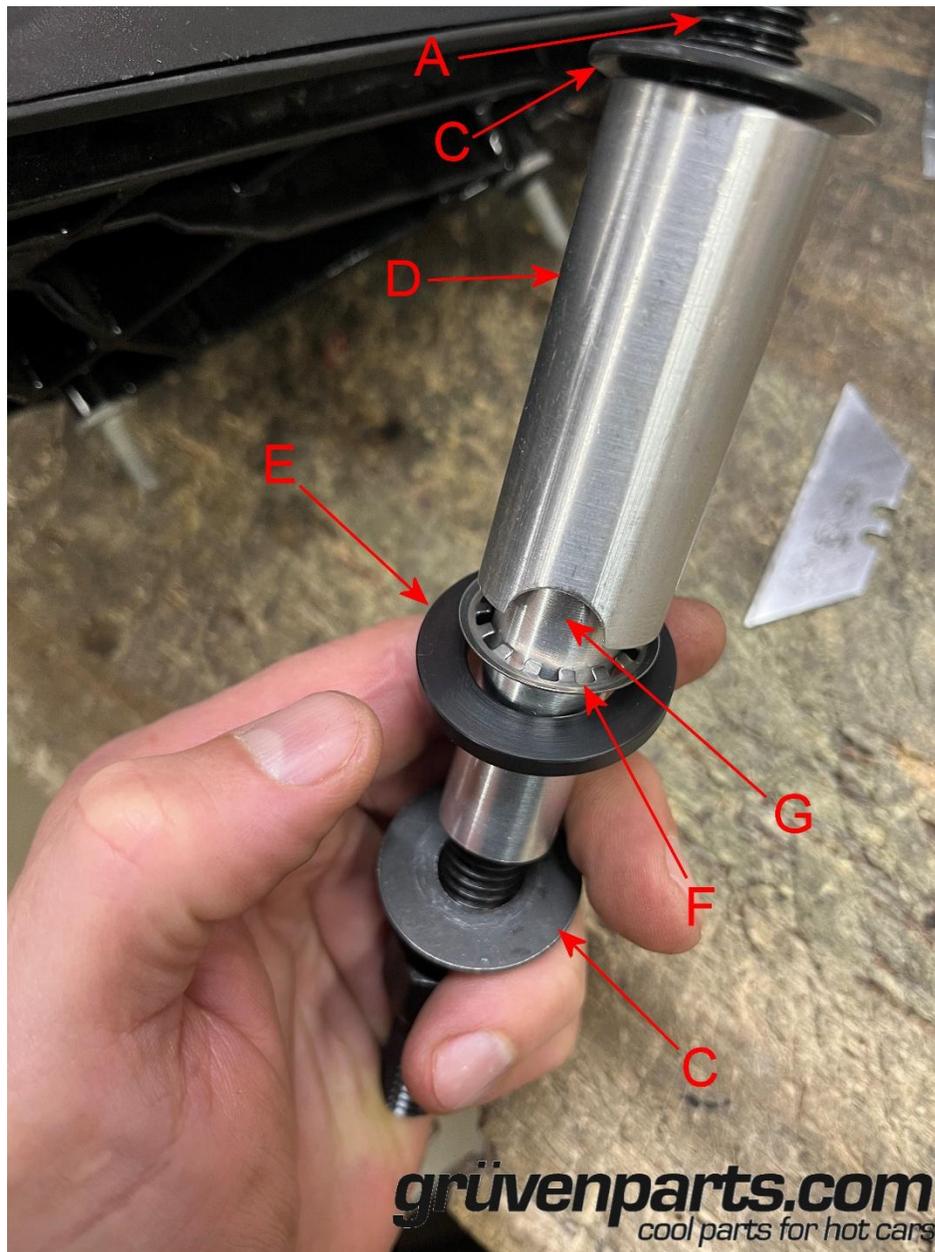
**A = Threaded Rod**

**B = Nut (x2)**

**C = Washer (x2)**

**D = Mandrel** – Position cut out so you can witness the lock ring position relative to the groove it will seat in

**E = Plastic Spring Spacer**

**F = Lock Ring** – Position so the 14 tabs face upwards

**G = Internal Locator Tube**

Figure 12 – New Pivot Tube Installation Hardware

Install threaded rod (A) thru the new mirror pivot tube and thru the internal locator tube (G) with nut (B) and washer (C) at either end. The top of the rod (A) should have the mandrel (D), lock ring (F) facing up, and plastic spacer (E) all residing above spring. Tighten the top nut until the mandrel forces the lock ring into the small groove in the new mirror pivot tube. There will be an audible click and you can view it thru the viewing cut out in the mandrel. Then Slowly release the nuts (B) and remove the installation hardware.

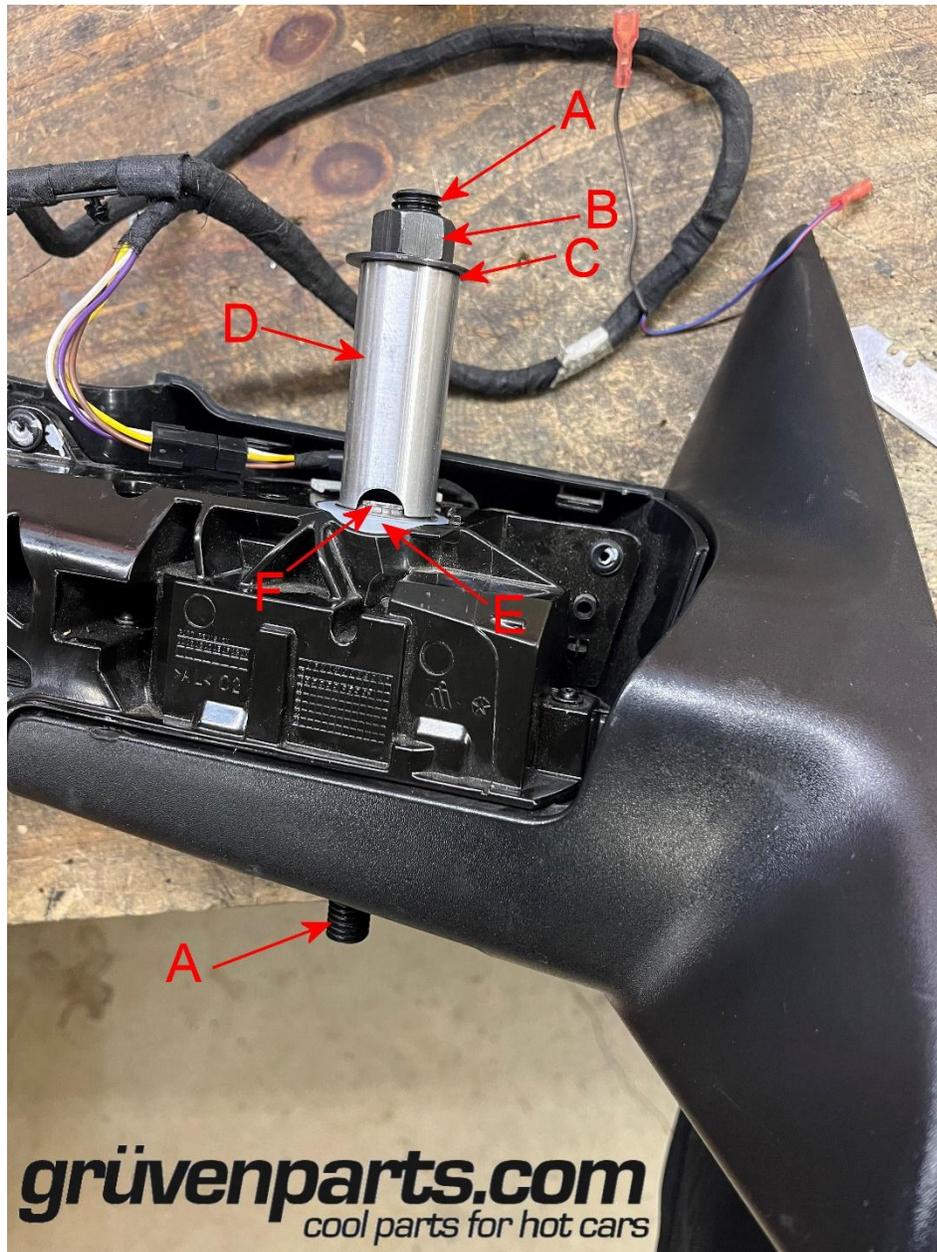
Figure 13 – New Pivot Tube Installation Hardware Installed on Mirror

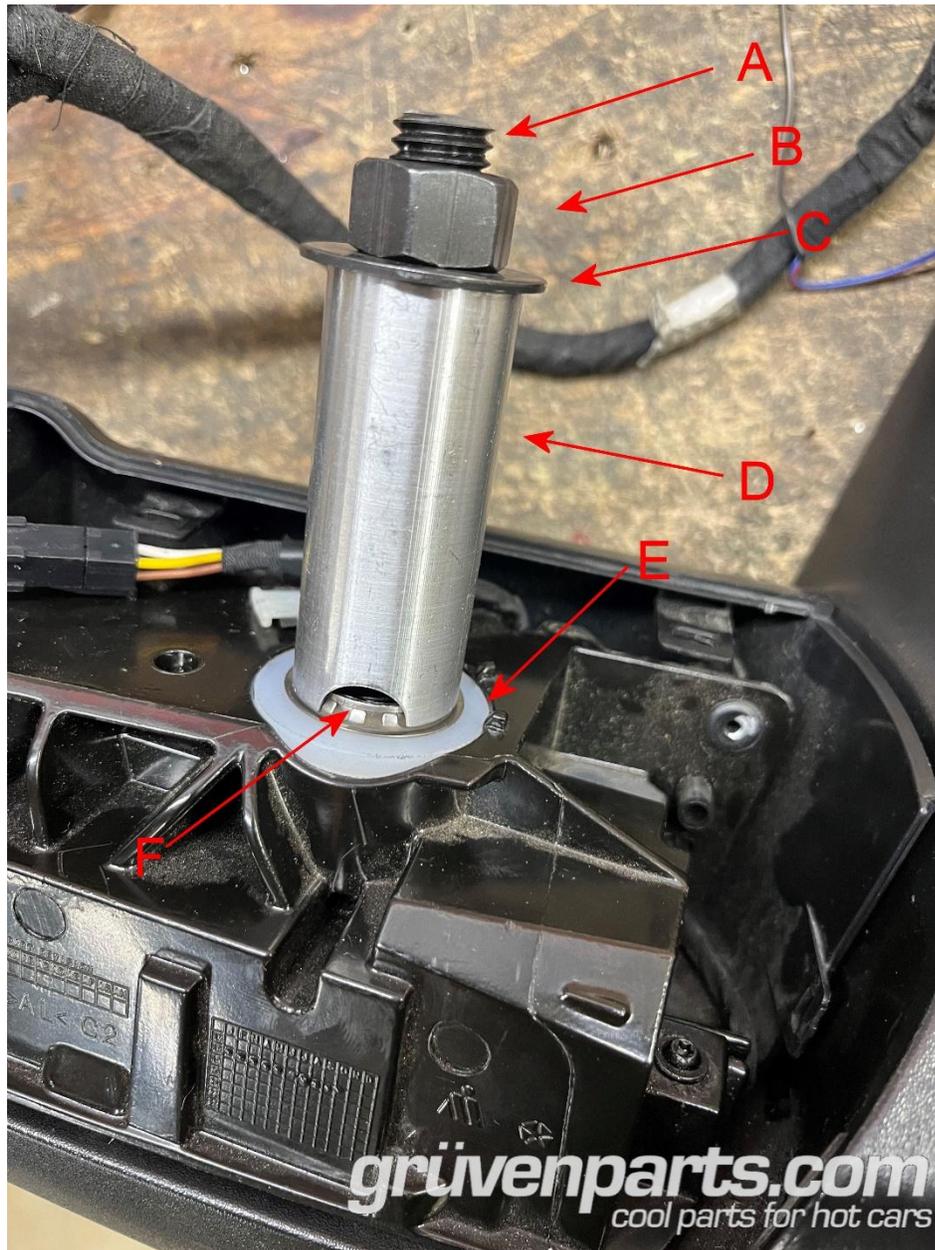
**Figure 14 – New Pivot Tube Installation Hardware Installed on Mirror with lock ring fully seated into the pivot tube groove**
