GruvenParts.com BRASS RAM 5th Gen (2019+) Power Folding Mirror Gear Replacement / Stop **Ring Instructions**

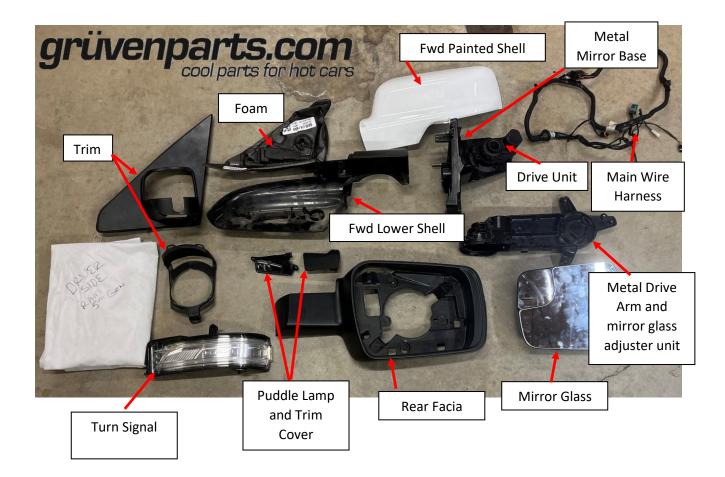
The picture below shows the all the components of a 5th Gen Ram power fold mirror assembly – drivers side. The Pass Side is similar.

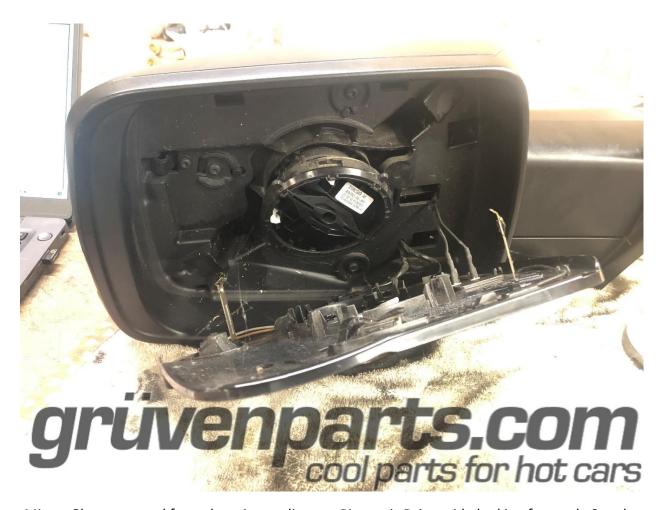
You will need to tilt the mirror glass down (as if you were backing up) so you can access the small area between the top edge of the mirror glass and the Rear Facia. You can gently pry this open more by using a soft, padded tool like the padded handle of a pair of channel lock pliers. DO NOT PRY OPEN TOO HARD OR YOU COULD BREAK THE GLASS OR REAR FACIA. Once the opening is wide enough, reach in with a small flat head screwdriver and release the top inner and top outer clips holding the mirror glass to the mirror adjuster unit mounted to the metal drive arm. The video shows this process. Note there are a total of 4 clips that hold the mirror glass to the mirror glass adjuster unit – you only need to disengage the top 2 clips and then gently pull the mirror glass free of the mirror glass adjuster unit. Note there will be wiring still attached to the back side of the mirror glass so don't move the glass too far yet.

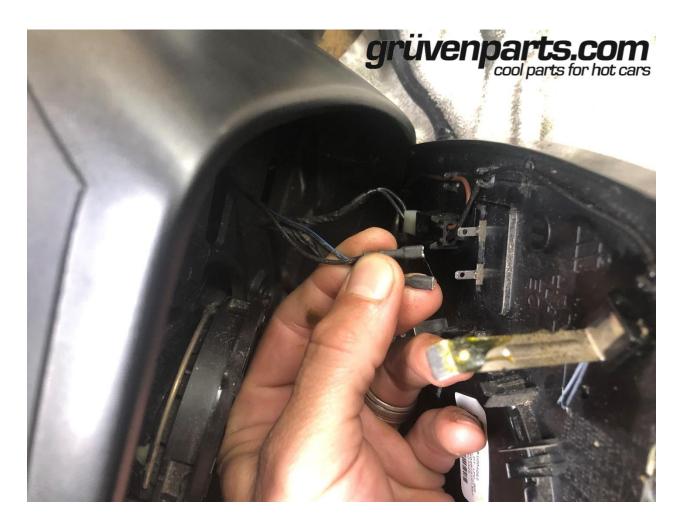
Mirror Glass removed from the mirror adjuster. Picture is Driver side looking forward. See the video link for details on how this was done. Note the wiring still attached to the mirror glass.

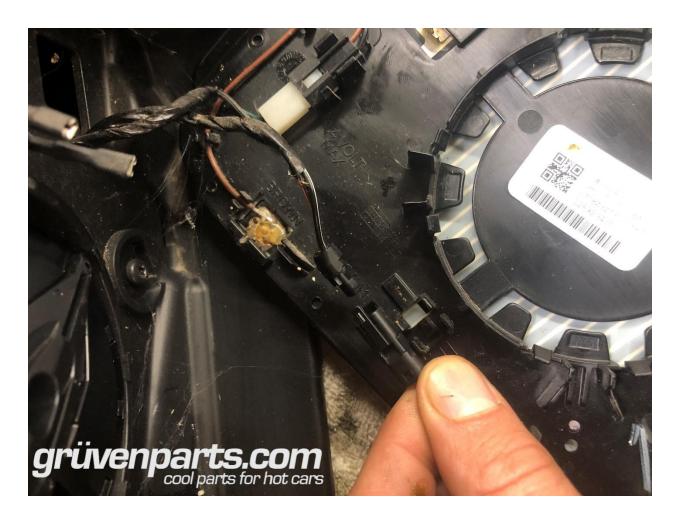
Now gently unclip the wiring associated with the mirror glass. There are usually 2 small black heater wires, then a wire plug. Unclip all and store the mirror glass in some bubble wrap.

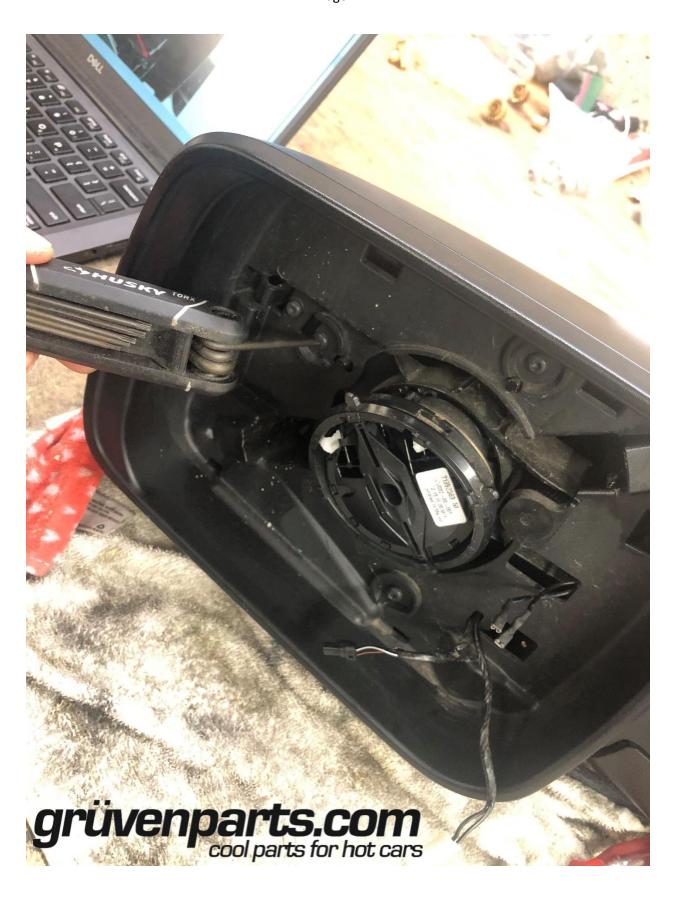
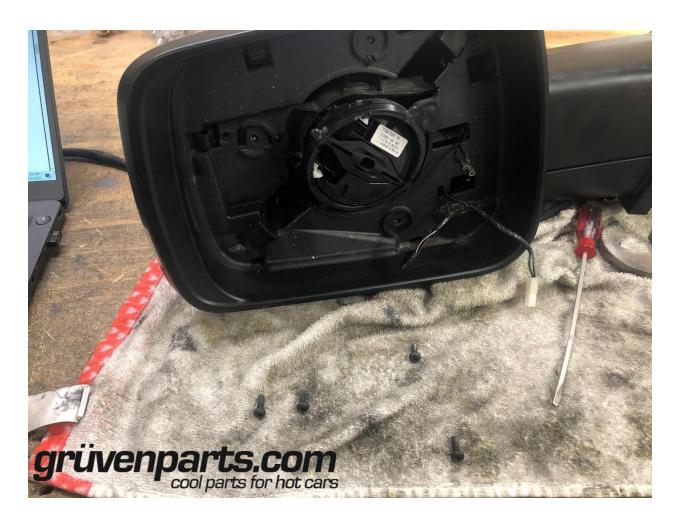
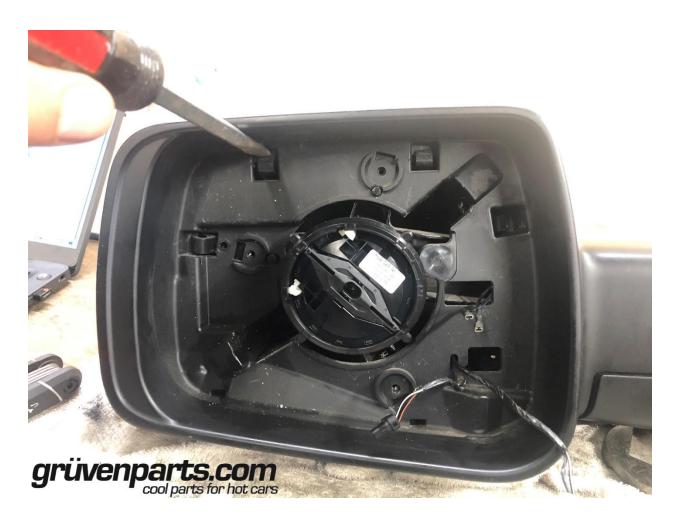
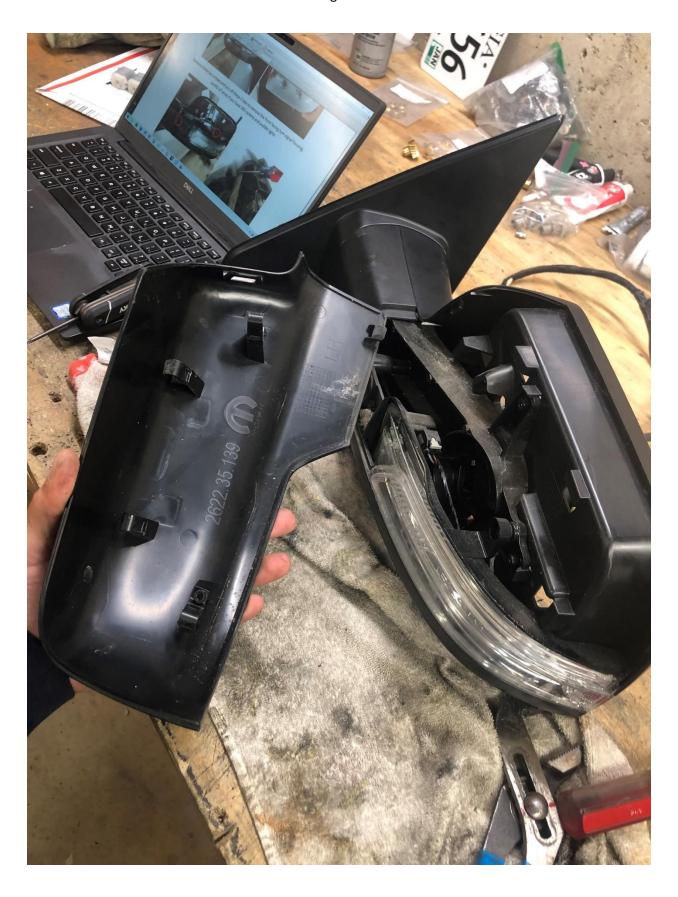
Step 2: Remove the Front Upper Painted Shell

Remove the visible torx screws and gently pry on the tabs that lock the front painted shell to the Rear Facia. The Front Painted Shell will pop off.

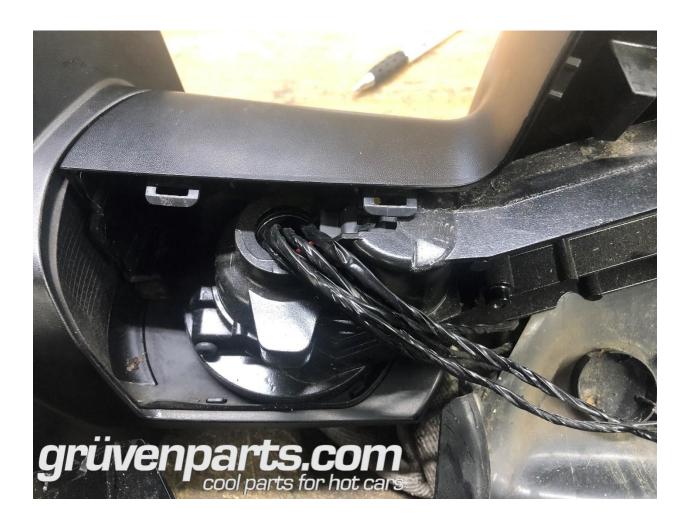
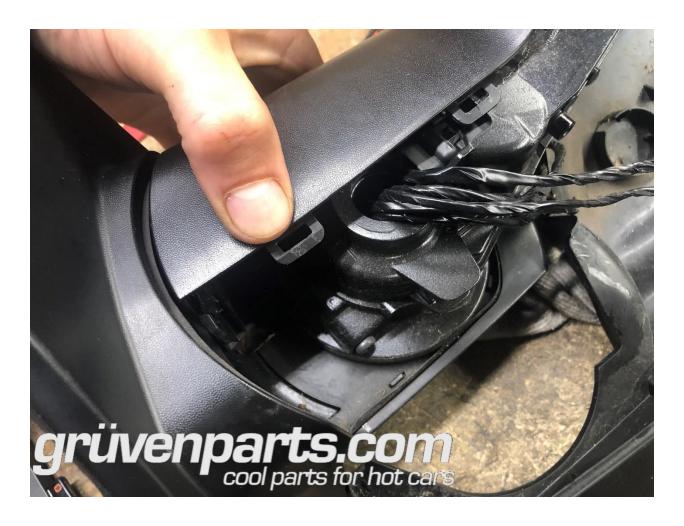
Step 4: Remove forward lower trim to expose the power fold drive unit. You can just unclip the tabs holding this in place carefully.

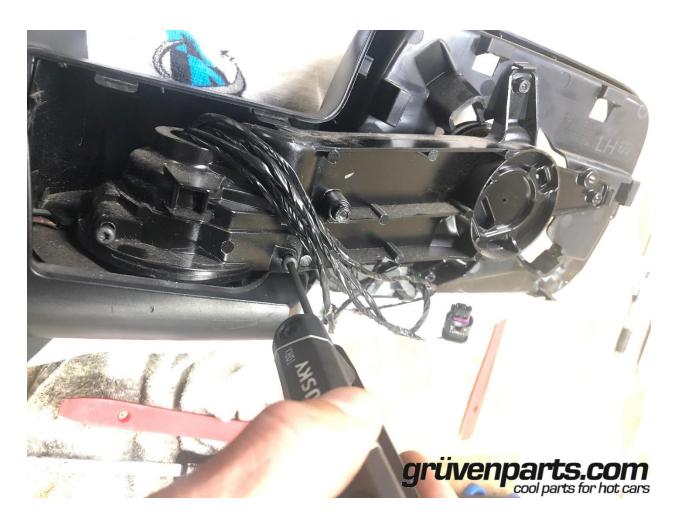
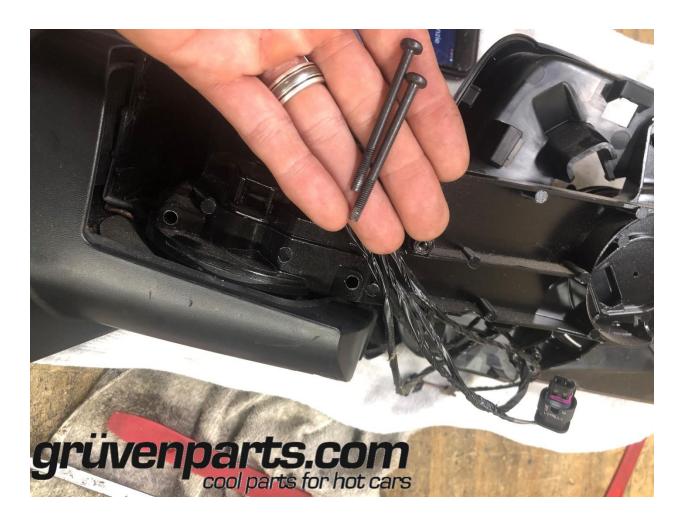
Step 5: Remove the metal drive arm by removing the 2 long torx screws that go thru the power fold drive unit. Wiggle the metal arm up and off of the power fold drive unit.

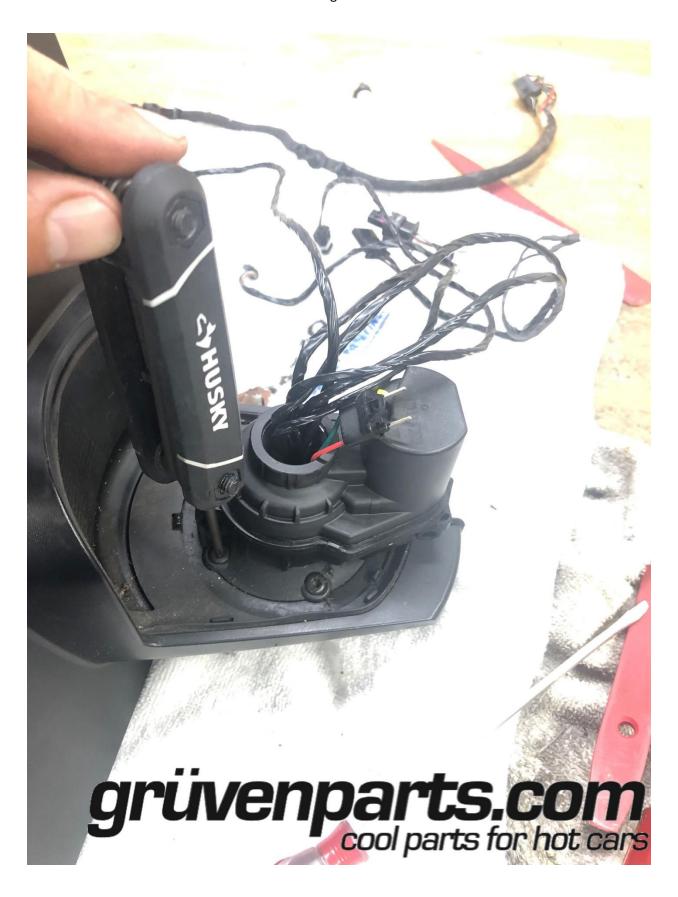
Step 6: Unbolt the drive unit from the vehicle and bring it onto a work surface.

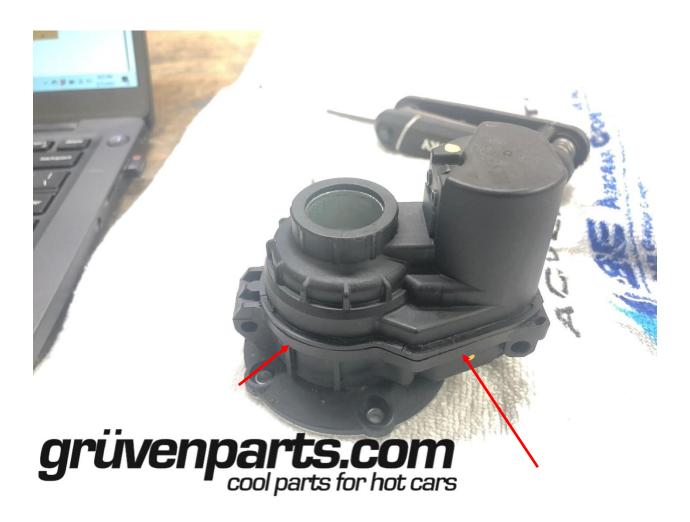
Step 7: Cut the plastic case just below the witness line where the upper and lower case halves were originally fused together. See Red Line in the picture below. You can use a small cutter such as a Dremel tool to do this. DO NOT Cut too deep. Work slow and cut just enough to separate the case halves. IF you cut too deep you will damage in the internal components. You can use a thin feel gauge to see if your cut has gone thru the case wall.

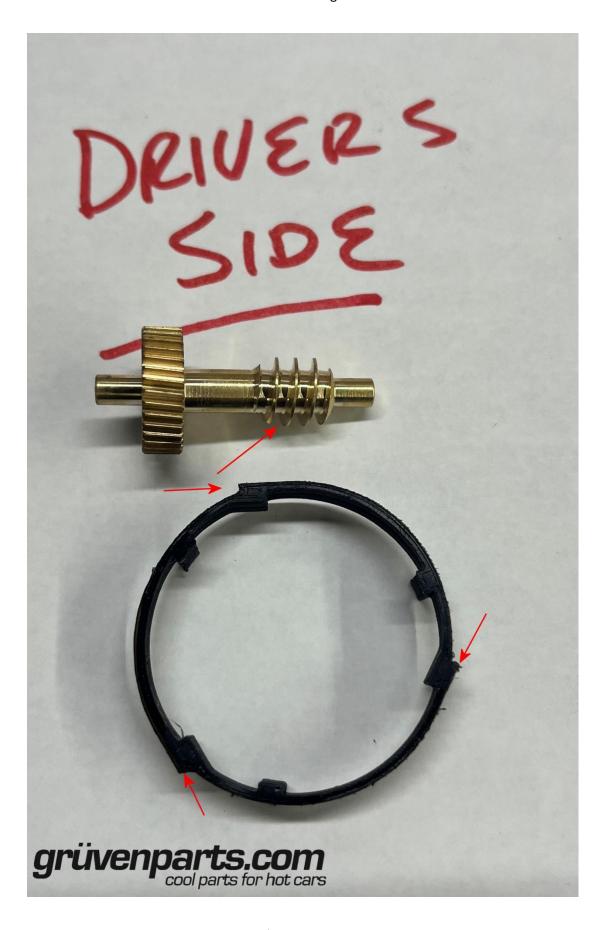
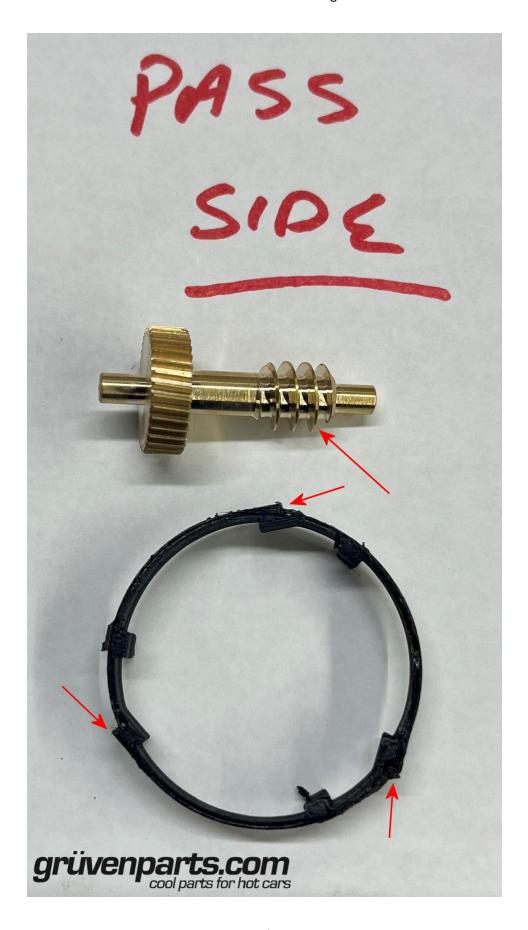
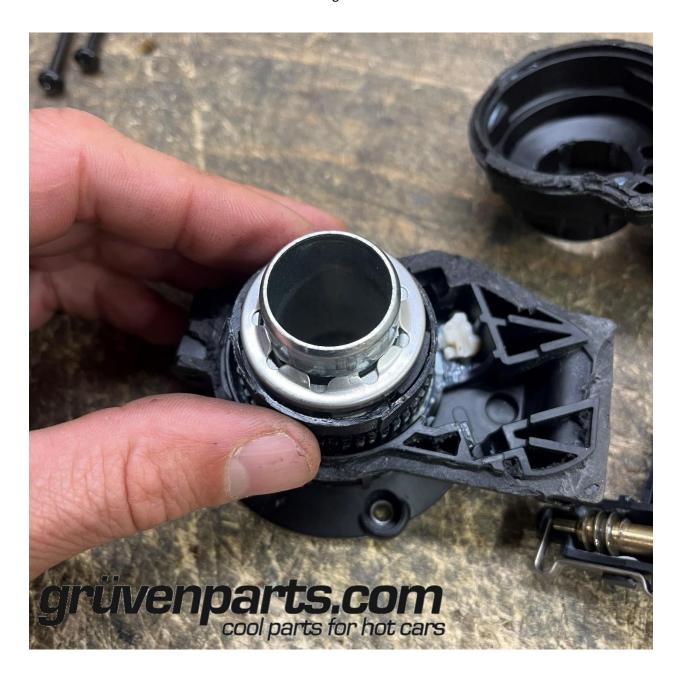
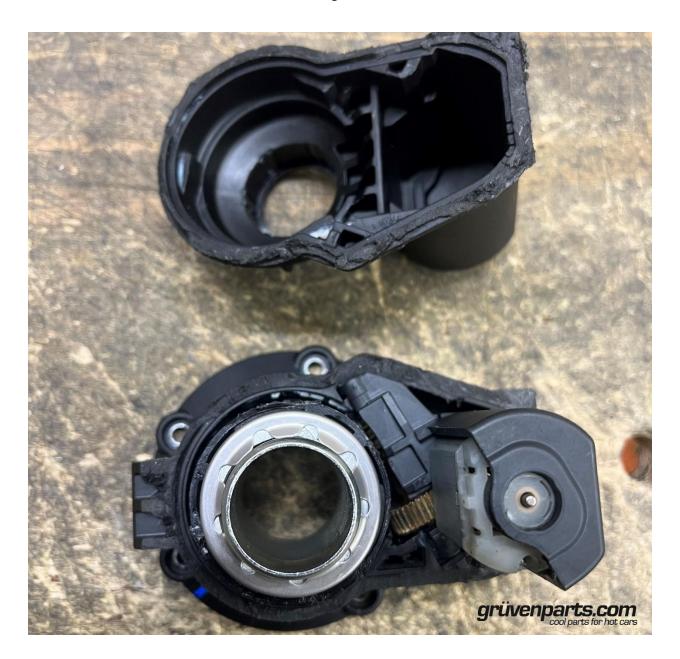
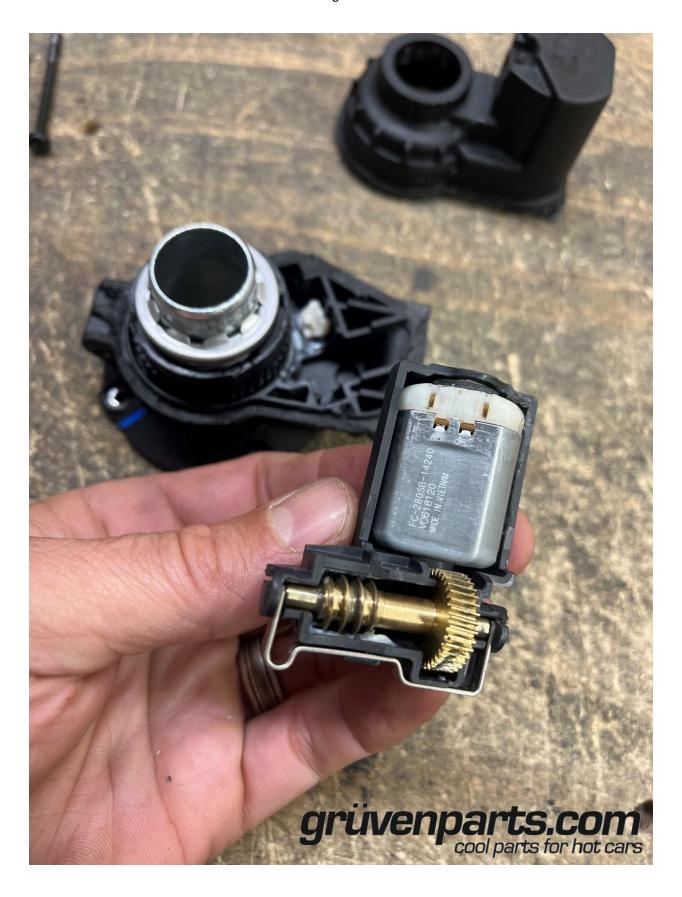
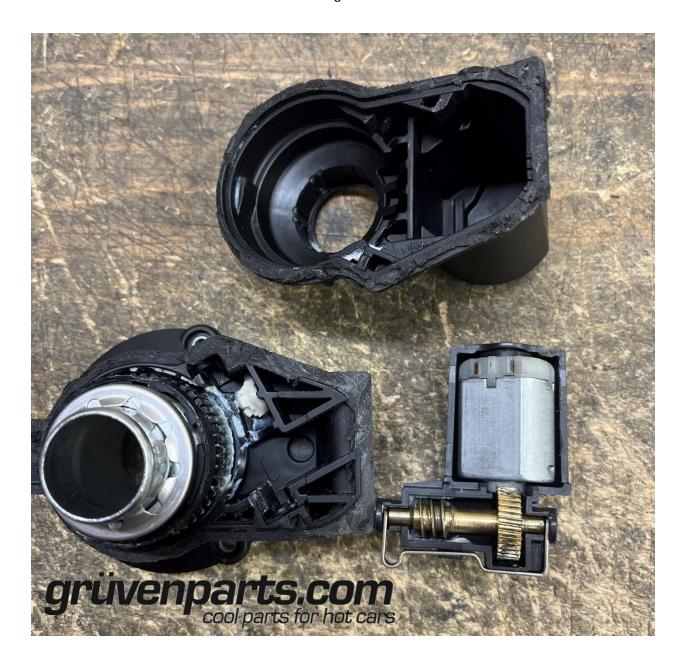
Step 8 – Remove the upper case half and clean up the cut surfaces – deburr and remove any debris. Remove the plastic OEM spiral drive gear and replace with GruvenParts all brass gear. Reinstall the C shaped metal bracket under the drive gear. Note in the pics below, the gruvenparts brass main gear has already been installed into the unit. Note the new brass gear and the Nylon stop ring are both side specific as shown below – do not install a passenger gear into a driver unit or it will sweep the wrong way! Note the direction of the worm portion on the shaft and how it leans differently for driver side versus pass side.

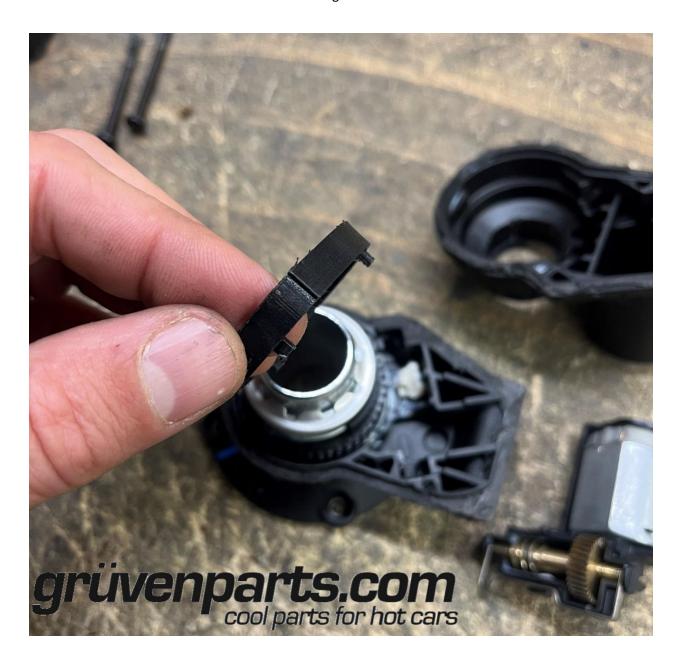
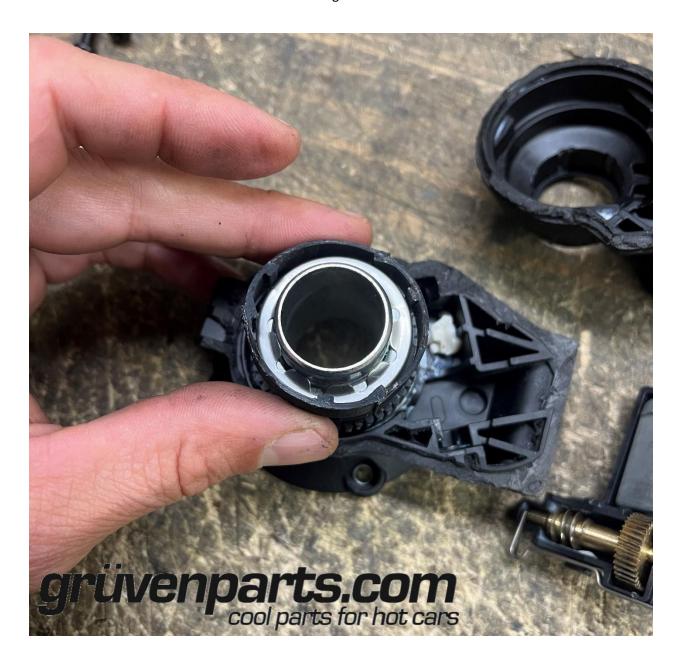
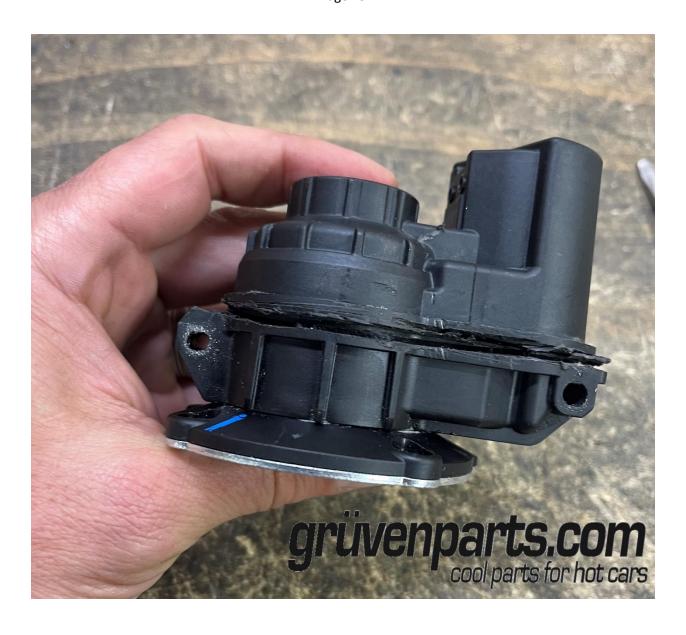
Step 10 – Remove remnants of OEM stop ring from the center gear under the main spring. Install the GruvenParts replacement stop ring with the 3 protrusions facing down. Then carefully test fit the upper case to lower case to ensure it sits flush such that the motor plug will fit in the motor. Note the stop rings are specific to each side. They prevent the arm from over rotating in the outward direction but do not limit rotation folding inwards. The metal frame has a built in stop to prevent over rotating inward.

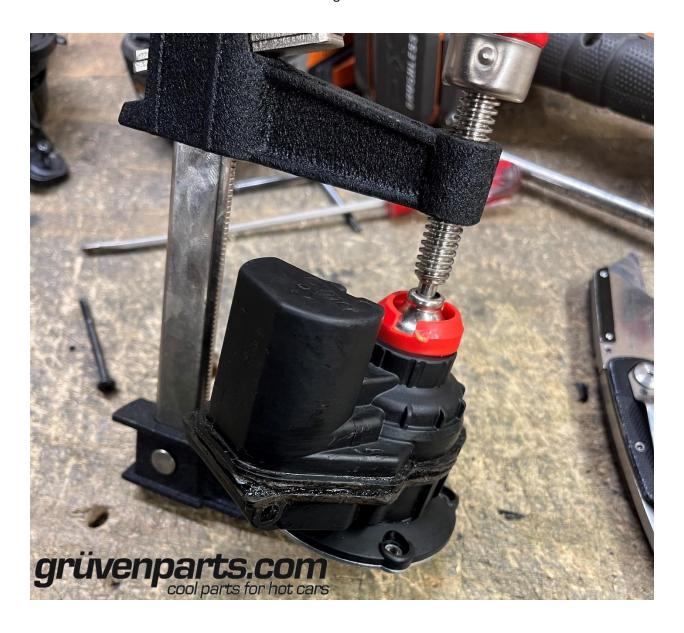
Step 10 – Plastic weld the case halves back together using a strong plastic epoxy. Clamp case and allow epoxy to fully cure.
