STEPS FOR REPLACING MKIV JETTA TRUNK LATCH MICROSWITCH

The following outlines the procedure for replacing the trunk microswitch on a MKIV Jetta (and possibly a Golf/GTI as well). These microswitches commonly fail, causing the trunk light to operate intermittently or not at all. Also, it causes the trunk open light on the instrument cluster to not work. The procedure was based on a 99.5 Jetta GLS VR6 - it may be slightly different on later-models cars (which have the emergency release inside the trunk).

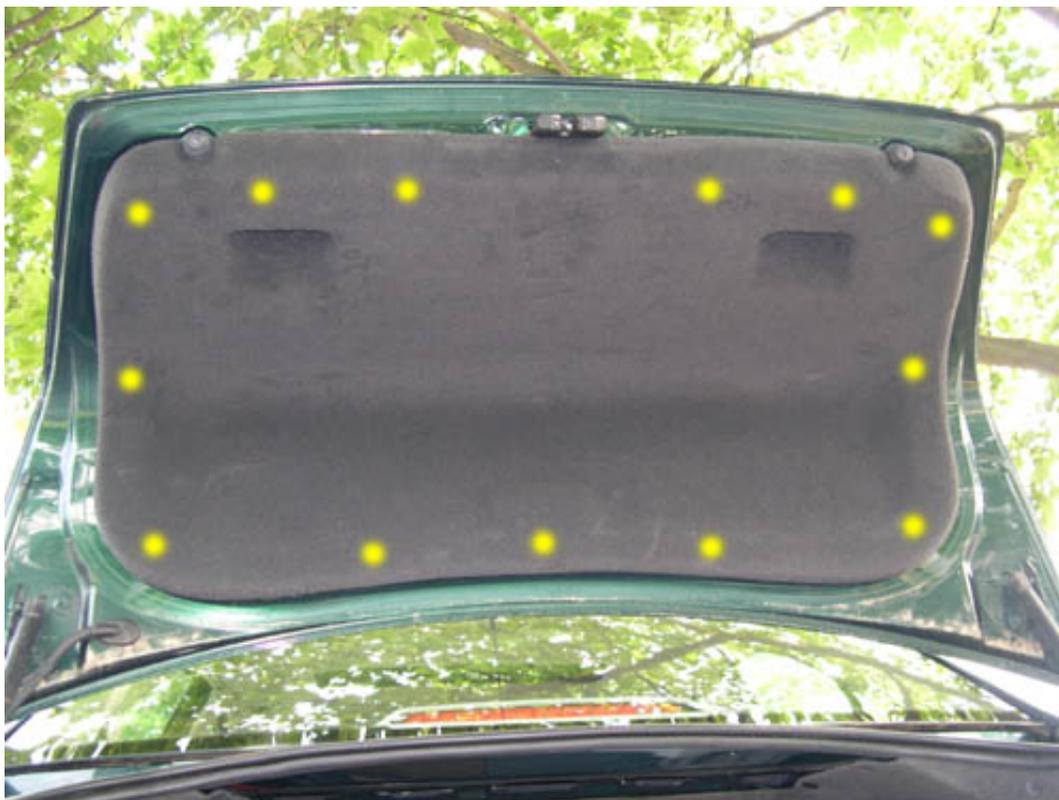
1. Open trunk lid and remove the carpet lining. There are 13 Phillips head screws which are located approximately where the yellow circles are in the following picture.

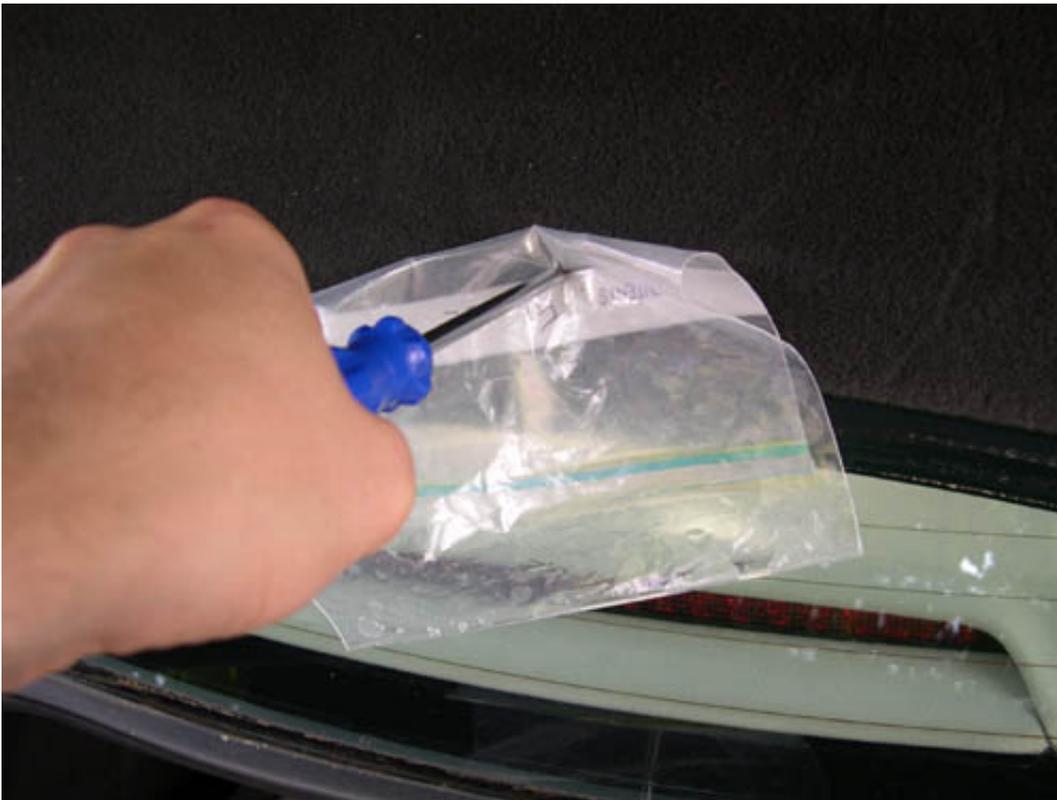
2. The screws in the above picture are coated with carpet fibers, so using a bare screwdriver may scratch the coating off. I used a ZipLoc Freezer bag folded in half to prevent this from happening, as shown below. It did a pretty good job of keeping the screw coating intact.

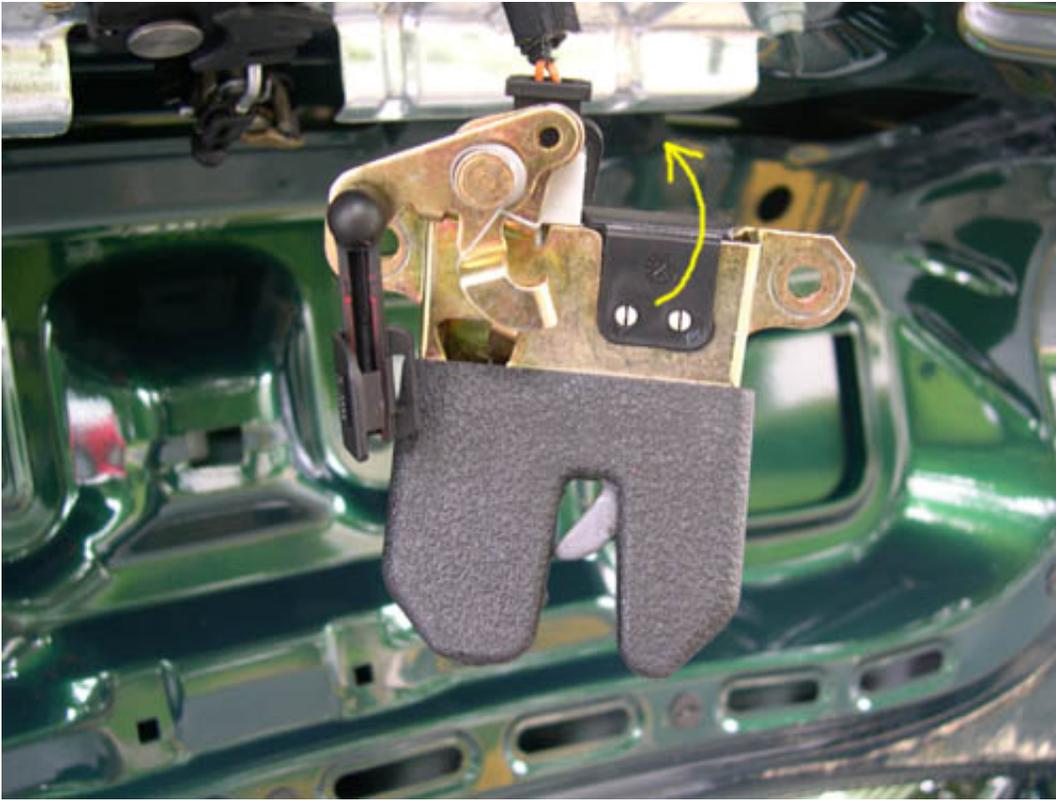
5. Flip up microswitch retaining flap on underside of trunk latch assembly (yellow arrow in picture below).

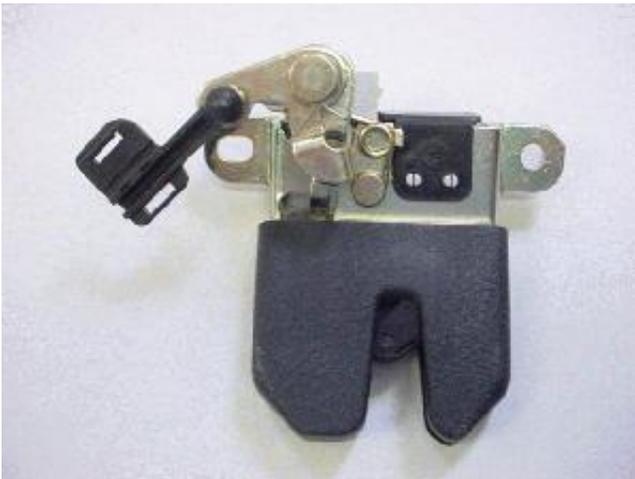
In case someone needs to replace the entire latch assembly, the VW part# is 1J5827505D01C. The cheapest price I've seen it for is \$44.76 at [1stVWParts](#). I'm not sure if the latch assembly comes with the micro, but based on the image below that I found on [IMPEX's](#) website, it looks like the latch may come with a micro.
